City of Lewiston

Fire Station Study

February 16, 2017 rev.

RE: 4137.00 / Lewiston Fire Station Study – Final Report

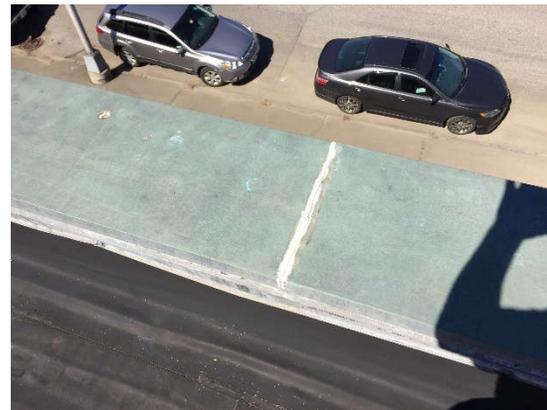
Roof System: The existing membrane roof system was last replaced in 1988. Roofing is placed over Precast Planks and Tee's. Signs of wear were observed around the base of the chimney. Moisture has infiltrated the insulation at the hose tower. The parapet cap flashing has been sealed which indicates there have been leaks. The current roof is in fair to poor condition, is nearing its useful life expectancy, and should be replaced in the next 1 to 5 years. Thermal improvements such as 3" or more of roof insulation over the roof deck would likely reduce energy cost. Insulating up the back side and over the top of the parapet will help reduce thermal bridging.

Photo CS-A1 – Membrane blisters

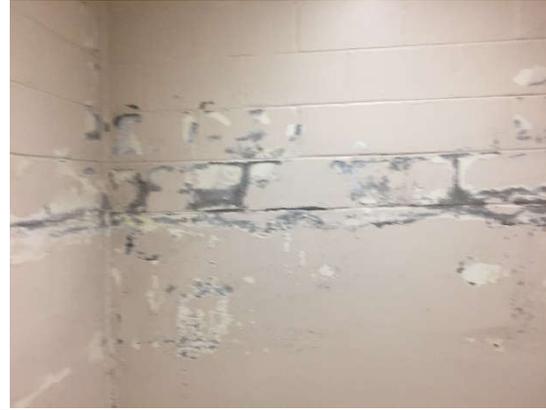
Exterior Wall System: Consists of 8" load bearing CMU with 2" air space and 4" face brick. Existing drawings indicate that the 2" air space has 1" +/- of cavity insulation. This insulation is likely a mineral wool or polystyrene as it is exposed to moisture. At best, the existing wall insulation R-value is R-5. Code minimum is R-13.3 continuous insulation. Based on the existing drawings, attached as "Exhibit A", wall and roof insulation do not connect. This creates a thermal bridge which allows moisture to build up inside the wall system. Wall system moisture damage was observed in Stair 1. The 4" face brick has weeps at the base of the wall and vents at the top of the wall which helps the 2" cavity to drain and dry out moisture. The exterior wall system is in fair condition but is poorly insulated. Envelope concerns such as deteriorated or open mortar joints, areas of moisture infiltration, fractured brick units, stress cracks in the masonry assembly and worn expansion joint materials need to be addressed. Thermal improvements to the exterior wall would likely reduce energy cost as well as reduce damage to interior finishes left by the formation of condensation within the CMU back-up wall. Thermal improvements could occur on the inside or

Photo CS-A3 – South Façade

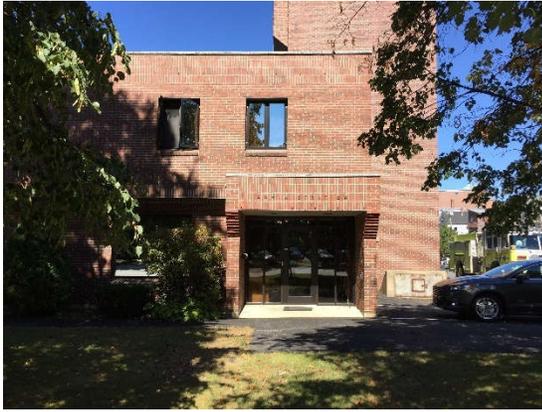
Exterior Aluminum Storefront: There are 2 exterior aluminum entry storefront doors which were replaced on or about 1998. Door in image A7 below is in good condition. Door in image A8 below is in poor condition. Storefront system in image A8 below is beginning to rust at the base. It should be replaced in the next 1 to 5 years.

Photo CS-A7 – East Entrance

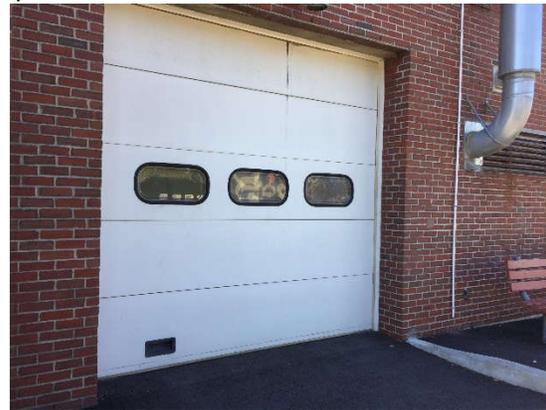
Exterior Overhead Doors: There are 7 exterior overhead doors. All of these doors are in good condition. Useful life expectancy is 10+ years with proper annual maintenance.

Photo CS-A9 – View of South Doors

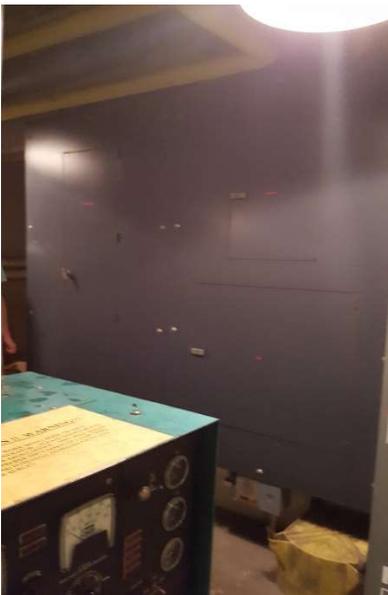
From the main electrical panel, power is distributed to several sub panels located throughout the facility. Most electrical panels appear to be in fair condition but do not appear to have circuits labeled well. A lack of existing spare circuits or breaker space to add future loads also appears to be an issue throughout the facility.

Photo E1 – Main Distribution Panel

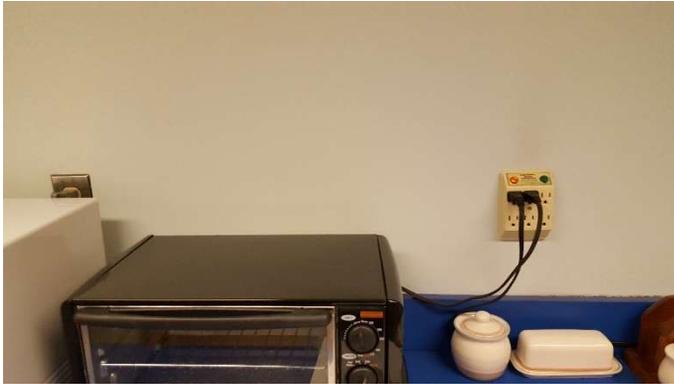
It was also noted that receptacles in bedrooms and living area are standard duplex receptacles rather than tamper-proof receptacles as required by Code (*NEC, Article 406.12*).

Photo E3 – Break Room Receptacle

- Install arc-fault circuit breakers for branch circuits feeding bedroom, living area and kitchen loads.
- Install tamper-proof receptacles in bedrooms and living area.
- Replace existing lighting fixtures with new LED fixtures.
- Install emergency battery packs or a separate life safety transfer switch
- Install communication cabling support system
- Install fire alarm system.

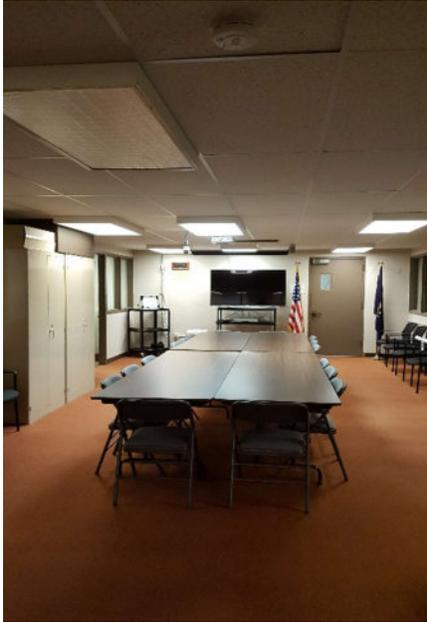
Corridor, office and common area lighting typically consist of either ceiling recessed or surface mounted lensed troffer style fixtures. Lighting appears to be in fair condition. Several lenses were observed to be cracked, damaged or yellowing due to age. Light fixtures located in apparatus bays are ceiling suspended industrial fixtures which also appear to be in fair condition.

Photo E4 – Typical Office Lighting

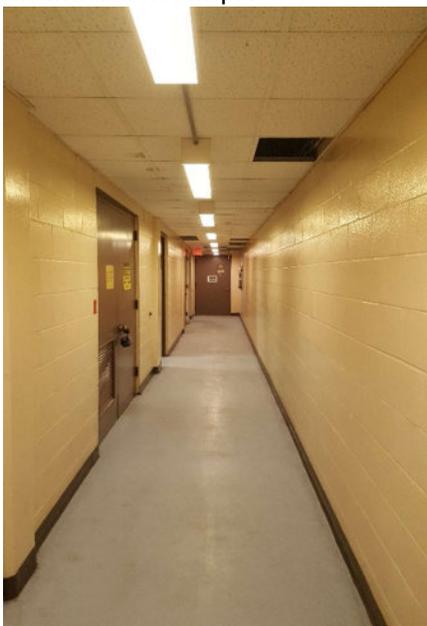
There were very minimal emergency lighting noted throughout the facility. The only area noted to contain emergency egress lighting were the stairwells, but it does not appear there is enough lighting to provide an average of 1 footcandle on the egress path.

Photo E6 – Corridor with no emergency lighting

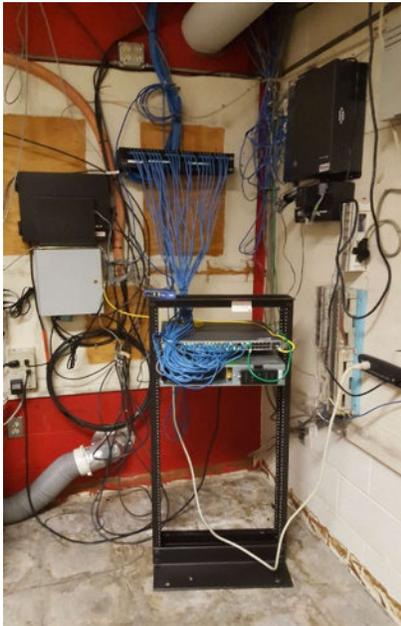
Communication services enter the building in the basement and are distributed out to individual work areas from single floor mounted rack. Communication rack does not appear to be well organized or labeled, making future installation and maintenance difficult. Cabling above ceiling does not appear to be supported properly, relying only on the ceiling tiles. This lack of support could like to degradation of cabling performance. Communication cabling in many rooms is run exposed and is looped over obstructions.

Photo E7 – Communication Rack in Basement

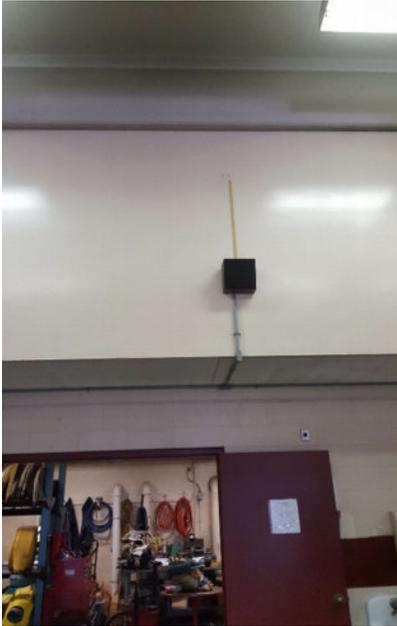
Apparatus bay has been provided with both wall mounted public address and a Sound Sphere omni-directional loud speaker. Upon conversation with facility staff, sound quality within apparatus bay is compromised with current provisions.

Photo E9 – PA speaker in Apparatus Bay

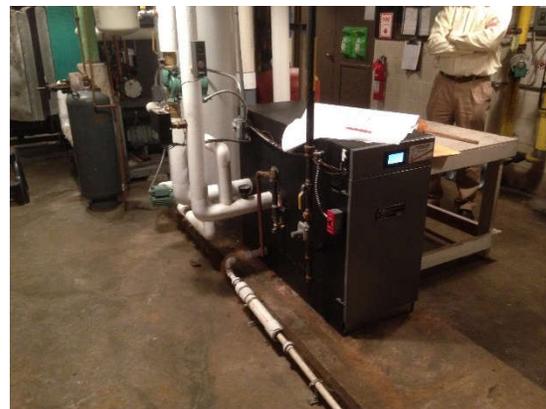
Facility is served by a central hot water boiler plant located in the basement. The existing boiler plant consists of an older cast iron HB Smith 19A-4 section oil-fired boiler and a recently installed Burnham condensing, direct-vent natural gas-fired boiler. HB Smith boiler is vented through the existing masonry chimney with proper breeching and draft damper. Chimney appears to be clay lined and has sufficient area now that one boiler has been removed. The Burnham boiler is vented with PVC through the ground floor and out the exterior wall. We have seen issues when venting condensing boilers using PVC pipe which has a relatively low rated temperature. Boiler venting should be replaced with polypropylene which is rated for boiler service. Piping is primarily copper and appears to be in fair to good condition and is well insulated throughout the facility.

Photo M1 – HB Smith Oil-Fired Boiler

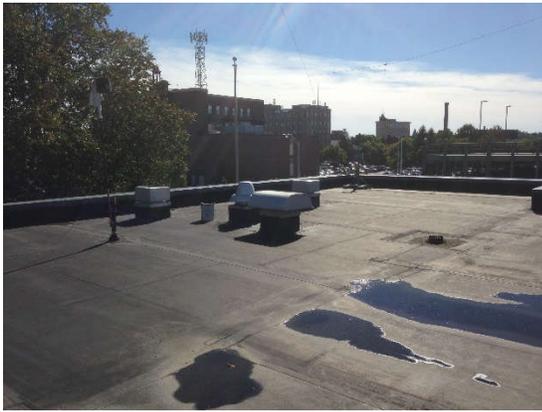
pipng was fully insulated to prevent condensation and heat loss. Cast iron baskets on the existing roof drains are in fair condition.

Photo P3 – View of Roof Drain (right)

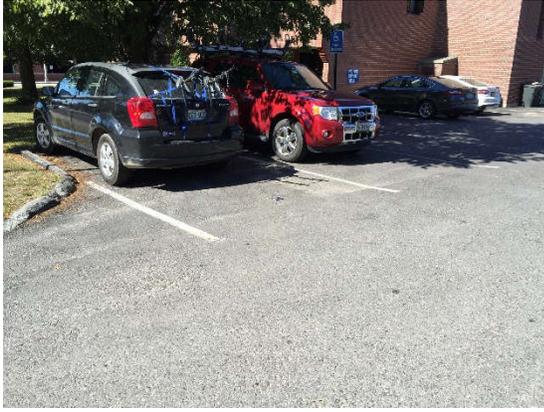
Photo C07 – Parking lot from College Street. Note poor condition of asphalt curbing.

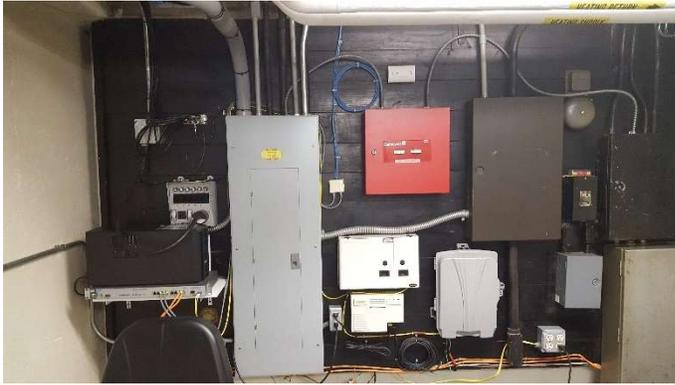
Standby power is provided to facility via portable 5kW generator that is kept in a locked storage container. Upon loss of normal power, the generator must be plugged into the receptacle located on the deck and power gets transferred to the select circuits. Receptacle generator connection appears to be a flexible cord extended through the exterior wall of the building and located in hinged enclosure to shield it from weather. Installation of flexible cord through wall does not meet Code (*NEC, Article 400.8*) and exterior box is in poor condition.

Photo E1 – Electrical Service Entrance

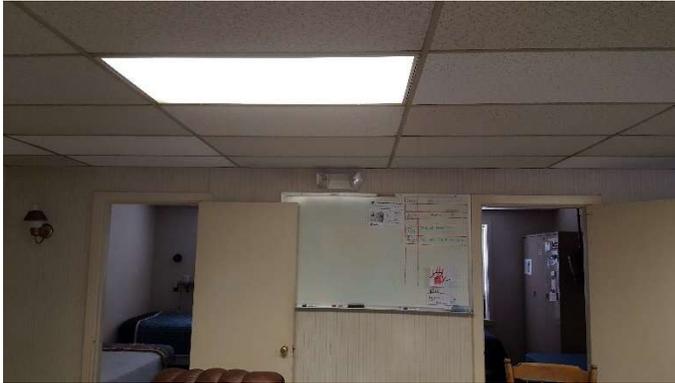
Building exits are currently marked only with non-luminescent paper signage. Constantly illuminated exit signage, either ac powered or photoluminescent, is required by Code (*NFPA 101, Chapter 7.8*).

Photo E3 – Living Area Lighting.

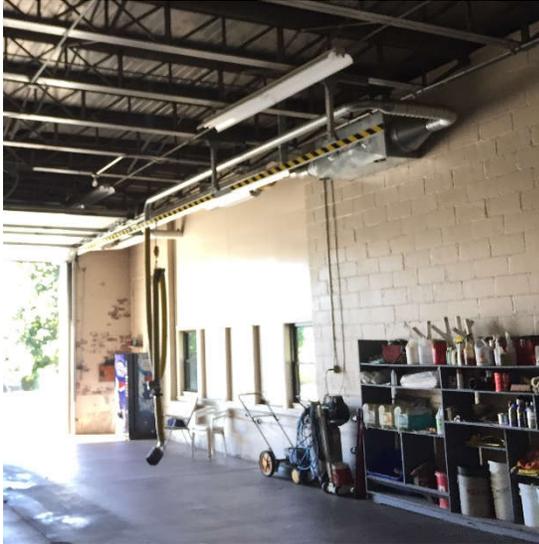
Photo M5 – Plymovent Hose, Track and Filter

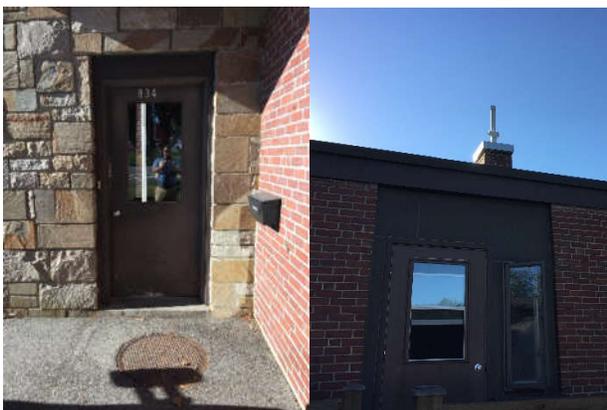
Exterior Fiberglass Doors: There are 3 exterior fiberglass insulated doors in metal frames which are in fair condition. These doors and frames are not original. Door hardware is knob type which should be replaced with lever type to comply with ADA. Useful life expectancy is 5 to 10 years with proper annual maintenance.

Photo MS-A5 – View of Doors

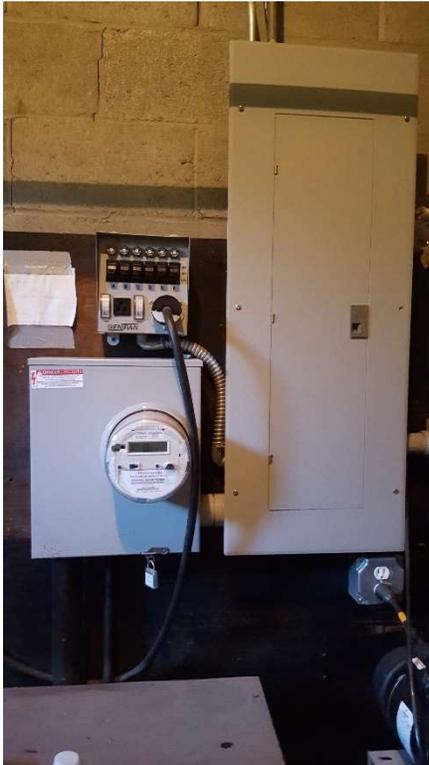
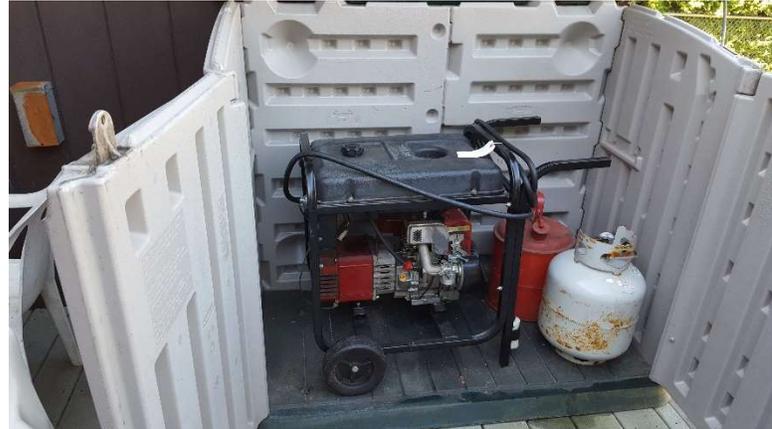
Standby power is provided to facility via portable 5kW generator that is kept in a locked storage container. Upon loss of normal power, the generator must be plugged into the receptacle located on the deck and power gets transferred to the select circuits. Receptacle generator connection appears to be a flexible cord extended through the exterior wall of the building and located in hinged enclosure to shield it from weather. Installation of flexible cord through wall does not meet Code (*NEC, Article 400.8*) and exterior box is in poor condition.

Photo E1 – Electrical Service Entrance Photo E2 – Portable Generator

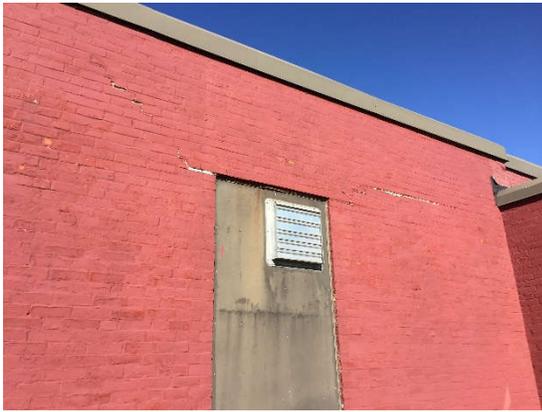
From an envelope standpoint, this building is in need of a comprehensive and thorough masonry restoration program.

Photo SS-A3 – East Façade

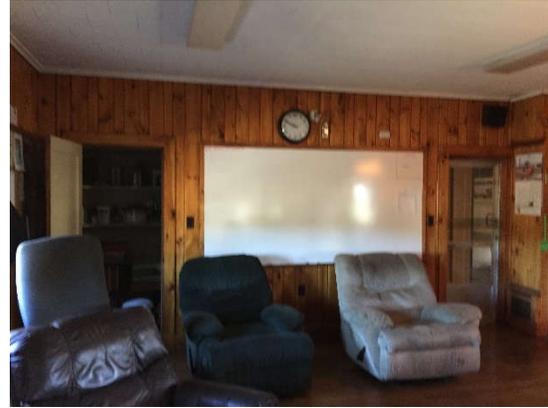
Photo SS-A16 – Carpet is worn at door

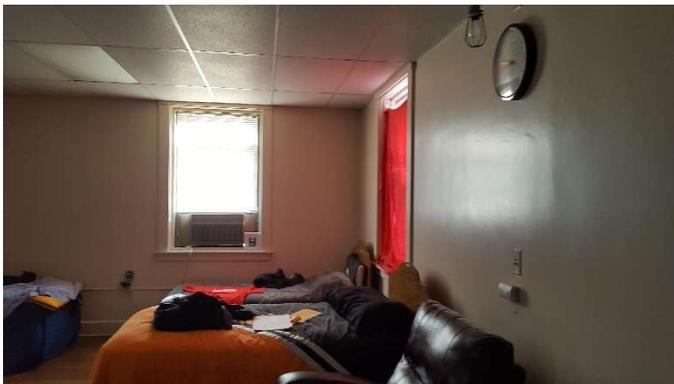
Building exits are currently marked only with non-luminescent paper signage. Constantly illuminated exit signage, either ac powered or photoluminescent, is required by Code (*NFPA 101, Chapter 7.8*).

Photo E3 – Bedroom.

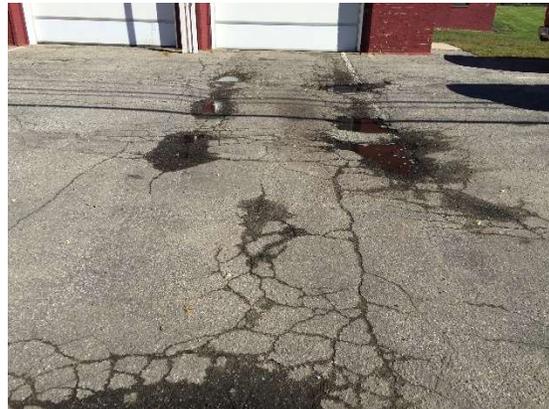
Photo C04 – Pavement condition in front of Emergency vehicle bays.
