**ENVIRONMENTAL REMEDIATION SUMMARY REPORT
BATES MILL COMPLEX
LEWISTON, MAINE**

July 24, 2003

SUMMIT ENVIRONMENTAL CONSULTANTS, INC.
640 Main Street
Lewiston, Maine 04240

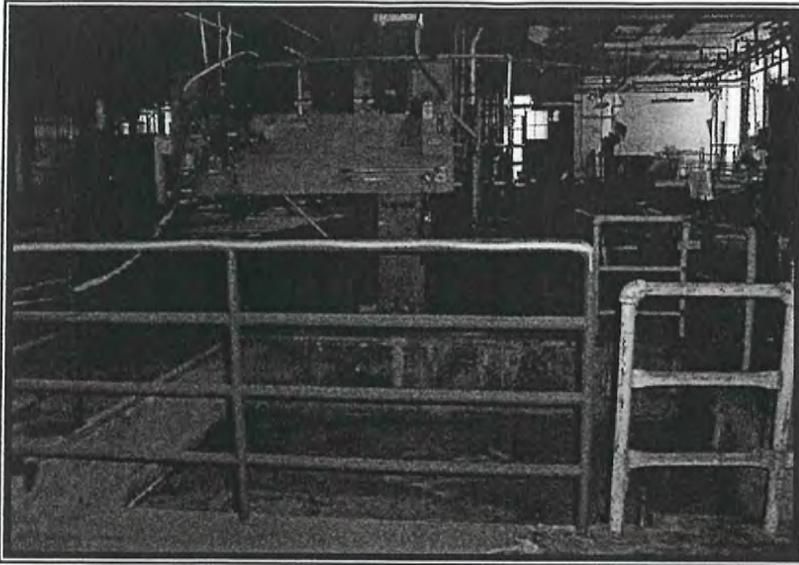
Photograph 10:

Mill 5 Starch Pits Following Cleaning

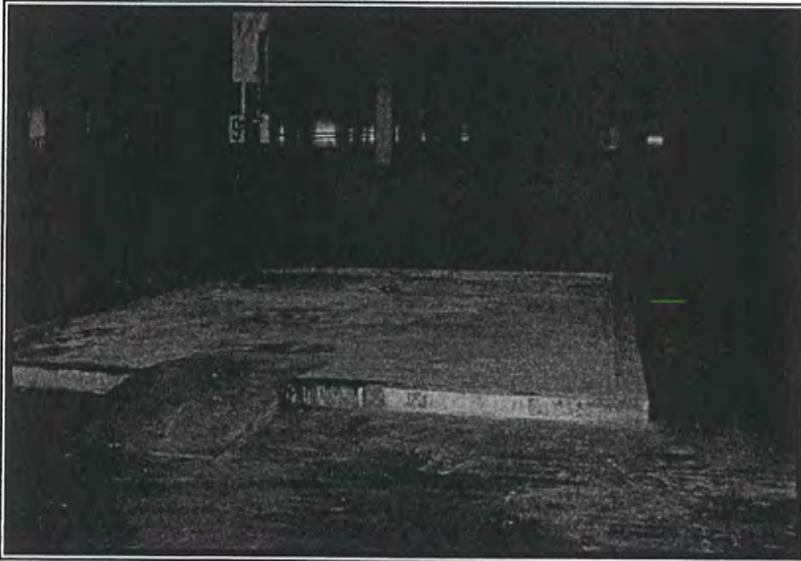
Photograph 11:

Mill 5 Temporary Hazardous Waste Storage Area Following Cleaning.
