# Lewiston Pedestrian Crossing Study

**HNTB**

4/15/2019

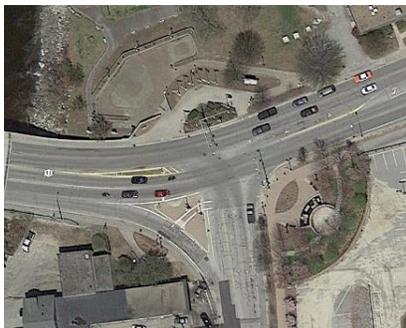
Figure 5.4 Main Street at Lincoln Street Aerial

The intersection of Main and Lincoln Street has a pedestrian crossing at Lincoln Street and the easterly approach on Main Street. This intersection is shown in Figure 5.4. Recently the crossings at this location were upgraded from standard parallel line crossings to high visibility block crossings.

- It should include a two-stage pedestrian crossing Main Street for this location, as shown in Figure 5.5;<sup>8</sup>
- Consideration should be given to using embedded LEDs for improved visibility;
- Signalized red turn arrows should be added to provide additional protection.

In addition, it is recommended that signage be placed alerting drivers turning right from Lincoln Street that they must yield to pedestrians in the crosswalk. Further pedestrian upgrades at this location should be made including APS push buttons, pedestrian countdown heads, and detectable warning surfaces.

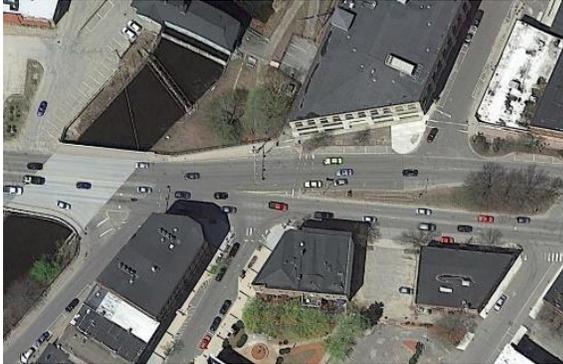
Figure 5.6 Main Street at Canal/Lisbon Street Aerial

The intersection of Main Street with Canal and Lisbon Streets is a difficult to navigate for both motorists and pedestrians. Contributing factors are the close proximity of the side streets, the geometry of the intersection, and the location of the buildings relative to the intersection as shown in Figure 5.6 and Figure 5.7.

Site distance for motorists turning left from Main Street onto Canal Street is inherently limited. It is recommended that the Canal Street crossing be upgraded to current ADA standards and that APS push buttons and pedestrian countdown heads be placed in this area to help reduce conflict with left-turning vehicles. In addition, a possible improvement might be reducing the radius and adding passive pedestrian detection that illuminates a signal on the mast arm pole as depicted in Figure 5.8.<sup>9</sup> These improvements will be in addition to the already completed high visibility markings in this intersection. This will improve safety as it currently is the site of multiple bike and pedestrian crashes.

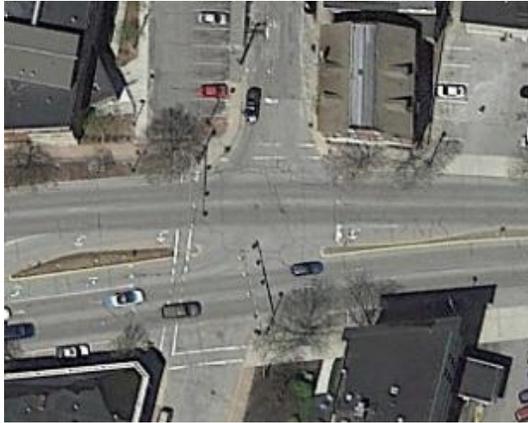
Figure 5.9 Main Street at Middle Street Aerial

The crosswalk striping across Main Street at Middle Street was recently replaced with high visibility striping. Updated signage, APS push buttons, a two-stage pedestrian crossing, and detectable warning surfaces are recommended in this location. Figures 5.9 and 5.10 below show this intersection.

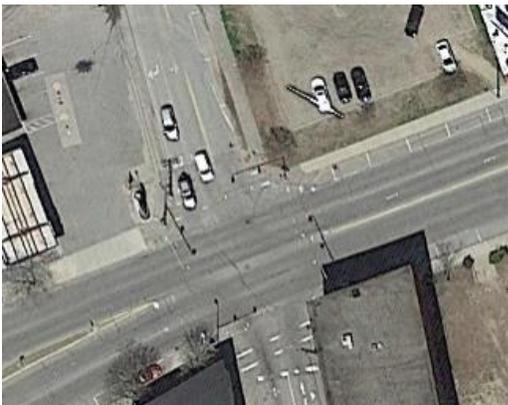
Figure 5.11 Main Street at Bates Street Aerial

As with the other intersections on Main Street, all legs of this intersection were recently restriped with high visibility striped crossings. Updated signage, APS push buttons and detectable warning surfaces are recommended in this location. Figures 5.11 and 5.12 below show this intersection.

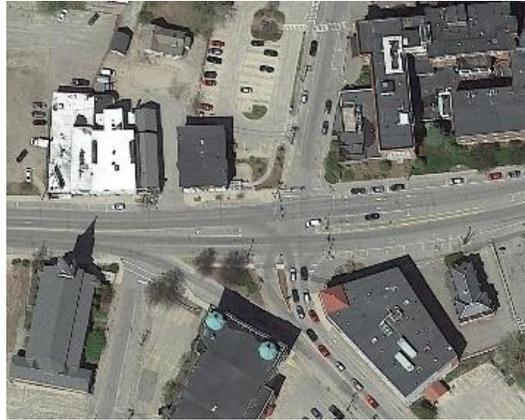
Figure 5.13 Main Street at Sabattus Street Aerial

The intersection of Main Street and Sabattus has recently been restriped with high visibility crosswalk markings. Updated signage, APS push buttons and detectable warning surfaces are recommended in this location. Figures 5.13 and 5.14 below show this intersection.

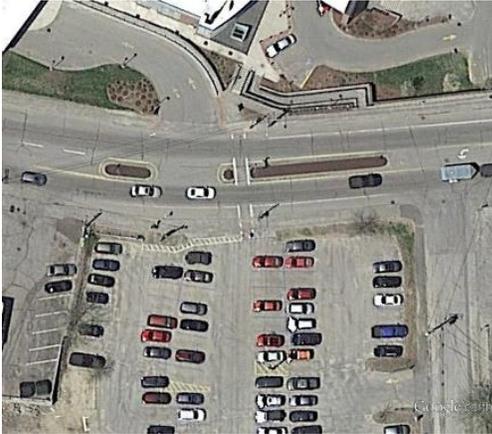
Figure 5.15 – Main Street at Maine Medical Center Aerial

This midblock crossing has been the source of previous safety investigations. Figures 5.15 and 5.16 below show this intersection. Currently there are identifying signs and lighted signs and the crosswalk has high visibility pavement markings. Whereas the Dunkin Donuts is moving from this location to another, the crosswalk will remain a large draw due to the CMMC parking lot. Maintaining the current infrastructure and further coordination between CMMC, MaineDOT and the City is recommended to improve safety.

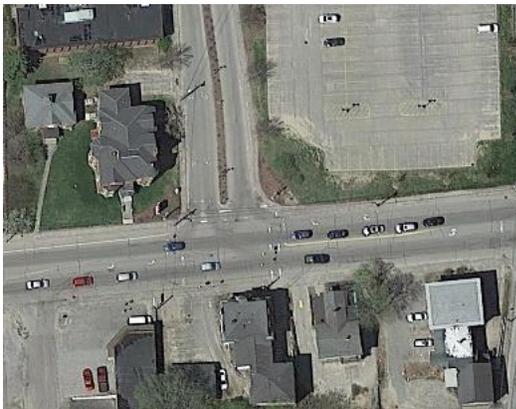
Figure 5.17 Main Street at High Street Aerial

The intersection of Main Street and High Street was recently upgraded from parallel crossing striping to high visibility blocks. Updated signage, APS push buttons and detectable warning surfaces are recommended in this location. Figures 5.17 and 5.18 below show this intersection.

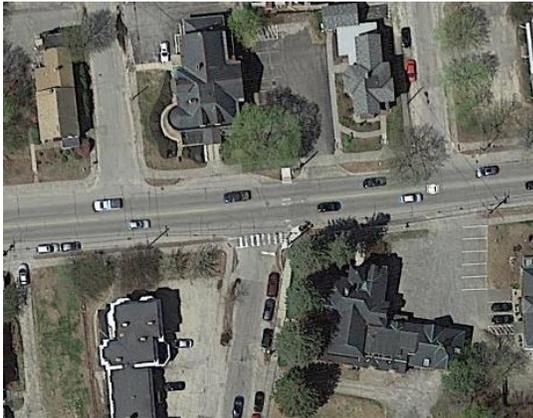
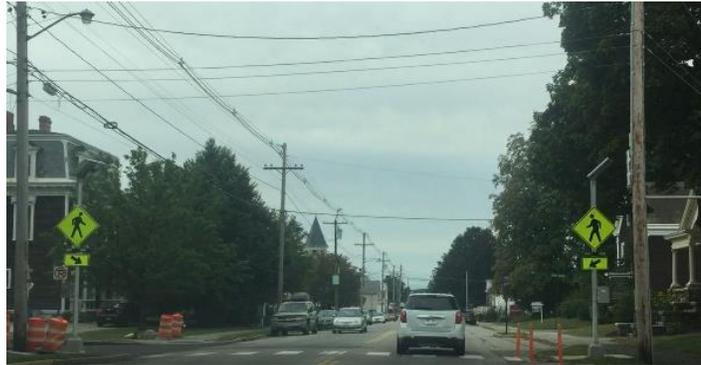
Figure 5.19 Main Street at Frye Street Aerial

Since this is the location of a fatal crash, the intersection of Main Street and Frye Street was upgraded to a high visibility crossing, with RRFBs, and ADA upgrades. Figures 5.19 and 5.20 below show this intersection.

No additional improvements are recommended at this time.

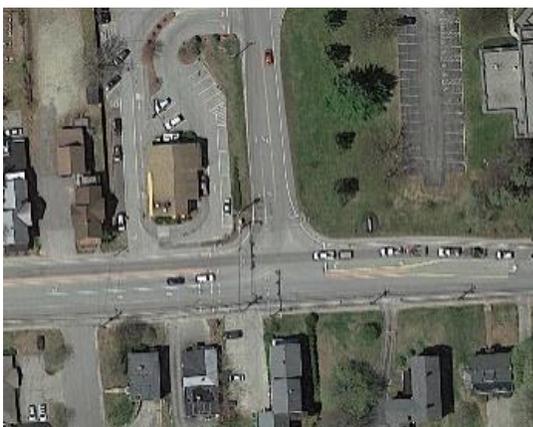
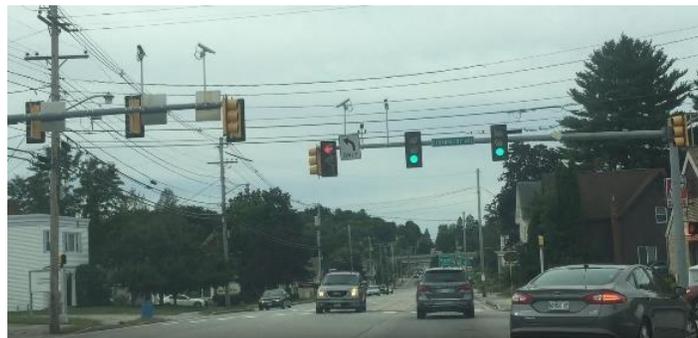
Figure 5.21 Main Street at Strawberry Avenue Aerial

The intersection of Main Street and Strawberry Avenue is an HCL, the area has recently been updated as part of a separate project. Figures 5.21 and 5.22 below show this intersection.

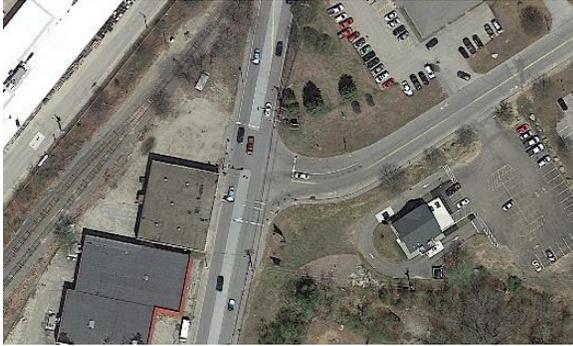
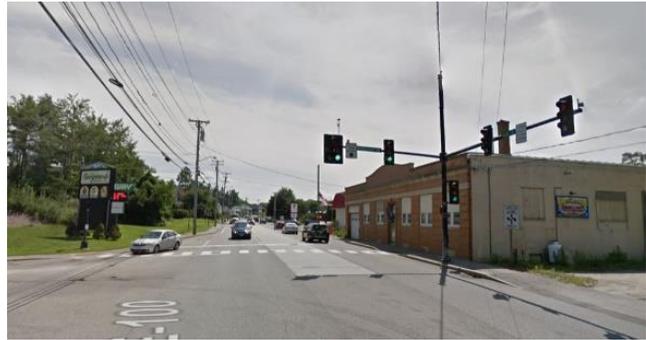
Figure 5.23 Main Street at Mollison Way Aerial

The intersection of Main Street and Mollison Way has recently been upgraded to enhanced block striping along with ADA upgrades, APS push buttons and detectible warning tiles. Figures 5.23 and 5.24 below show this intersection.

Updated signage is recommended for this location.

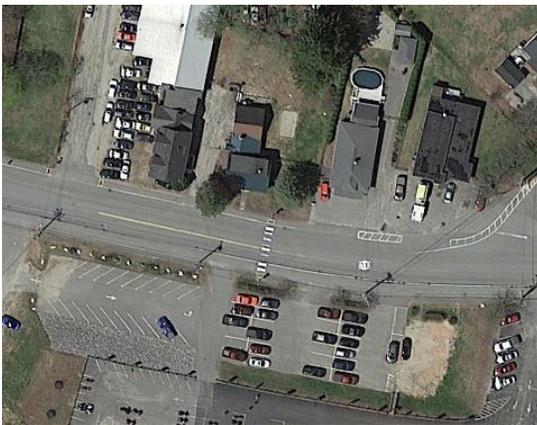
Figure 5.25 Main Street Near Switzerland Road Aerial

The final existing marked crossing is located near Switzerland Road, which is shown in Figures 5.25 and 5.26 below. The crossing has detectable warning surfaces, RRFBs and high visibility blocked pavement markings. No additional improvements are recommended at this time.

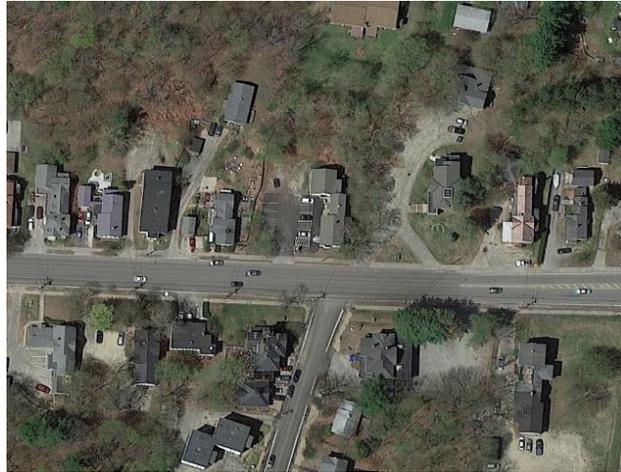
Figure 5.27 Main Street at Mountain Avenue Aerial

A midblock crossing at the intersection of Main Street and Mountain Avenue, shown in Figure 5.27, would be a logical consideration for a crossing since it is the midpoint between two existing pedestrian crossings, although there are not many draws in this area for pedestrian activity.

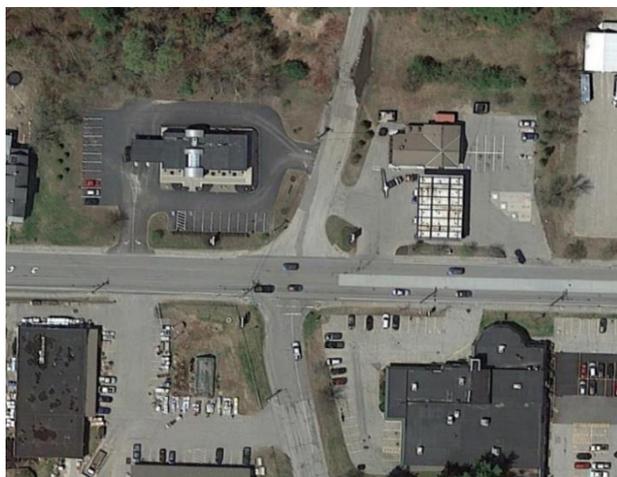
Figure 5.28 Main Street at Montello/Landry Street Aerial

A crossing at the intersection of Main Street, Montello Street and Landry Road, shown in Figure 5.28, would help provide a connection for bus users as there are numerous bus stops in this stretch of the corridor. This is an HCL, so if a crossing is placed at this intersection every effort must be made to improve vehicular safety.

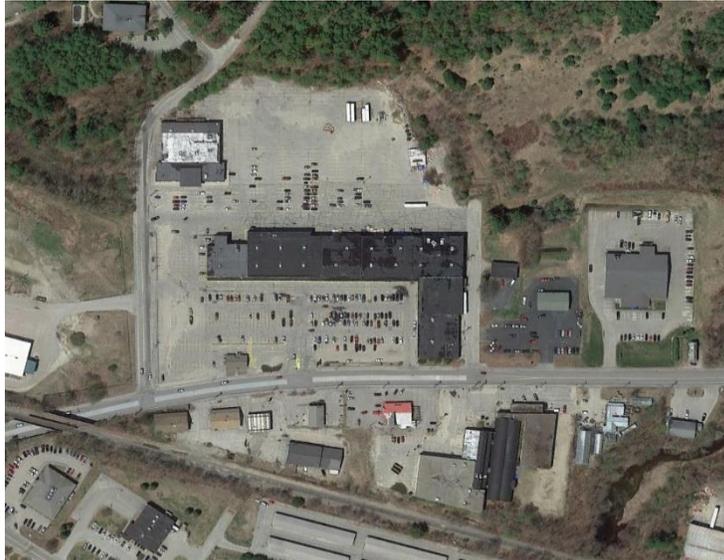
Figure 5.29 Main Street at Marden's Aerial

A new pedestrian crossing is recommended across Main Street across from the Marden's Shopping Center (Figure 5.29) to address the long distance between crossings and would be collocated at a bus stop. If property across from the Marden's Shopping Center is redeveloped, the City should consider requiring cross connections between properties and combining entrances due to the high number of driveways/entrances in this section of roadway.

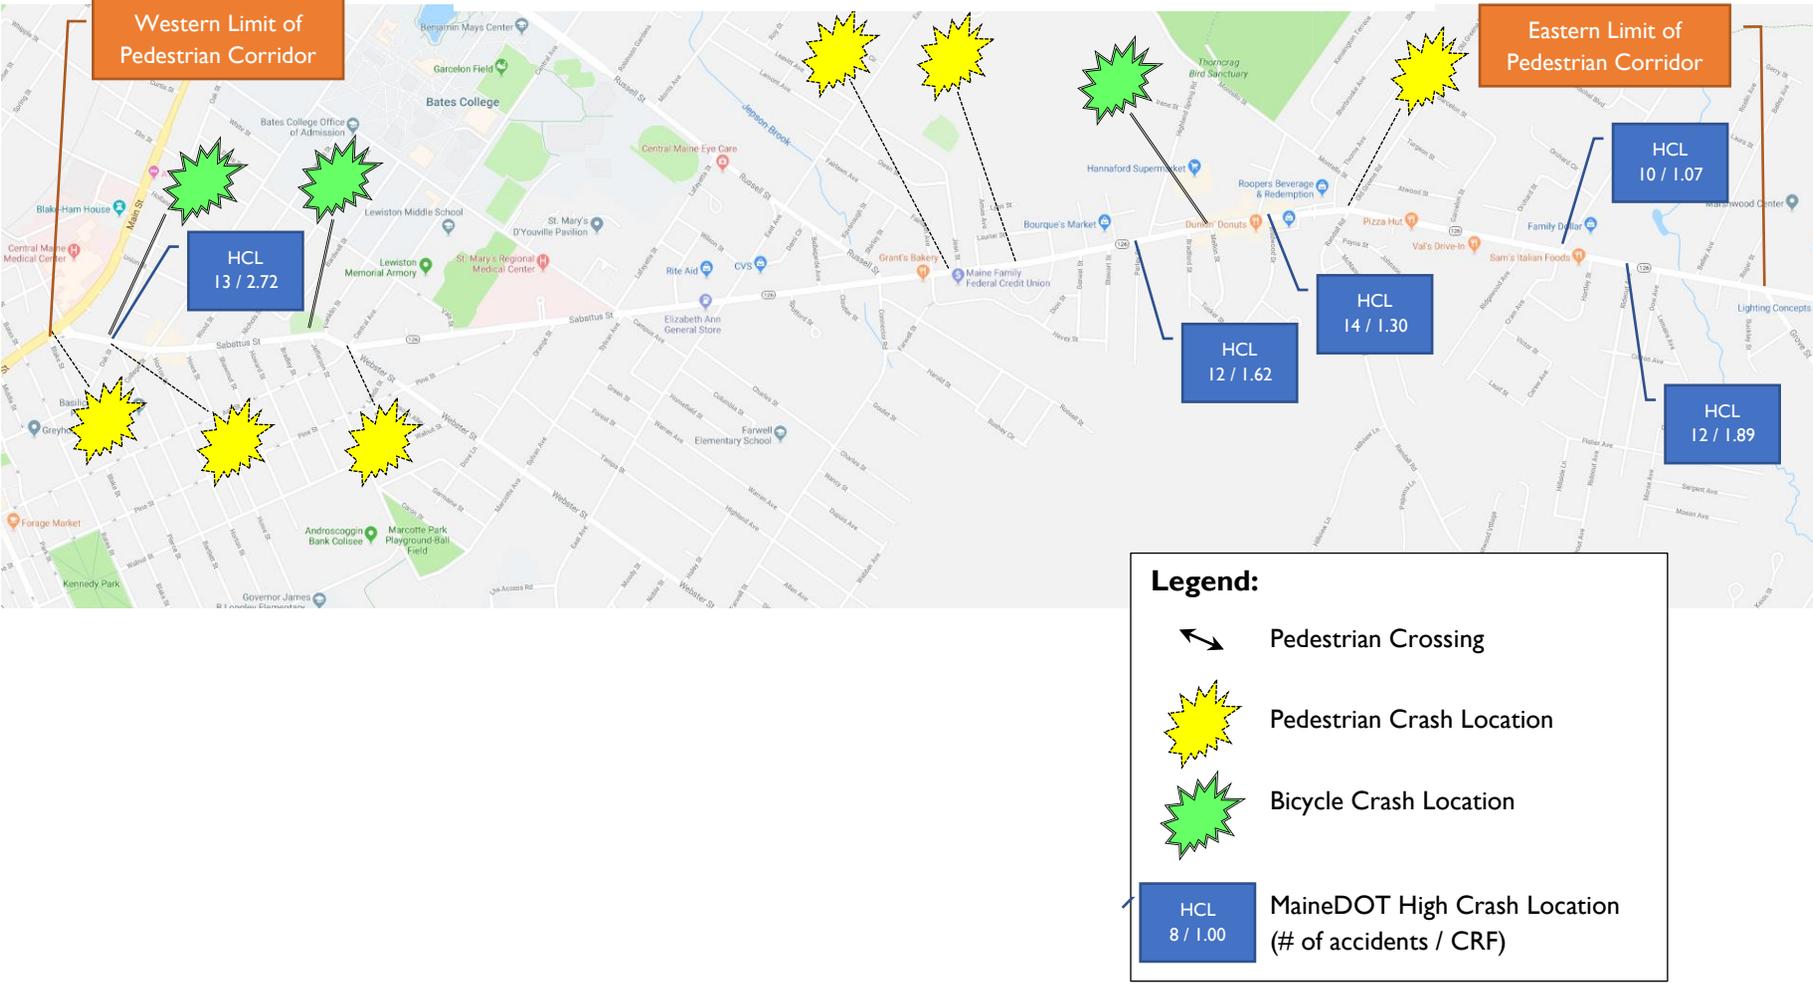
### Figure 6.3 Sabattus Street Pedestrian Corridor Safety

The 2.75-mile corridor experienced nine pedestrian collisions and four bicycle collisions in the past three years. Figure 6.3 provides an overview of the key characteristics of the Sabattus Street corridor. The corridor has five locations currently identified as HCLs.

- One HCL occurred within the denser part of Lewiston:
  - Sabattus at Bartlett and Oak Street..... 13 crashes.....CRF 2.72
- Most of the HCLs occurred outside of the denser part of Lewiston:
  - Sabattus at Perley Street ..... 12 crashes.....CRF 1.62
  - Sabattus near Laurier Street..... 14 crashes.....CRF 1.30
  - Sabattus at Temple Street..... 10 crashes.....CRF 1.07
  - Sabattus at Rideout Avenue..... 12 crashes.....CRF 1.89
- The 2.75-mile corridor had a total of 130 crashes with a CRF 1.11.

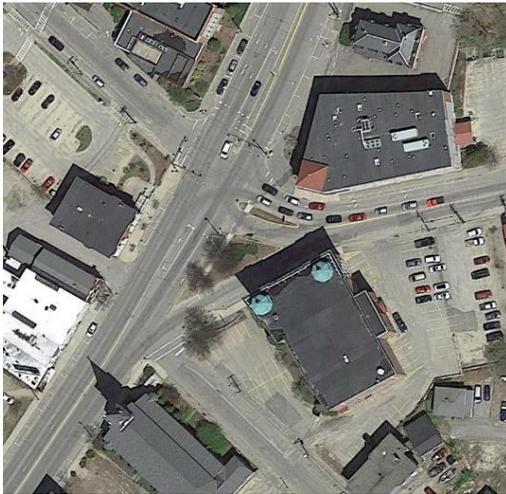
Figure 6.4 Sabattus Street at Main Street Aerial

The Sabattus Street and Main Street intersection has recently been restriped to include high visibility block striping. It is recommended that crosswalk signage be placed to increase the visibility of this crossing. ADA improvements are also necessary at this crossing such as the addition of detectable warning surfaces. Figures 6.4 and 6.5 below show this intersection.

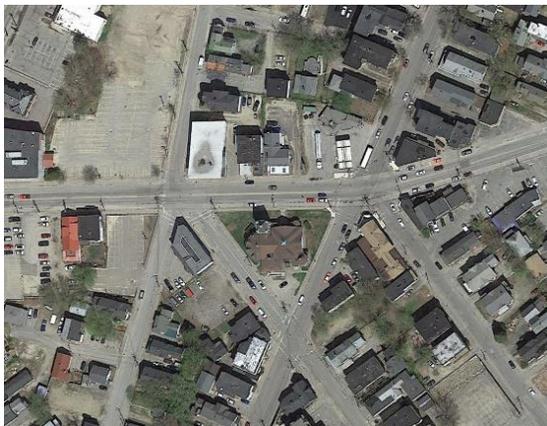
Figure 6.6 Sabattus Street at Oak Street Aerial

The intersection of Sabattus Street with Oak Street is a complex five-leg intersection with both bicycle and pedestrian crashes as well as a vehicular HCL. These intersection is shown in Figures 6.6, 6.7 and 6.8. We recommend adding signage where needed to enhance visibility of existing pedestrian crossings. Adding RRFBs should be considered as well as ADA improvements.

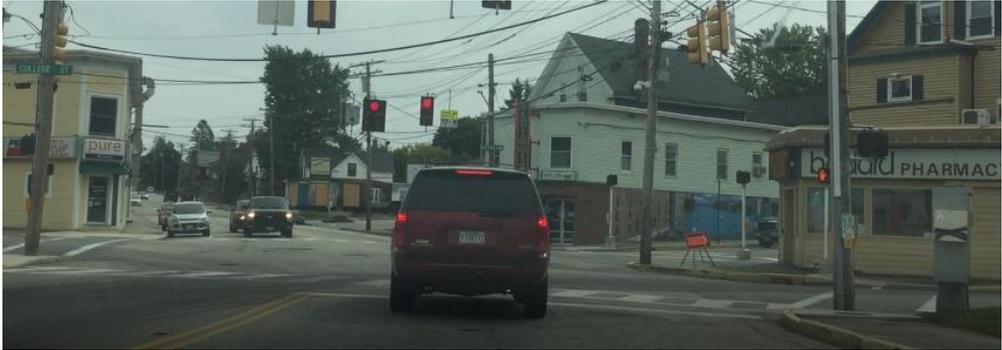
Figure 6.8 Sabattus Street at College/Horton Street View

The intersection of Sabattus Street at College Street and Horton Street is similarly complex. The intersection has recently been restriped with high visibility block striping across Sabattus Street and ADA improvements and right turn signage to meet current standards. No changes are proposed for this location.

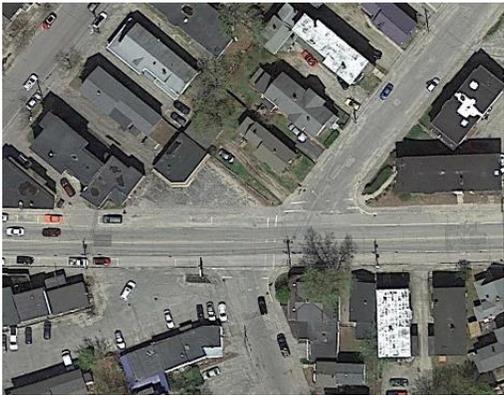
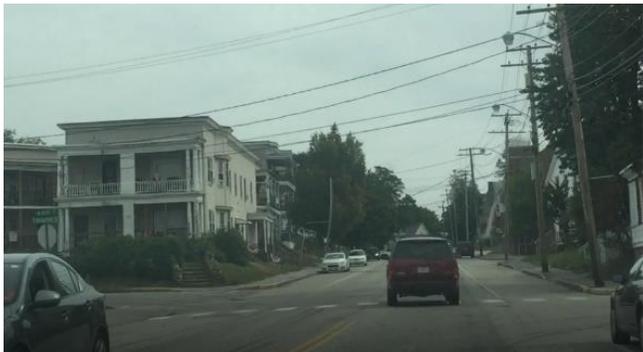
Figure 6.9 Sabattus Street at Howe Street Aerial

The intersection of Sabattus Street at Howe Street and Wood Street was recently restriped with the high visibility block striping. These are shown in Figures 6.9 and 6.10. We suggest that RRFBs and new signage be added to draw attention to the crossing as well as ADA improvements at this intersection.

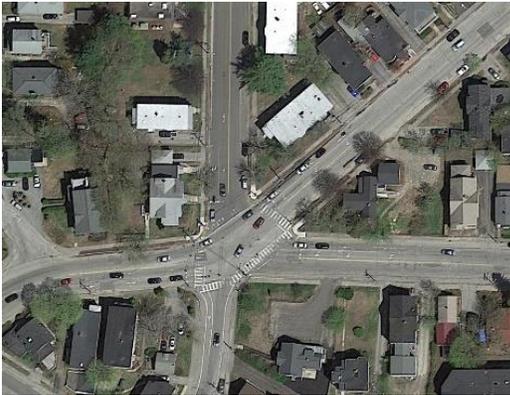
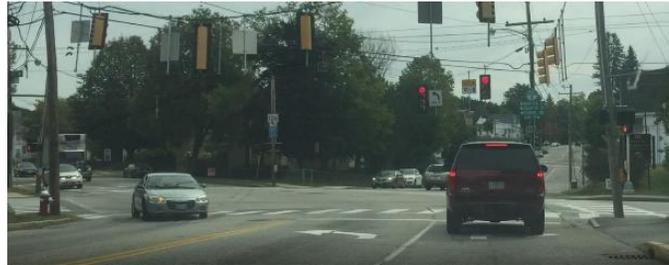
Figure 6.11 Sabattus Street at Central, Webster and Ash Streets Aerial

This is another five-leg intersection and also the location of a pedestrian crash. Figures 6.11 and 6.12 show this intersection. Crosswalk striping has recently been upgraded from two solid parallel lines to enhanced block striping. Because of this and recent intersection upgrades, no additional improvements are recommended at this time.

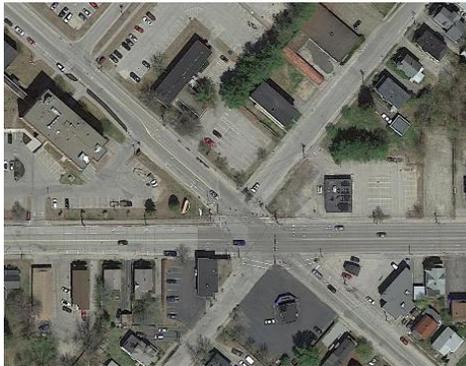
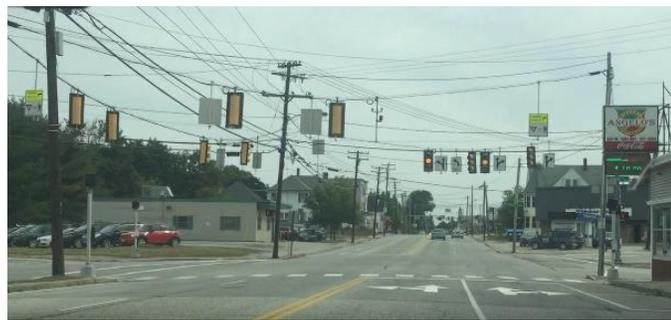
Figure 6.13 Sabattus Street at Lafayette, Sylvan, and Campus Avenues Aerial

The intersection of Sabattus Street with Lafayette Street, Sylvan Avenue, and Campus Avenue is shown in Figures 6.13 and 6.14. Crosswalk striping was recently upgraded in this intersection from two solid parallel lines to enhanced block striping. Because of this and recent intersection upgrades, no additional improvements are recommended at this time.

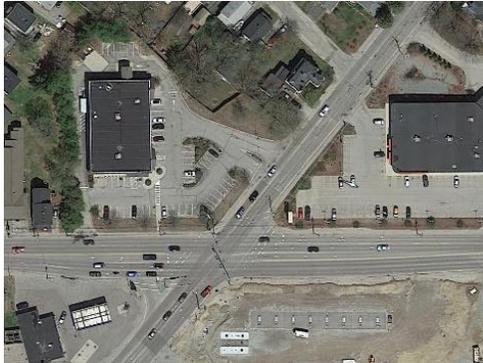
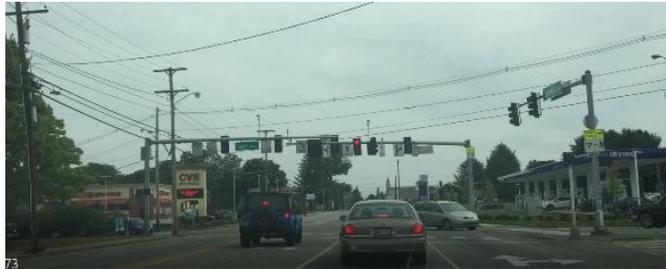
Figure 6.15 Sabattus Street at East Avenue Aerial

As with other intersections in the corridor, the intersection of Sabattus Street and East Avenue was recently upgraded to enhanced block striping, signage and ADA improvements. This intersection is shown in Figures 6.15 and 6.16. No additional improvements are recommended at this time.

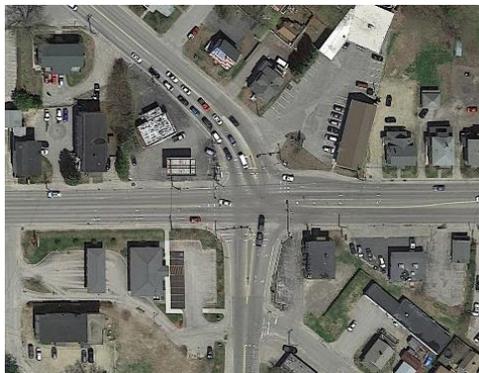
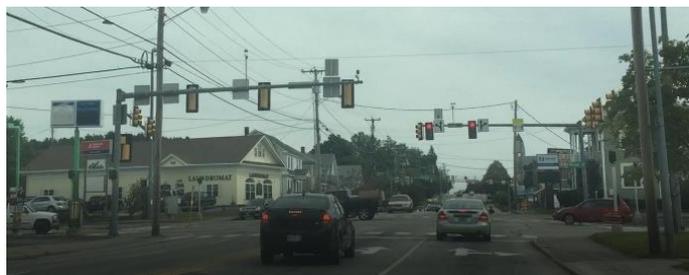
Figure 6.17 Sabattus Street at Russell Street Aerial

As with other intersections in the corridor, the intersection of Sabattus and Russell Streets was recently upgraded to enhanced block striping, signage and ADA improvements. This intersection is shown in Figures 6.17 and 6.18. No additional improvements are recommended at this time.

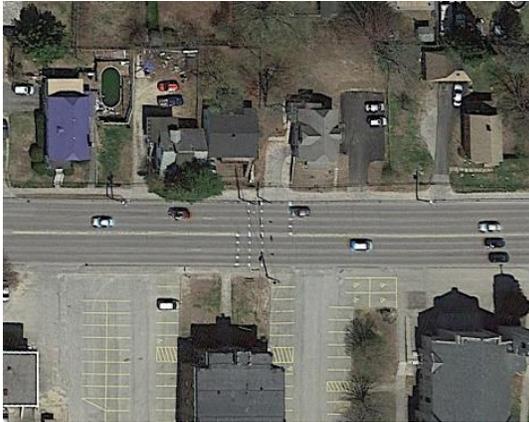
Figure 6.19 Sabattus Street East of Laurier Street Aerial

The midblock crossing east of Laurier Street was recently upgraded, as shown in Figures 6.19 and 6.20, to include pedestrian signage, pedestrian-activated overhead flashing beacons and detectable warning surfaces. No additional improvements are recommended at this time.

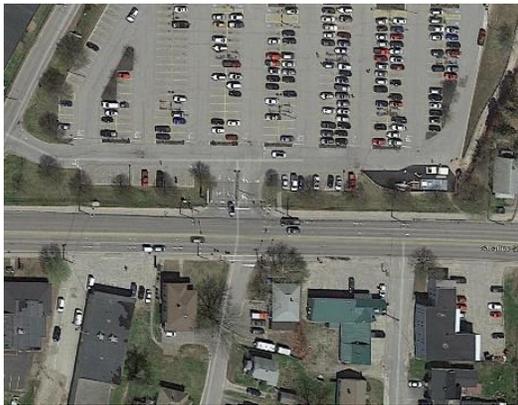
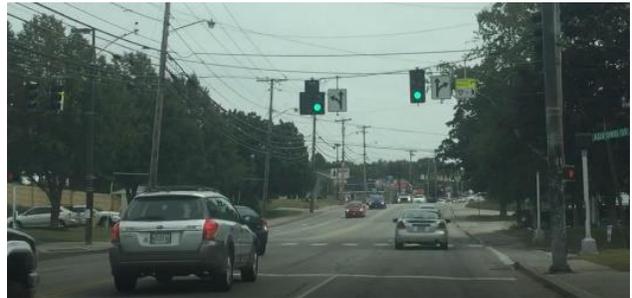
Figure 6.21 Sabattus Street at Bradford Street Aerial

As with other intersections in the corridor, the intersection of Sabattus and Bradford Streets was recently upgraded to enhanced block striping, signage and ADA improvements. This intersection is shown in Figures 6.21 and 6.22. No additional improvements are recommended at this time.

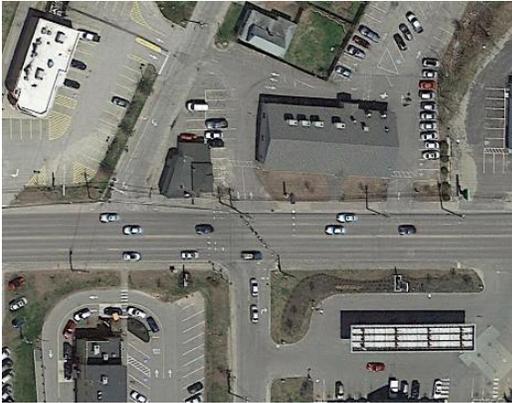
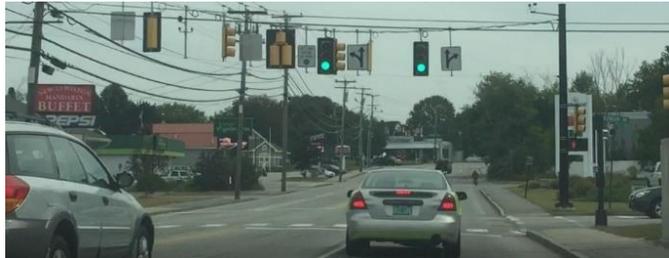
Figure 6.23 Sabattus Street at Wildwood Drive

As with other intersections in the corridor, the intersection of Sabattus Street and Wildwood Drive was recently upgraded to enhanced block striping, signage and ADA improvements. This intersection is shown in Figures 6.23 and 6.24. No additional improvements are recommended at this time.

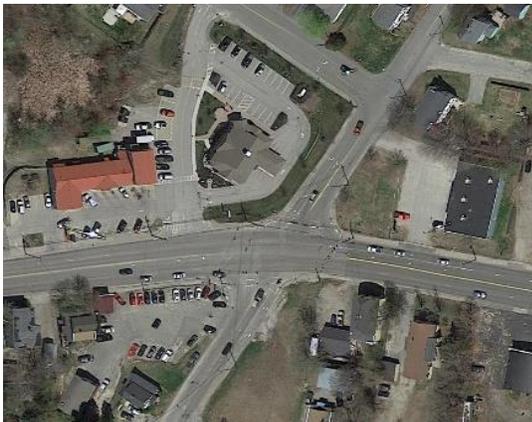
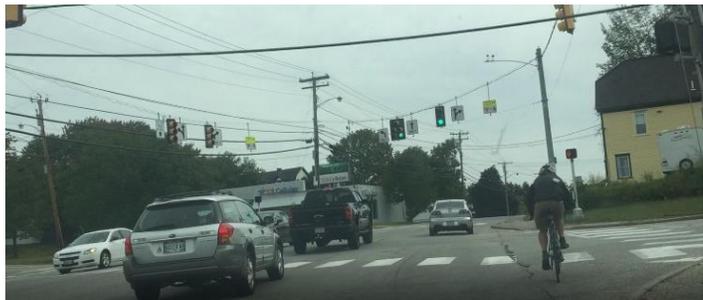
As with other intersections in the corridor, the Sabattus Street and Randall Road intersection was recently upgraded to enhanced block striping, signage and ADA improvements. This intersection is shown in Figures 6.25 and 6.26. No additional improvements are recommended at this time.

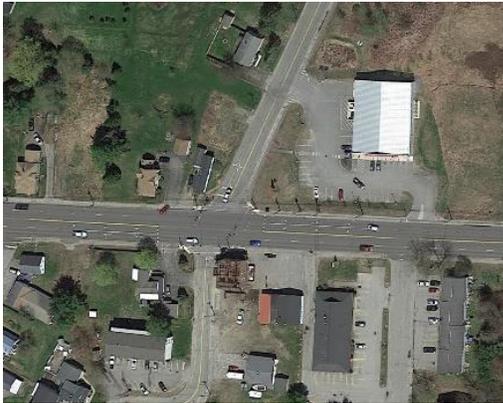
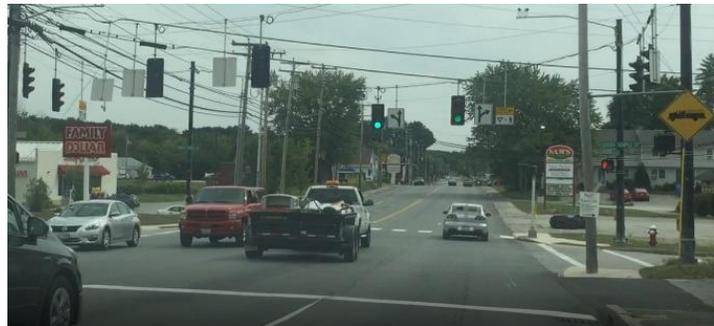
This intersection of Sabattus and Temple Street is currently identified as an HCL, and is shown in Figures 6.27 and 6.28. As with other intersections in the corridor, this intersection was recently upgraded to enhanced block striping, signage and ADA improvements. No additional improvements are recommended at this time.

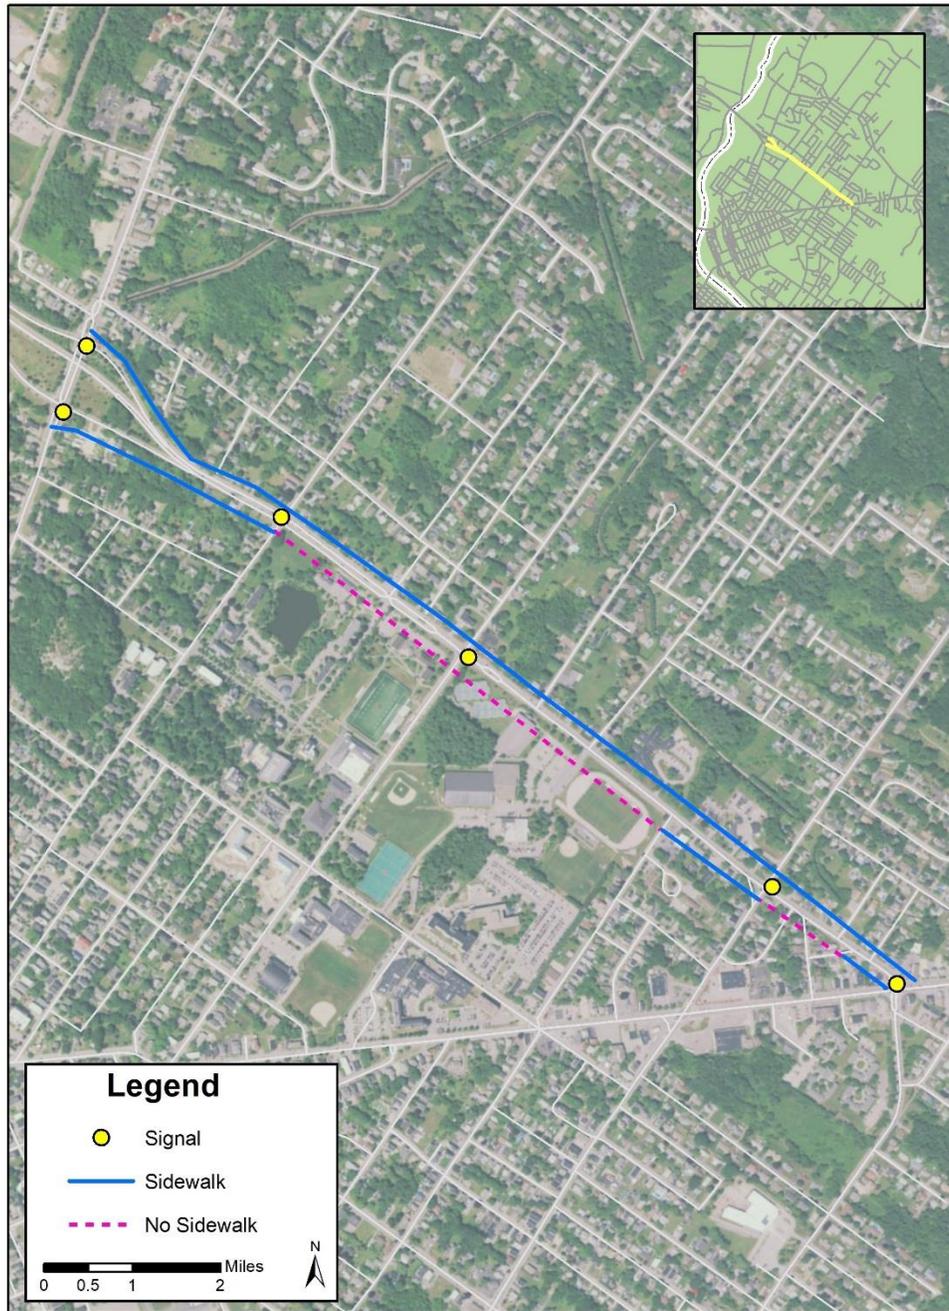
**Figure 7.1**  
**Russell Street Signals and Sidewalks**  
*City of Lewiston, Maine*

The following two figures identify existing pedestrian facilities in the corridor. The first, Figure 7.1 shows existing crosswalks and signalized locations. The second, Figure 7.2 shows pedestrian crossings by type of crossing and locations of pedestrian crossings.

There are five signalized crossings along this 1.25-mile stretch and one unsignalized marked crossing location. Several do not meet ADA standards, lacking pedestrian countdown heads, APS Push buttons, ramp slopes, and pavement markings and are also missing detectable warning surfaces.

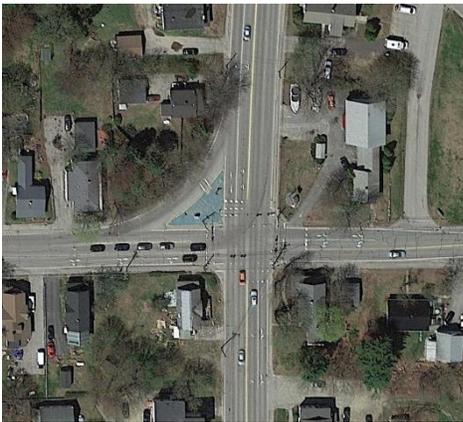
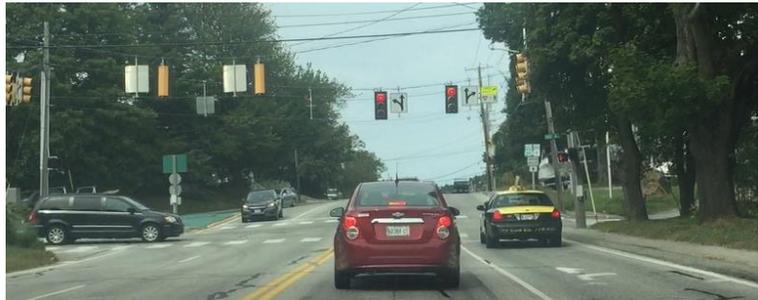
The intersection of Russell Street and East Avenue has been classified as an HCL and is shown in Figures 7.4 and 7.5. It has been recently enhanced with new high visibility block crossing striping. We recommend that a right turn arrow be added for pedestrians crossing the slip lane.

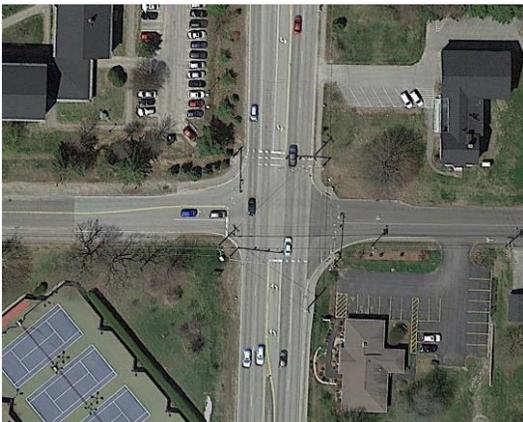
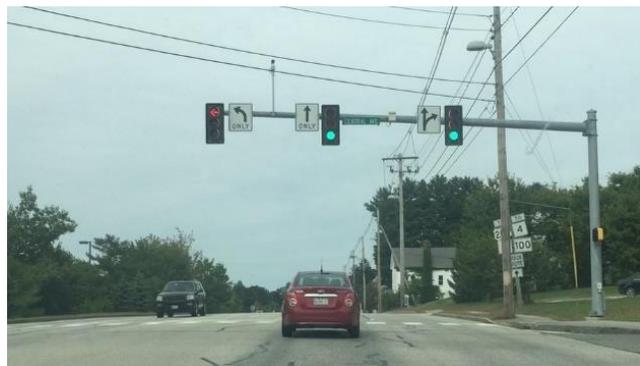
The intersection of Russell Street and Central Avenue has recently been restriped with high visibility block crossing striping. The intersection is shown in Figures 7.6 and 7.7. Yield to pedestrians in crosswalk signing should be placed on the mast arms where applicable.

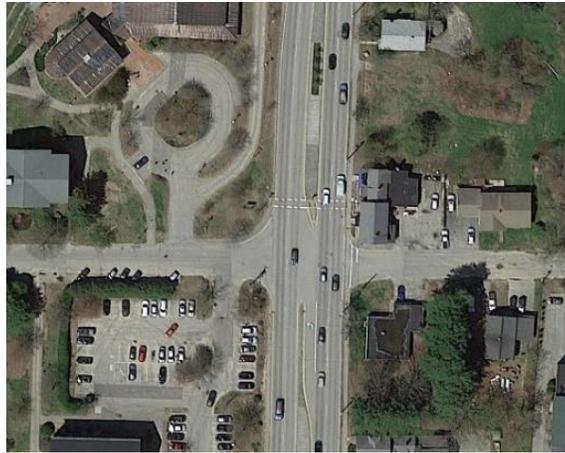
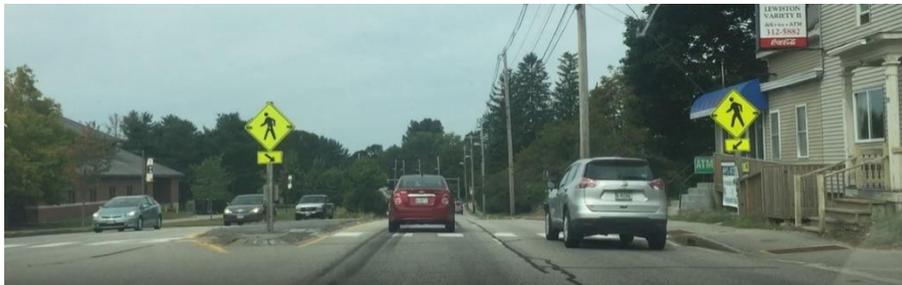
The midblock crossing at Lewiston Variety on Russell Street was recent upgraded to include high visibility block crossing striping and LED crosswalk indications as shown below. The intersection is shown in Figures 7.8 and 7.9. No recommendations for improvements are made at this time.

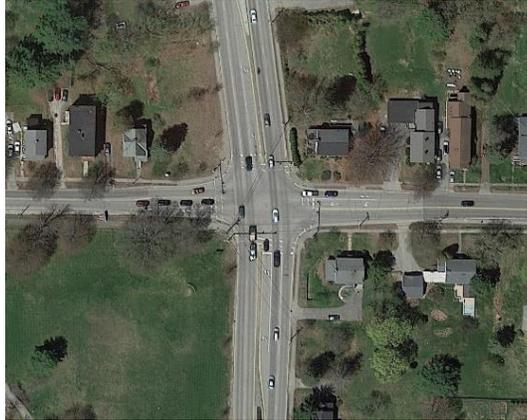
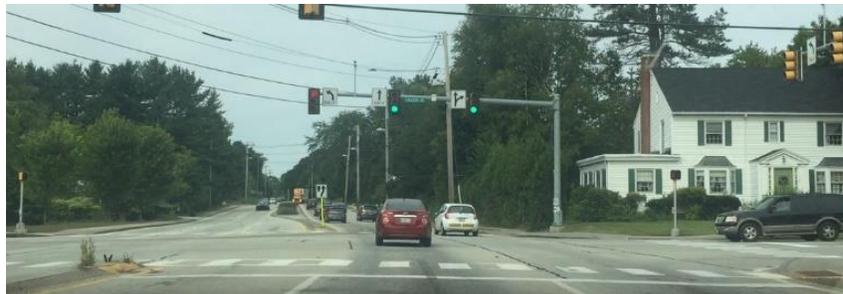
The intersection Russell Street and College Street has recently been restriped to include a high visibility crosswalk block crossing. This intersection is shown in Figures 7.10 and 7.11. Signage enhancements at this intersection are recommended to improve driver awareness of the crossing.

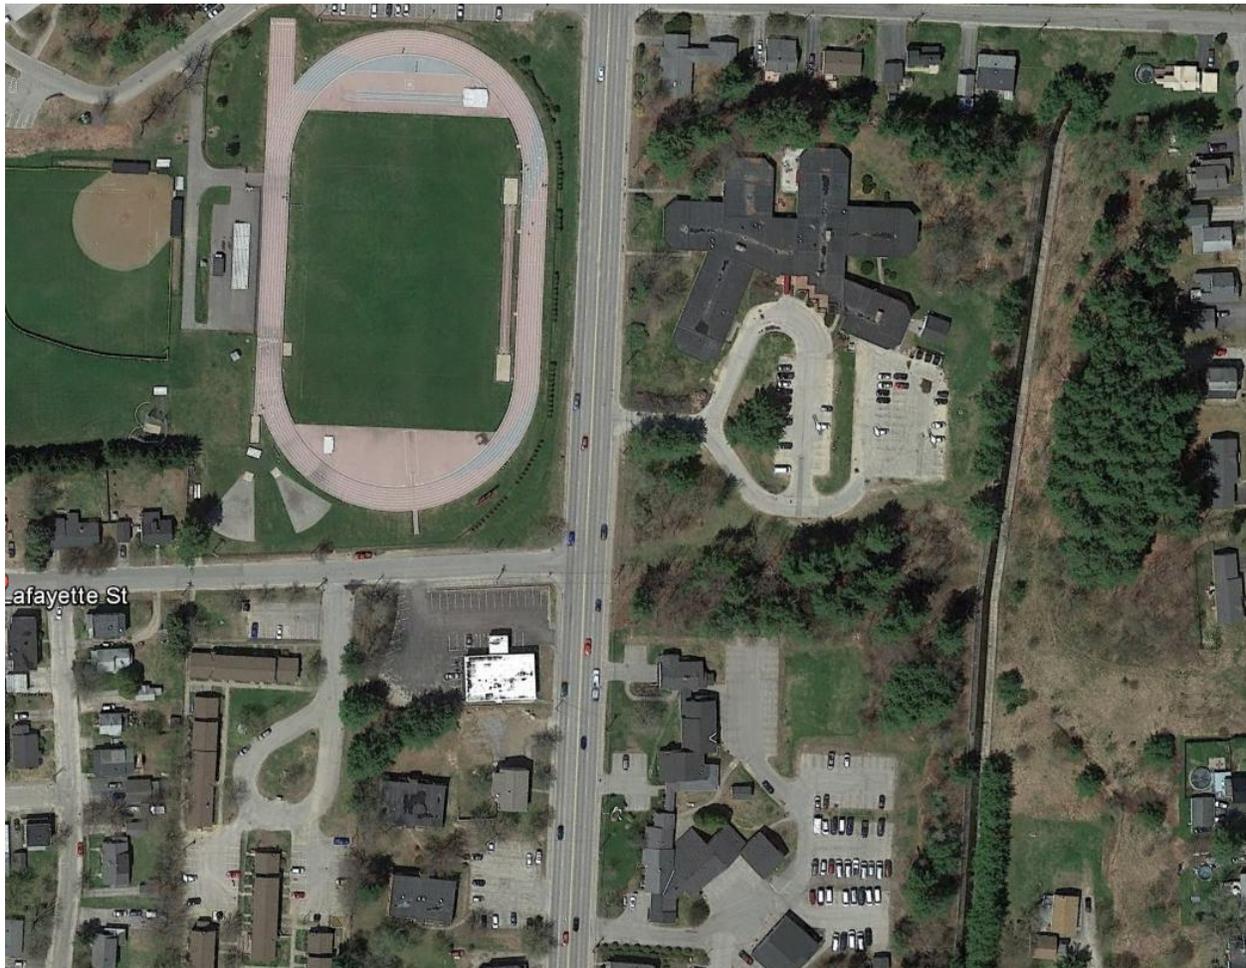
Figure 7.12 Russell Street at Lafayette Street Aerial

A crosswalk was considered at the intersection of Russell and Lafayette Streets, but due to its history as an HCL, high vehicular speeds, and need for pedestrians to cross four lanes of traffic, it is not recommended to add a crosswalk at this location at this time. This intersection is shown in Figure 7.12. If a new sidewalk is added in this area, a crossing should be reconsidered.

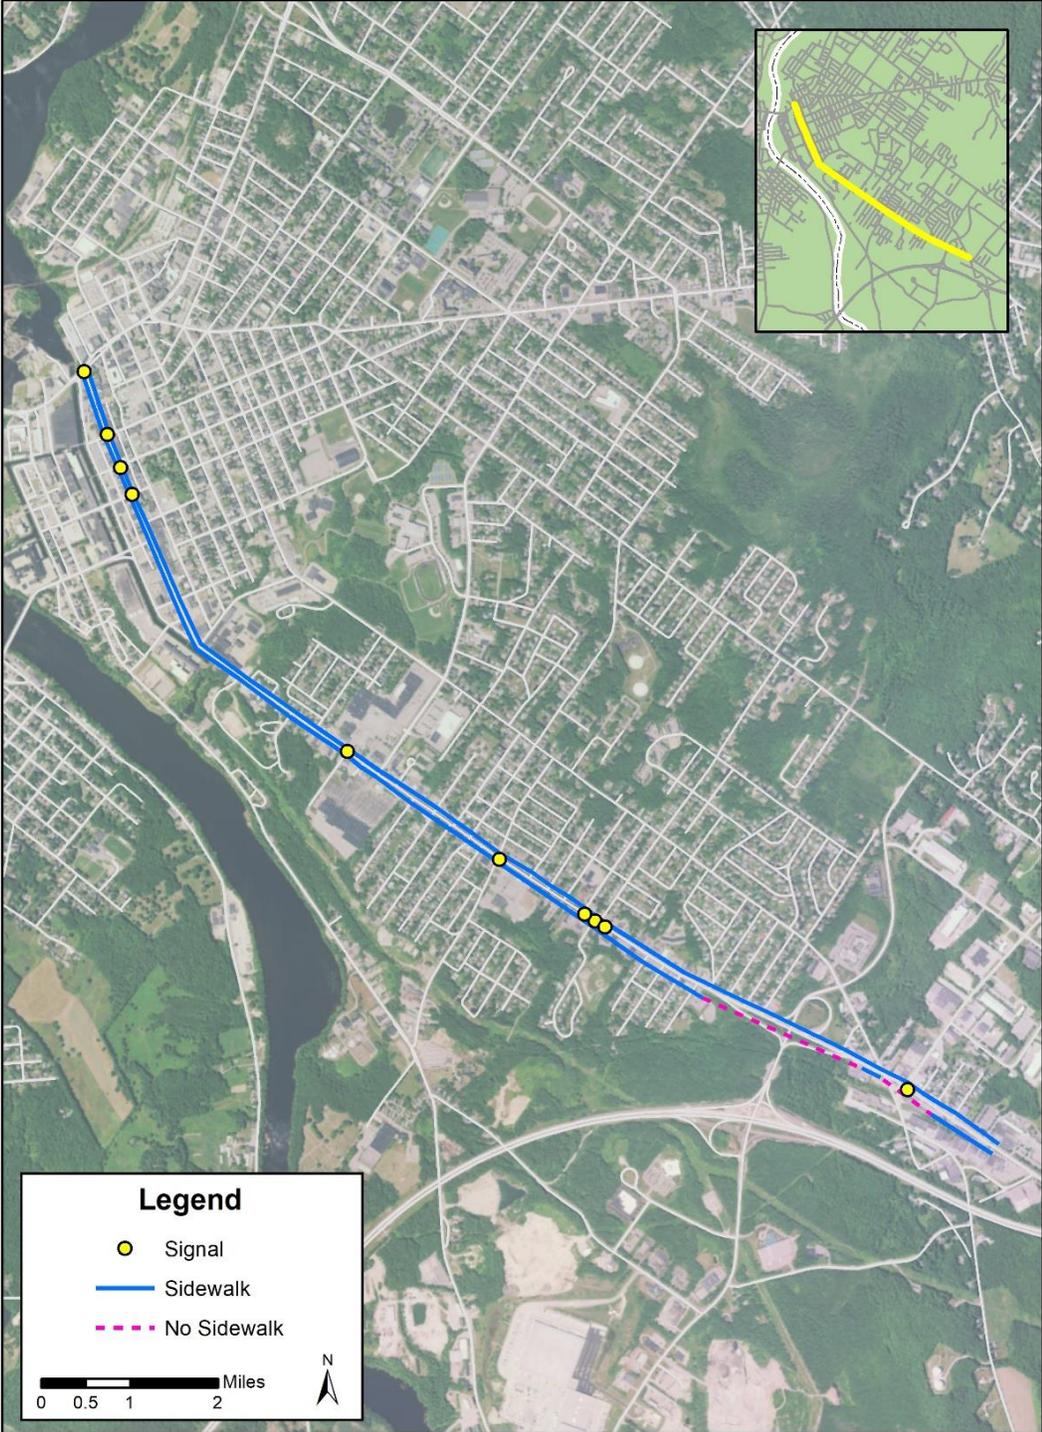
# Figure 8.1 Lisbon Street Signals & Sidewalks

The following two figures identify existing pedestrian facilities in the corridor. The first, Figure 8.1 shows existing crosswalks and signalized locations. The second, Figure 8.2 shows pedestrian crossings by type of crossing and location of pedestrian crossings.

Near the urban core there is a mix of signalized and unsignalized crossing locations, although the number of crossings declines at the termination of Canal Street. Many crossings near the urban core were recently upgraded to meet all ADA standards. Several crossings further out do not meet ADA standards, lacking pedestrian countdown heads, APS Push buttons, ramp slopes, and pavement markings and are also missing detectable warning surfaces.

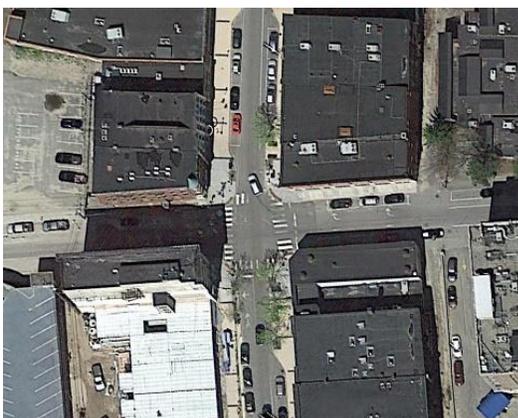
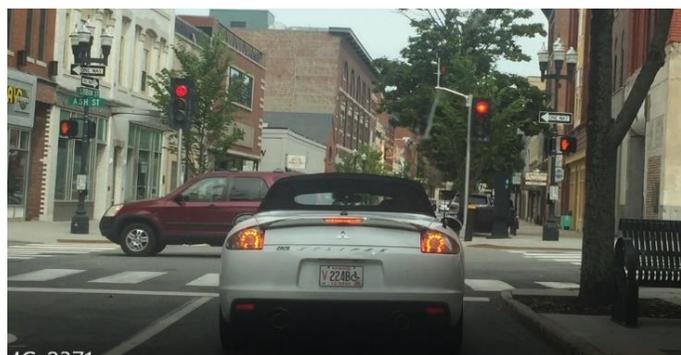
The intersection of Lisbon Street and Ash Street has been recently restriped and upgraded to meet all ADA standards. Figures 8.4 and 8.5 show this intersection. The only improvement that is suggested is improving pedestrian signage.

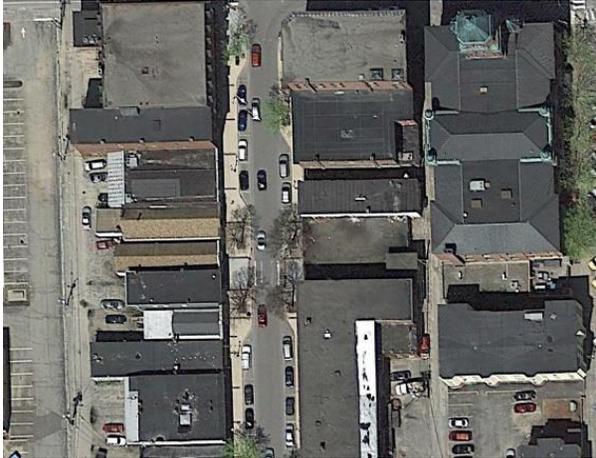
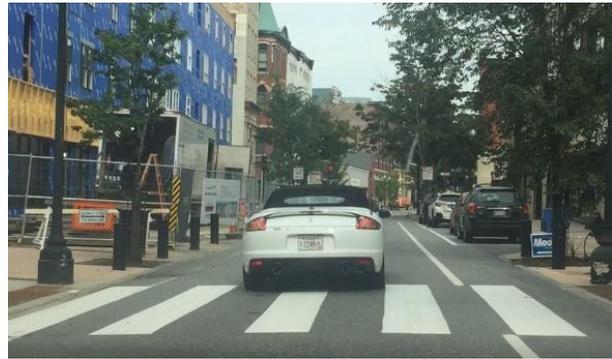
The midblock crossing between Ash Street and Pine Street has been recently restriped and upgraded to meet all ADA standards. This intersection is shown in Figures 8.6 and 8.7. No additional improvements are recommended at this time.

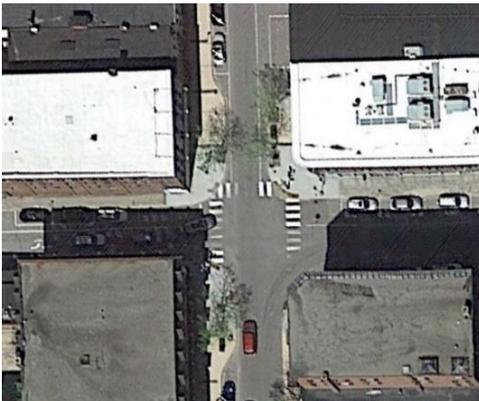
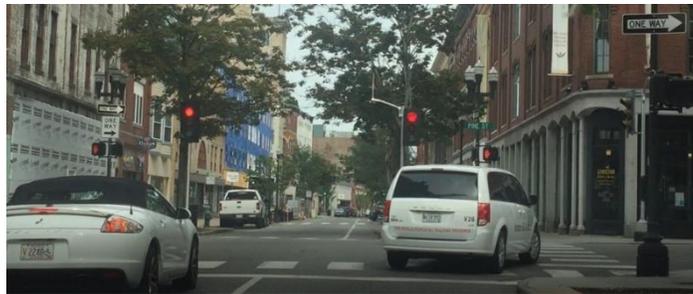
The intersection of Lisbon Street and Pine Street has been recently restriped and upgraded to meet all ADA standards. Figures 8.8 and 8.9 show this intersection. No additional improvements are recommended at this time.

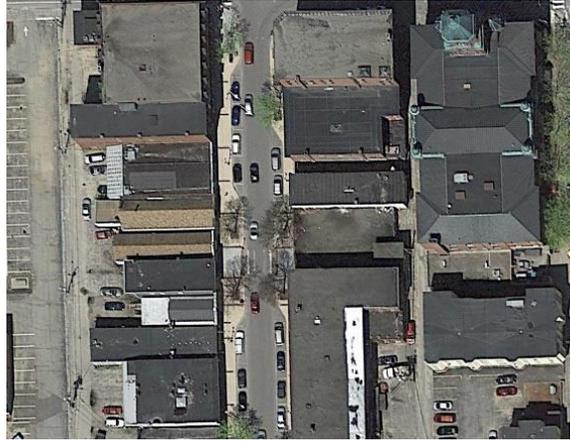
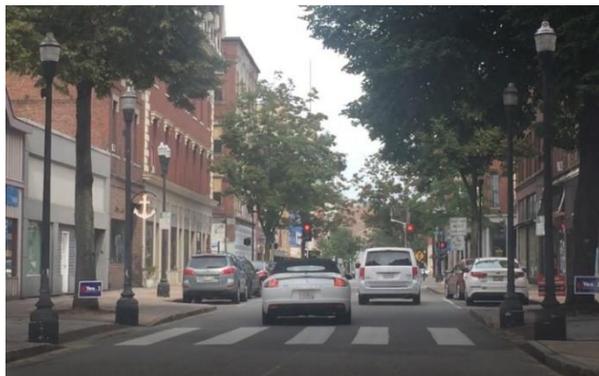
The midblock crossing between Pine Street and Chestnut Street has been recently restriped and meets all ADA standards. It is shown in Figures 8.10 and 8.11. No additional improvements are recommended at this time.

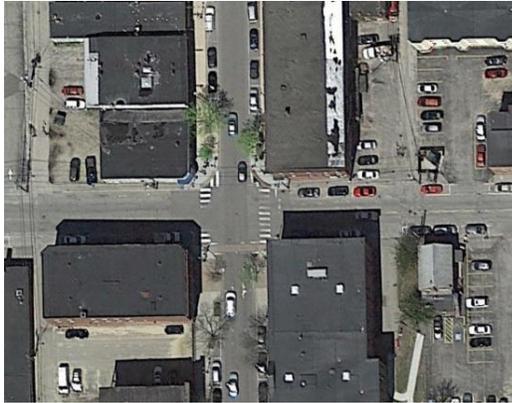
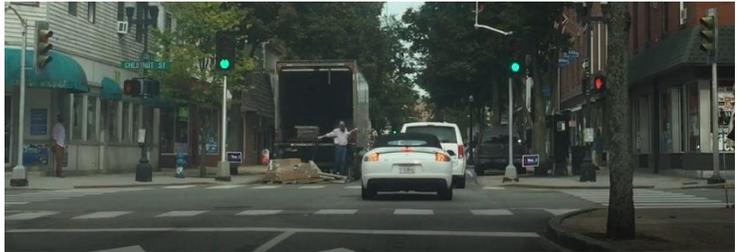
The intersection of Lisbon Street and Chestnut Street has recently been upgraded with high visibility crosswalk striping and ADA improvements. This intersection is shown in Figures 8.12 and 8.13. No additional improvements are recommended at this time.
