# Lewiston Pedestrian Crossing Study

**HNTB**

4/15/2019

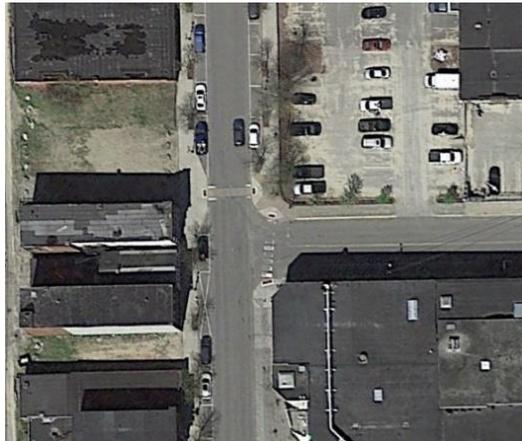
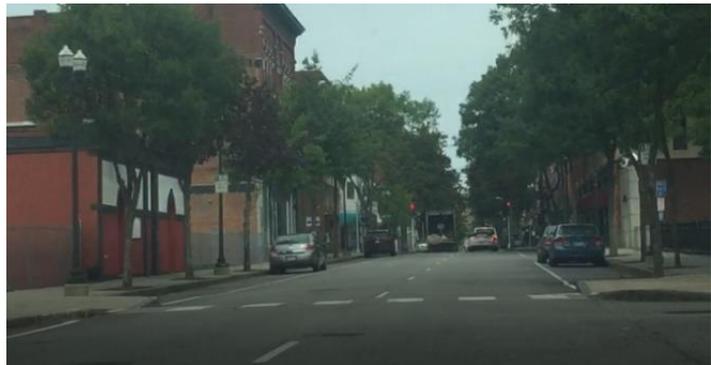
The intersection of Lisbon Street and Spruce Street has recently been upgraded with high visibility block crosswalk striping and ADA improvements. This intersection is shown in Figures 8.14 and 8.15. No additional improvements are recommended at this time.

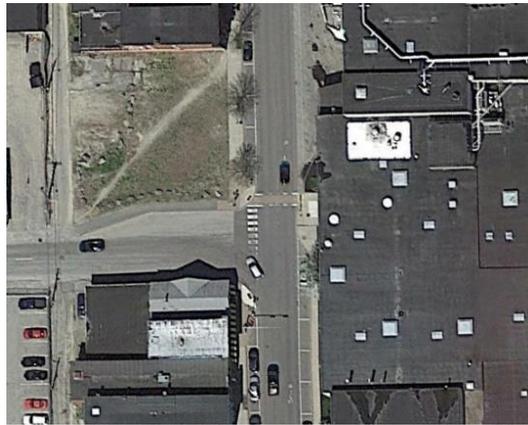
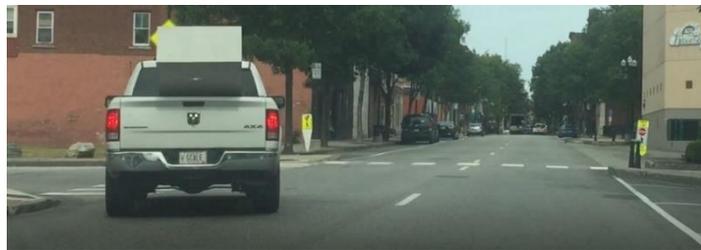
The intersection of Lisbon Street and Cedar Street has recently been upgraded with high visibility block crosswalk striping and ADA improvements, including signage.

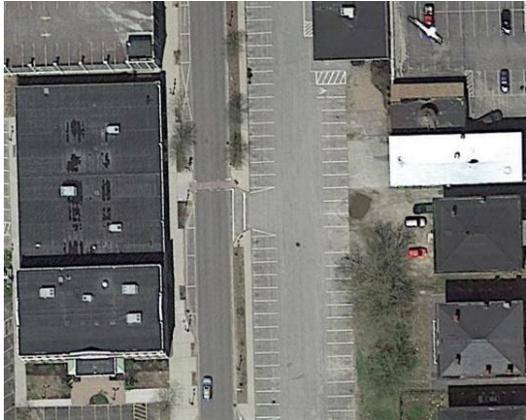
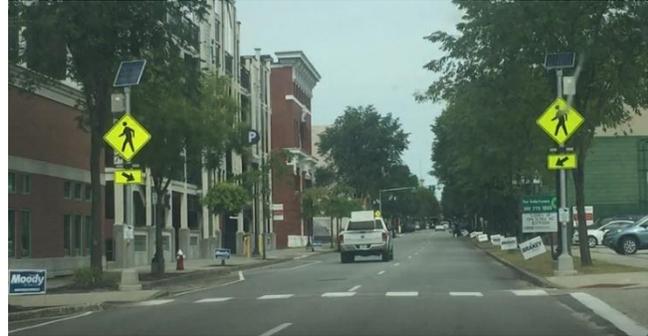
The midblock crossing between Cedar Street and Maple Street was recently updated with new high visibility block crosswalk striping and ADA improvements, including RRFBs. The intersection is shown in Figures 8.18 and 8.19. No additional improvements are recommended at this time.

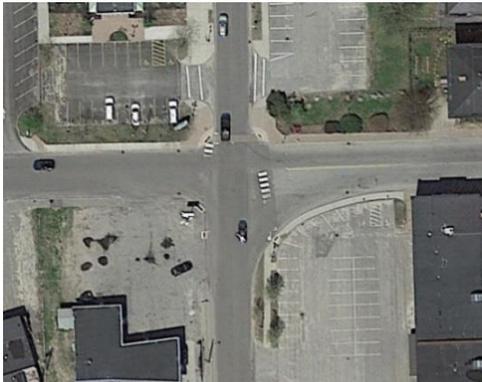
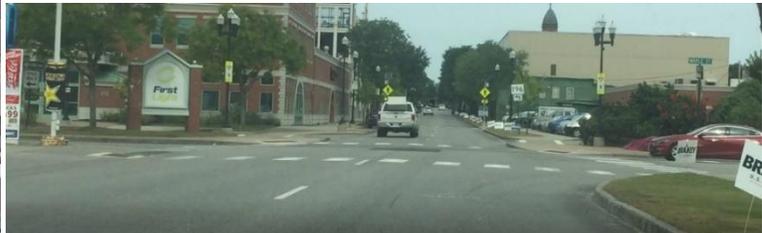
The intersection of Lisbon Street and Maple Street has been updated recently with new high visibility crosswalk striping and ADA improvements. This intersection is shown in Figures 8.20 and 8.21. No additional improvements are recommended at this time.

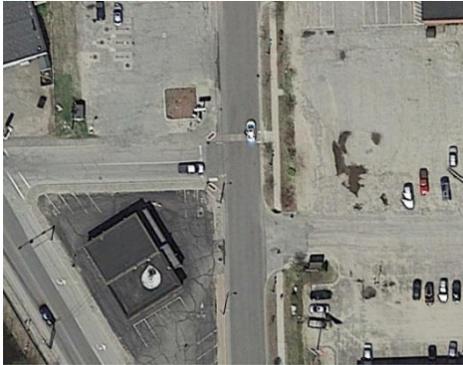
Figure 8.22 Lisbon Street at Locust Street Aerial

The intersection of Lisbon Street and Locust Street has been updated recently with new high visibility block crosswalk striping. This intersection is shown In Figures 8.22 and 8.23. No additional improvements are recommended at this time.

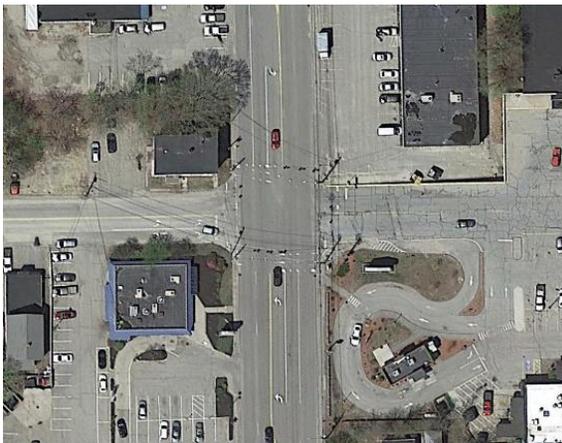
Figure 8.24 Lisbon Street at Essex Street Aerial

Improvements for the intersections of Lisbon and Essex Streets and Lisbon Street and East Avenue are currently in the design phase. The Lisbon and Essex Street intersection is shown in Figure 8.24, and the Lisbon Street and East Avenue intersection is shown in Figure 8.25.

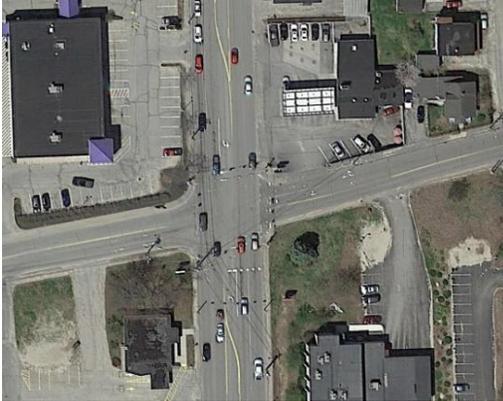
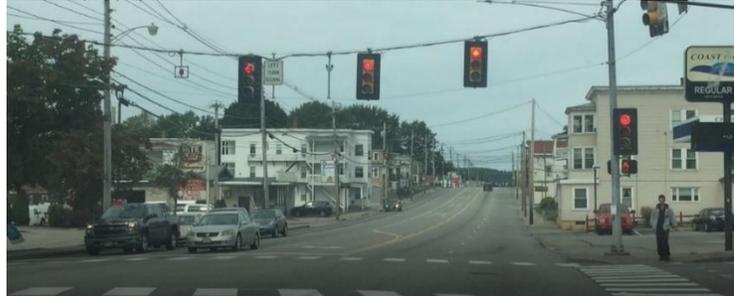
The intersection of Lisbon Street and South Avenue has been restriped to include high visibility block striping at all crossings, and it is shown in Figures 8.26 and 8.27. Updated signs and ADA pedestrian upgrades are recommended.

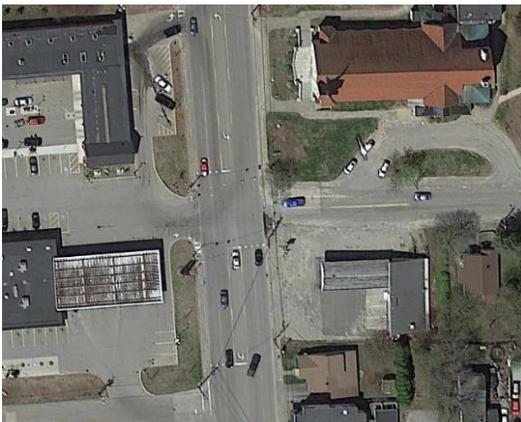
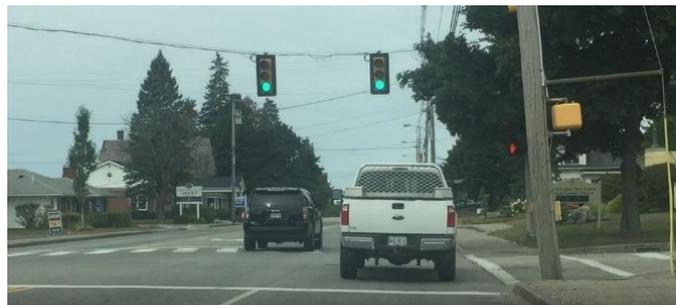
The intersection of Lisbon Street and St. Croix Street has been updated recently with new high visibility block crosswalk striping. It is shown in Figures 8.28 and 8.29. ADA upgrades, APS push buttons signs, and detectable warning surfaces are recommended.

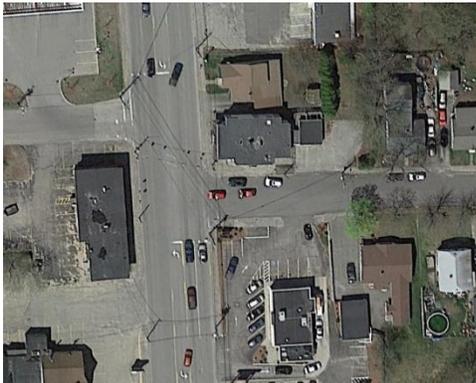
Figure 8.30 Lisbon Street at Scribner Boulevard Aerial

This intersection of Lisbon Street and Scribner Boulevard has been updated with new high visibility block crosswalk striping. ADA upgrades, APS push buttons and detectable warning surfaces are recommended. The intersection is shown in Figures 8.30 and 8.31.

Bumpouts were examined for use at this location, but due to the narrow lanes on both Lisbon Street and Scribner Boulevard, they are not recommended in this location. Likewise, after evaluating the potential use of small bumpouts, it was determined that they would not significantly reduce crossing lengths and would cause maintenance concerns relating to snow removal, so they are not recommended. Straightening the crossing and ensuring adequate crossing time with countdown heads will have a more significant improvement at this location, so they are recommended.

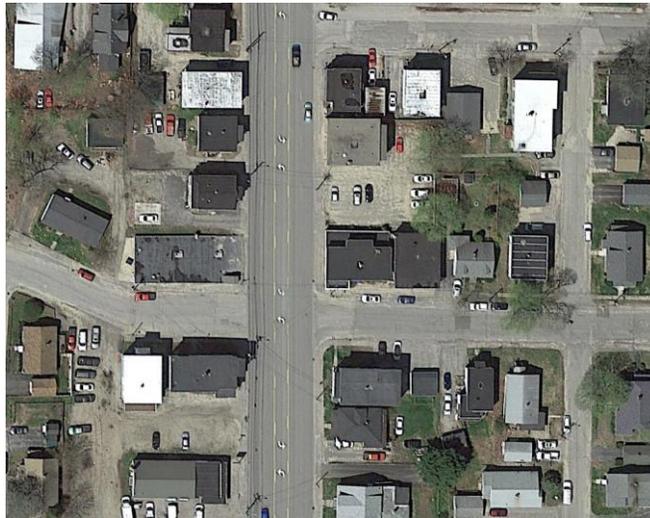
Figure 8.32 Lisbon Street at Webber Street Aerial

There was one fatality at the intersection of Lisbon and Weber Streets, but it was unique in that it involved one specific pedestrian who frequently jaywalking here without a crosswalk. This intersection is shown in Figure 8.32. As it is an area with high vehicular speeds and many driveways and entrances, a pedestrian crossing is not recommended at this time.

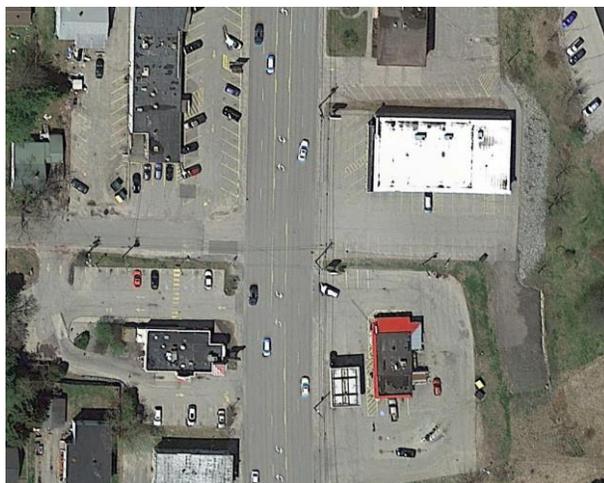
Figure 8.33 Lisbon Street at Jones Avenue Aerial

The intersection of Lisbon Street and Jones Avenue is shown in Figure 8.33. Although this intersection might appear to be an ideal location for a pedestrian crosswalk, five lanes of high-speed travel would make it dangerous for pedestrians even if a mid-point pedestrian refuge was provided. Therefore, a crossing at this location not recommended.

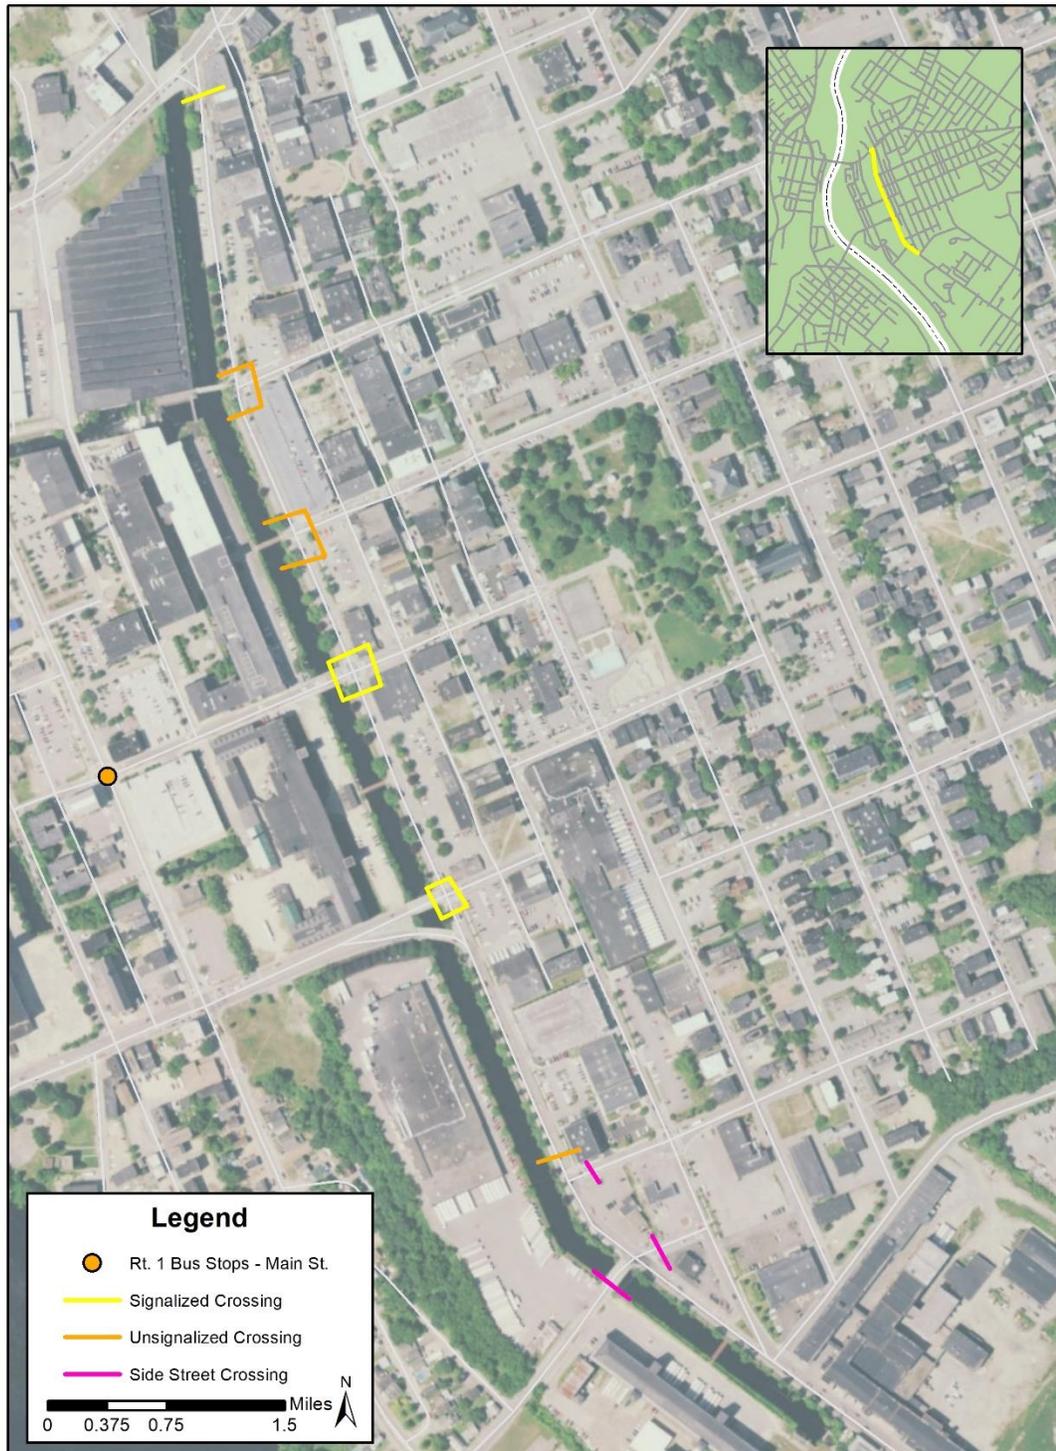
**Figure 9.2**  
**Canal Street Pedestrian Crossings**  
*City of Lewiston, Maine*

The following two figures show existing pedestrian facilities in the corridor. The first, Figure 9.1 shows existing crosswalks and signalized locations. The second, Figure 9.2 shows pedestrian crossings by type of crossing and locations of pedestrian crossings.

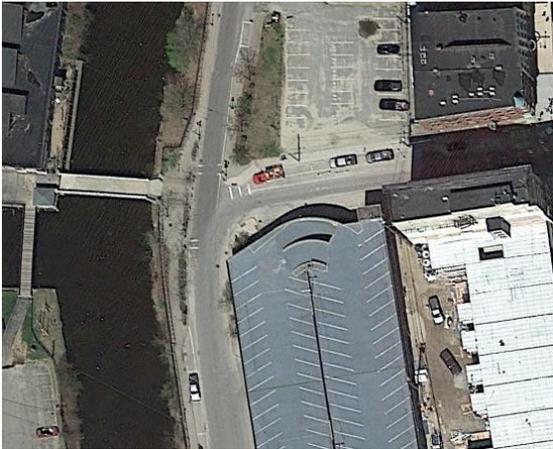
Figure 9.4 Canal Street at Ash Street Aerial

The intersection of Canal Street and Ash Street has recently been restriped to be a high visibility block crossing. ADA improvements are recommended at this location. Figures 9.4 and 9.5 show this intersection.

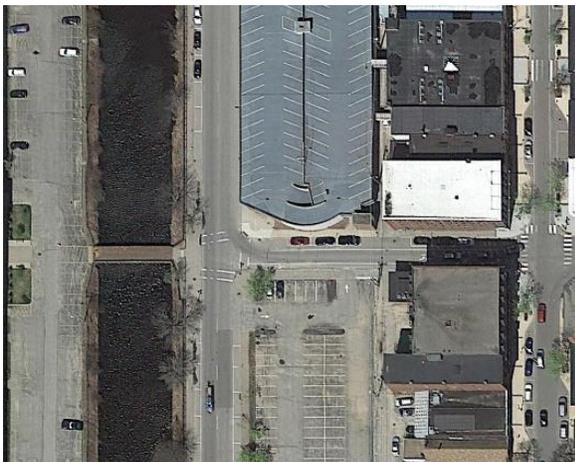
Figure 9.6 Canal Street at Pine Street Aerial

The intersection of Canal Street and Pine Street has previously been a pedestrian crash location, and it is shown in Figures 9.6 and 9.7. This intersection has recently been restriped to be a high visibility block crossing. ADA improvements are recommended at this location.

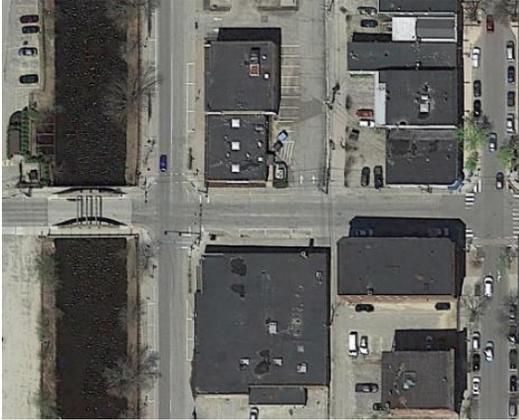
Figure 9.8 Canal Street at Chestnut Street Aerial

The intersection of Canal Street and the Chestnut Street Bridge has previously been classified as an HCL. It is shown in Figures 9.8 and 9.9. This intersection has recently been upgraded with high visibility block crossing striping with ADA improvements. We recommended a re-evaluation of the bridge to the mill during retrofit and redesign opportunities in the future.

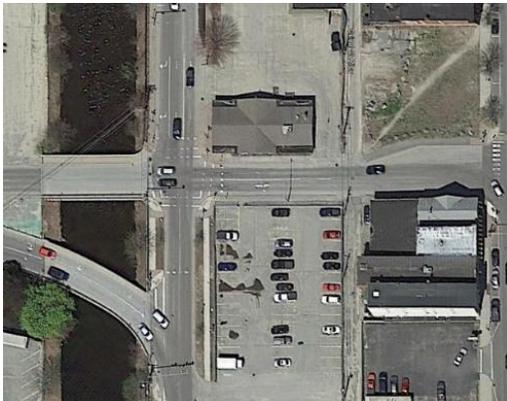
Figure 9.10 Canal Street at Cedar Street Aerial

The intersection of Canal Street and the Cedar Street Bridge has a history of being an HCL with both bicycle and pedestrian crashes. It is shown in Figures 9.10 and 9.11. The intersection has recently been upgraded with high visibility block crossing striping and ADA improvements. We recommended consideration be given to eliminating the southwesterly pedestrian ramp on the corner of the bridge to discourage pedestrians from walking along the southerly side of the bridge.

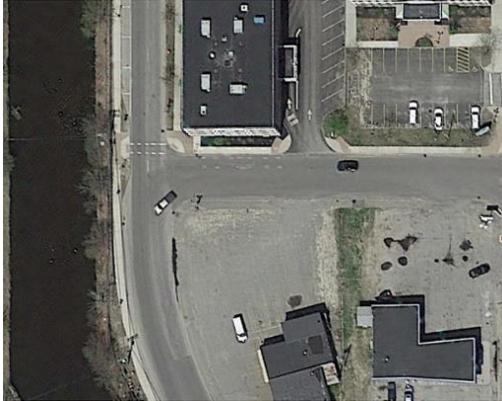
Figure 9.12 Canal Street at Maple Street Aerial

The intersection of Canal Street and Maple Street is in an area of historic speeding. It is shown in Figures 9.12 and 9.13. The crossing has recently been upgraded to high visibility block crossing striping with ADA improvements. We recommend consideration of the use of RRFBs.

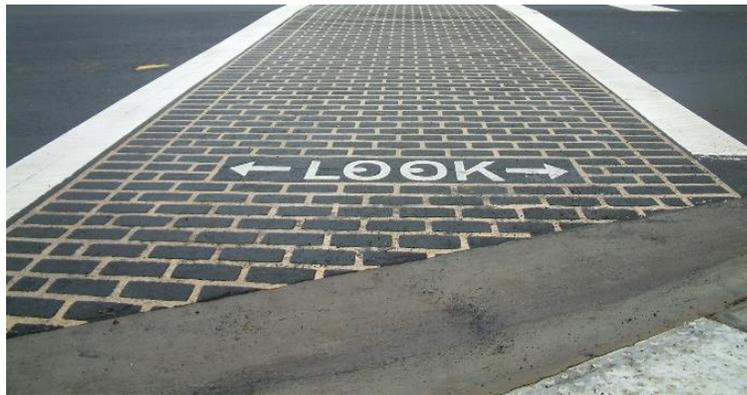
Look for Cars Before Crossing Marking

- Evaluate overhead lighting at the vehicular and pedestrian level and consider replacement of existing bulbs with LEDs to improve illumination.
- Build upon the existing safety campaigns developed by Bicycle Coalition of Maine and the MaineDOT Task Force for Safety
  - Educate residents regarding appropriate places to locate trash.
  - Encourage bicyclists and pedestrians to wear high visibility clothing.
  - Enforce jaywalking laws with a stop and educate campaign at high incident locations.
  - Consider locations where bike lanes can and should be implemented.
  - Remind users to look for cars before crossing – consider adding pavement markings for this such as:<sup>11</sup>

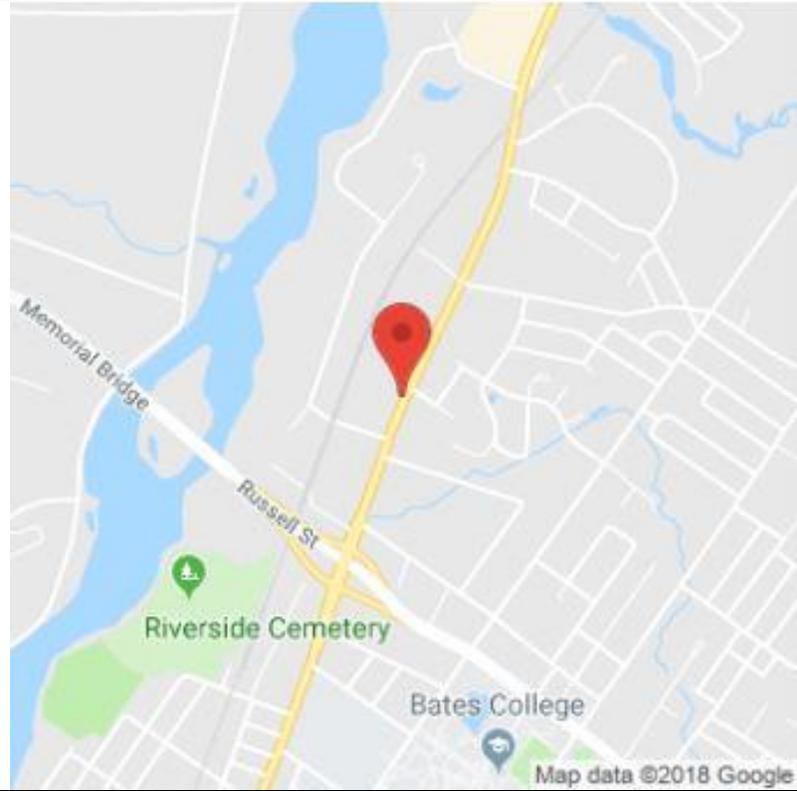
| | <p><b>Location:</b> Intersection of Main Street and Bearce Avenue</p> <p><b>Description:</b> Three-lane roadway with a shared left-turn lane, sidewalks on both sides</p> |

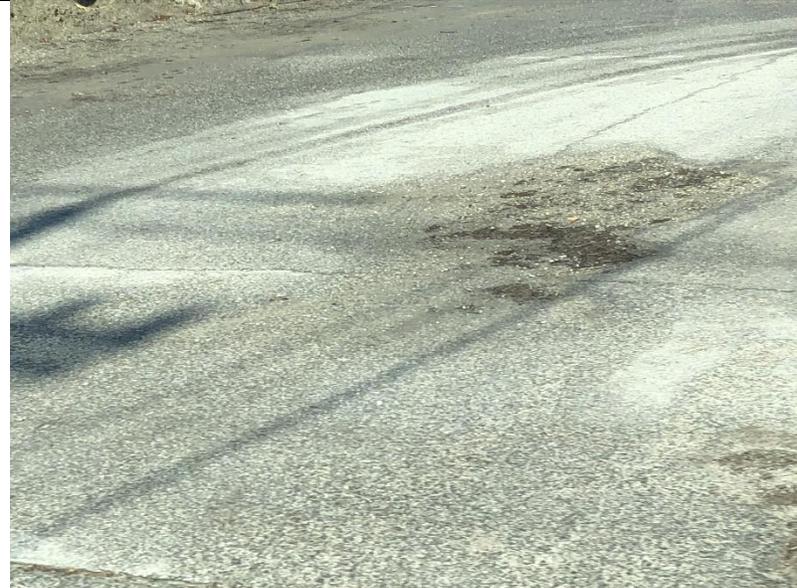
| | <p><b>Location:</b> Intersection of Main Street and Bearce Avenue</p> <p><b>Description:</b> Driveway access to local business</p> <p><b>Problem:</b> Deteriorating pavement and debris</p> |

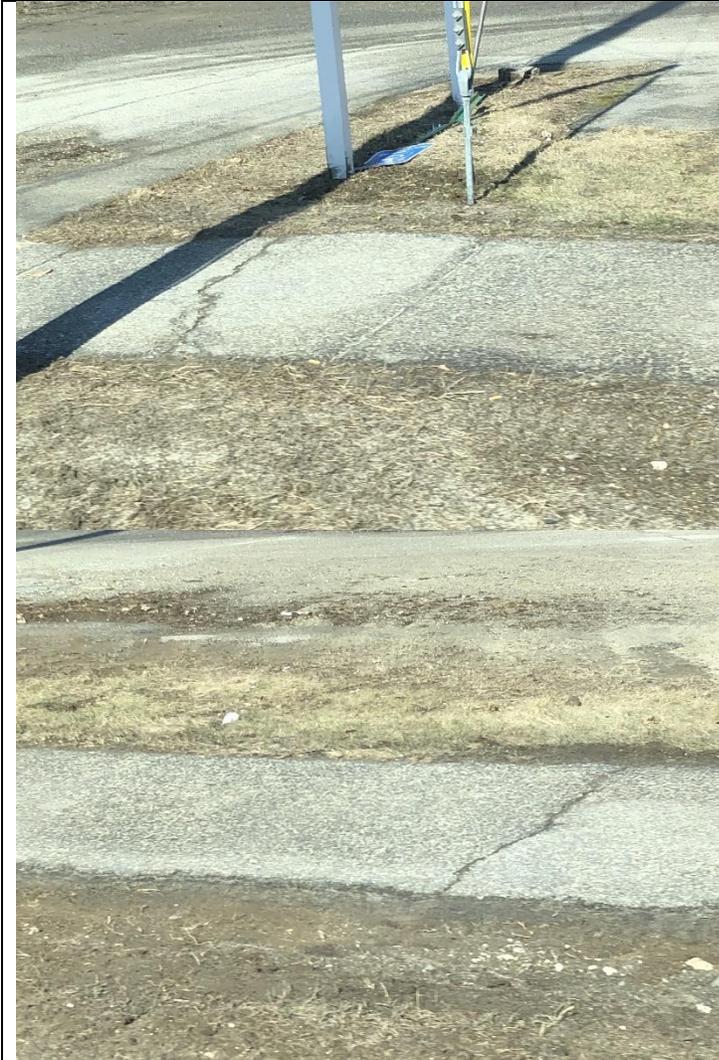
**Location:** Intersection of Main Street and Bearce Avenue

**Problem:** Deteriorating sidewalk pavement

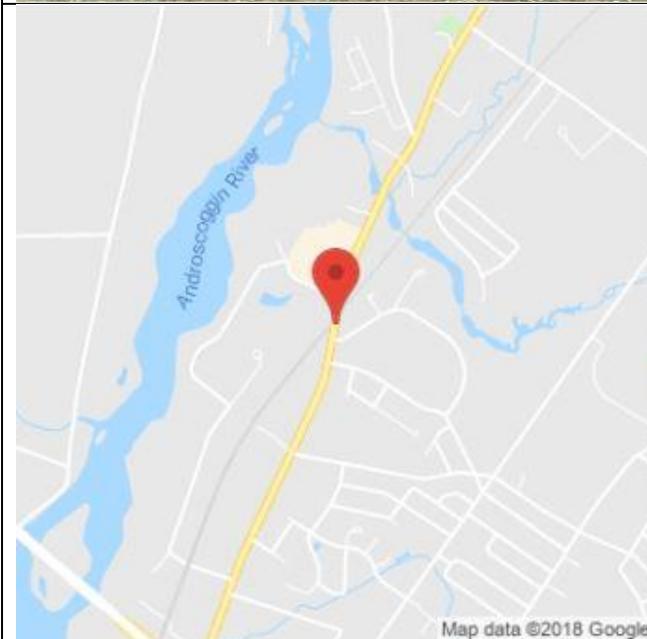
**Location:** Intersection of Lisbon Street and Mollison Way

**Description:** Signalized T-intersection, three-lane roadway with left-turn lanes, bridge with train tracks passing over Main Street approaching intersection heading downtown, sidewalk on one side

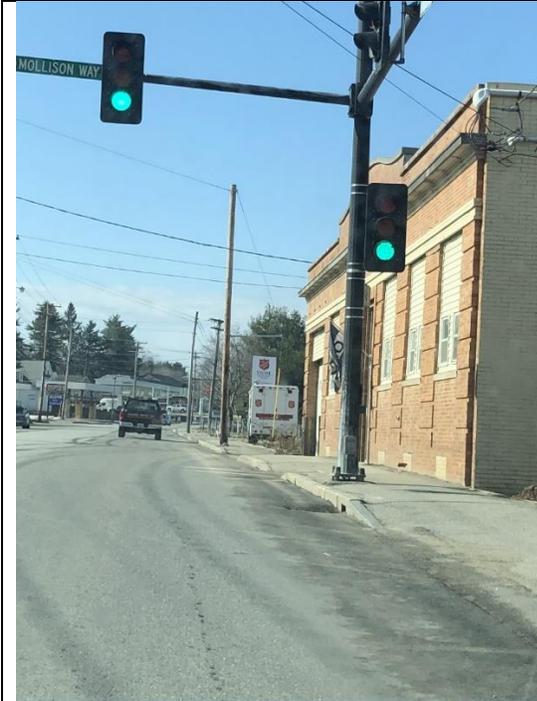
**Location:** Intersection of Lisbon Street and Mollison Way

**Description:** Sidewalk along Main Street

**Problem:** Mast arm and utility pole obstructing sidewalk, no pedestrian signs or signals or markings across driveway or Main Street, obstructed site distance due to bridge

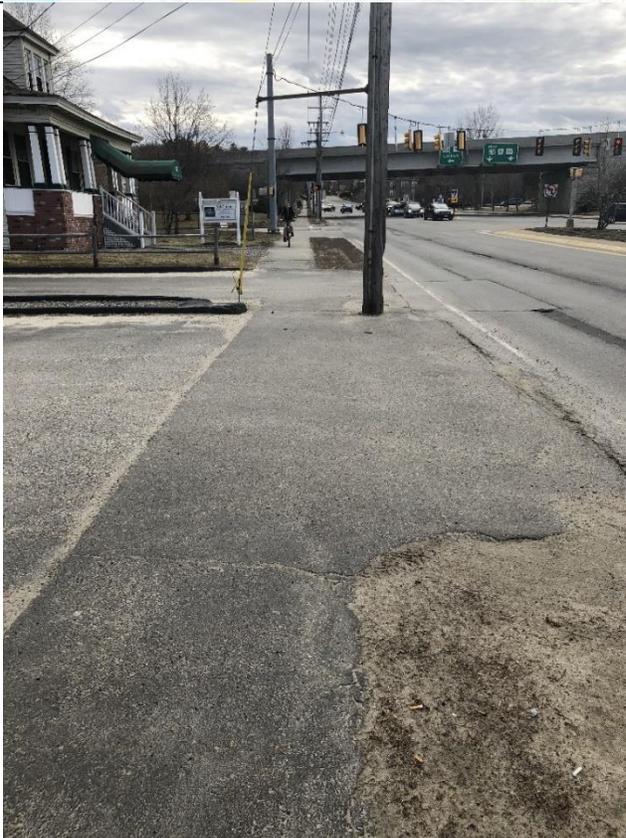
**Location:** Intersection of Main Street and Pettingill Street

**Description:** Sidewalk along Main Street with driveway access and side streets

**Problem:** Pavement deteriorating with debris, no pedestrian signs, signals or markings across driveway or side street

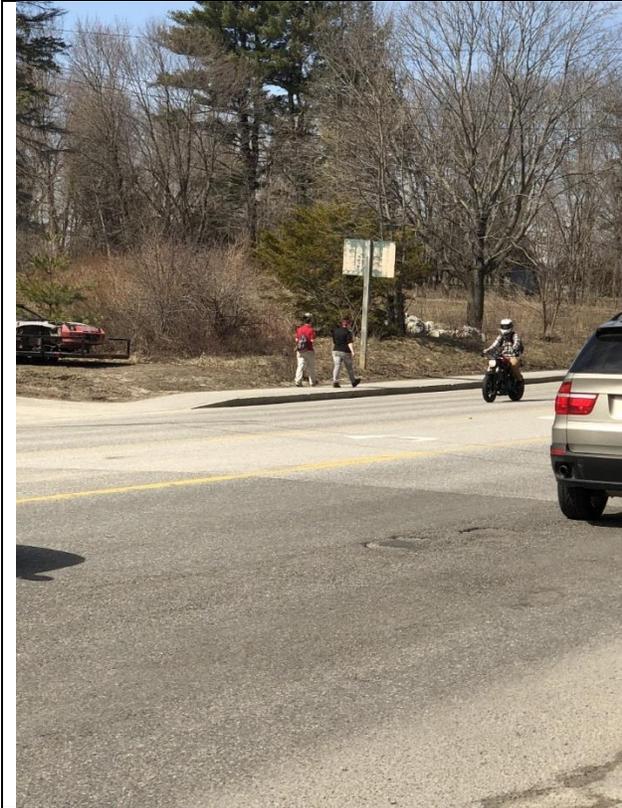
**Location:** Intersection of Main Street and Pettingill Street

**Description:** Pedestrian using sidewalk

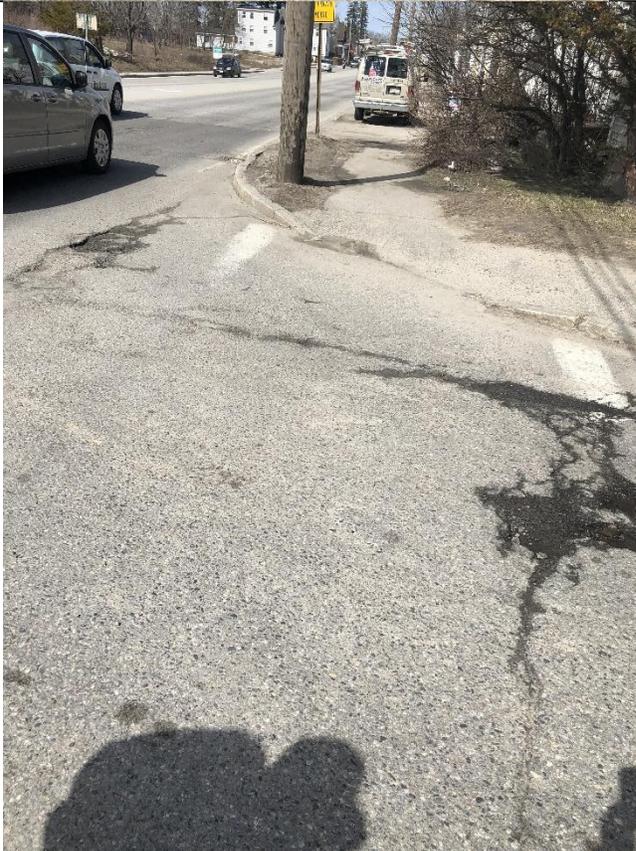
**Location:** Intersection of Main Street and Pettingill Street

**Description:** Crosswalk across side street along Main Street

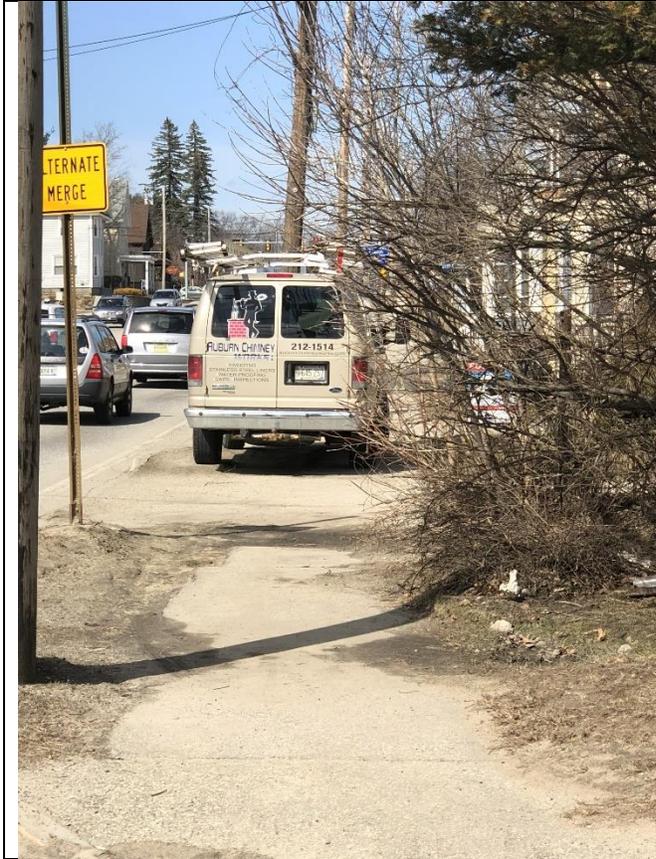
**Location:** Intersection of Main Street and Pettingill Street

**Problem:** No pedestrian signs or signals, faded crosswalk marking, pavement deteriorating

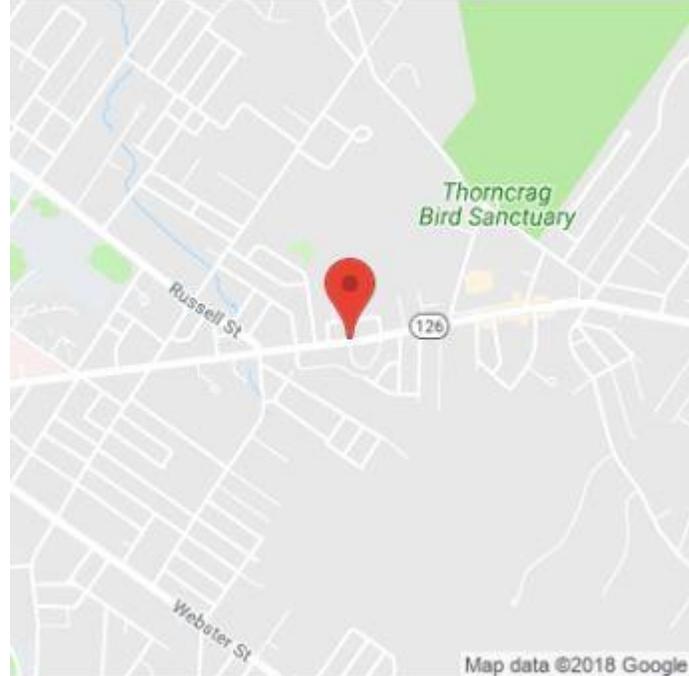
| <p>A Google Map showing the intersection of Sabattus and Laurier Street. A red location pin is placed at the intersection. To the north is the Thorncrag Bird Sanctuary, shown in green. Other streets labeled include Russell St and Webster St. A road sign for 126 is visible. Map data is attributed to ©2018 Google.</p> | <p><b>Location:</b> Intersection of Sabattus and Laurier Street next to Holy Family Church</p> <p><b>Description:</b> Four-lane roadway with sidewalks on either side, pedestrian crossing with signs and signal, driveway access</p> |

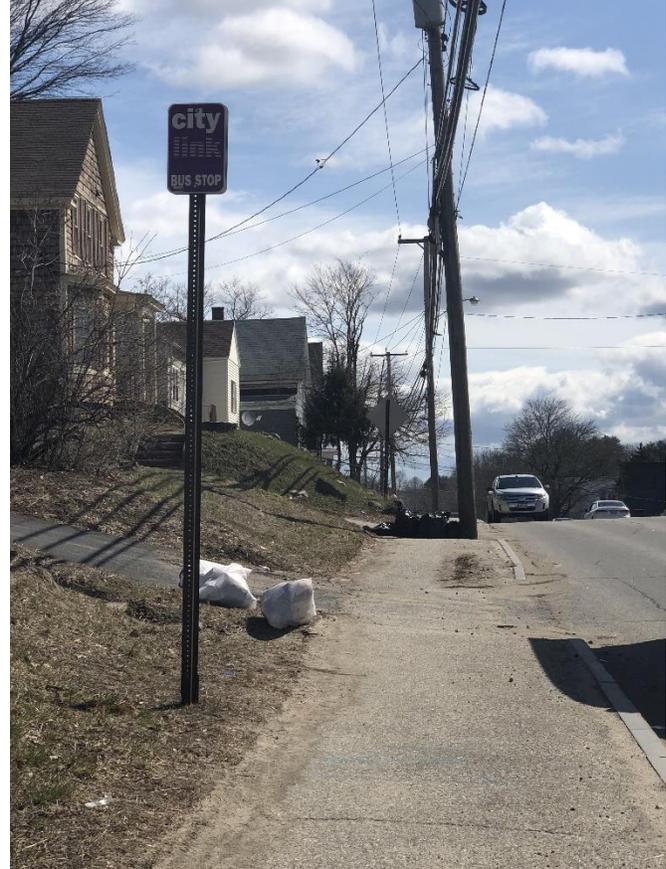
| <p>A photograph of a sidewalk along Sabattus Street. In the foreground, a black signpost with a 'city' logo and 'BUS STOP' text stands on the sidewalk. To the right, a utility pole with multiple wires is positioned near the sidewalk. In the background, there are houses, trees, and a clear sky with some clouds. A white car is visible on the road.</p> | <p><b>Location:</b> Intersection of Sabattus and Laurier Street next to Holy Family Church</p> <p><b>Description:</b> Sidewalk along Sabattus Streets with driveway access</p> <p><b>Problem:</b> Deteriorating sidewalk with obstructions (utility poles and trash)</p> |

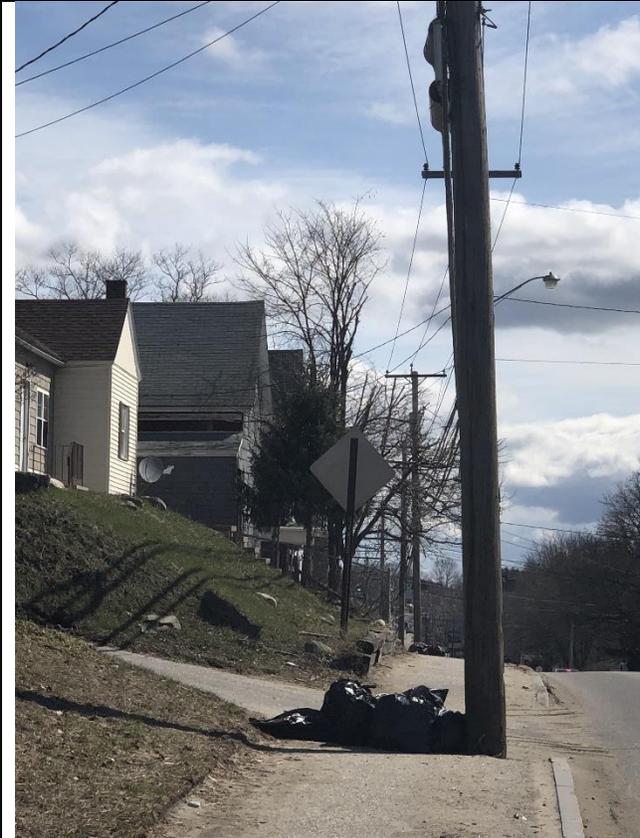
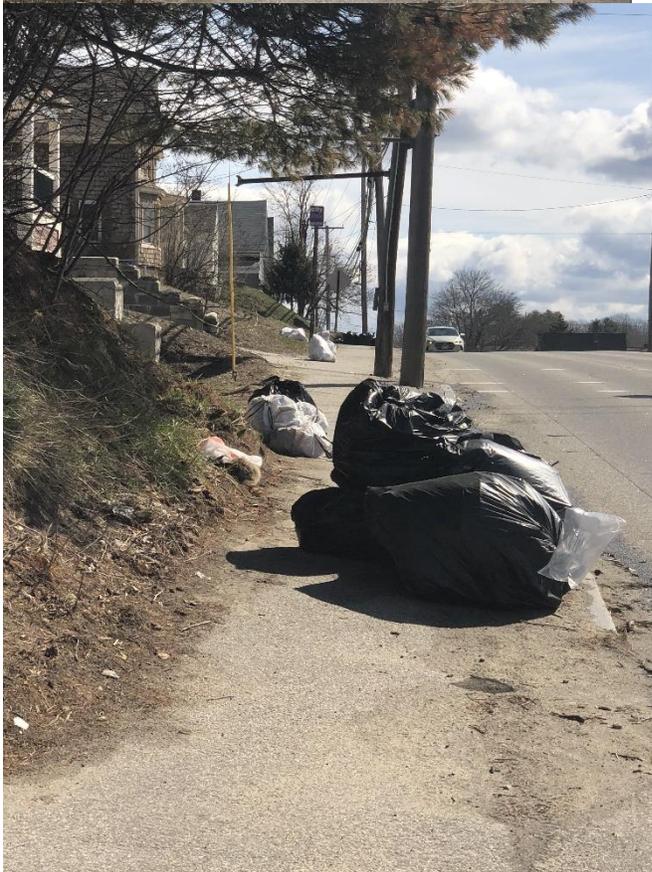
**Location:** Intersection of Sabattus and Laurier Street next to Holy Family Church

**Description:** Sidewalk along Sabattus Streets with driveway access

**Problem:** deteriorating sidewalk with obstructions (utility poles and trash), debris in sidewalk, not ADA compliant

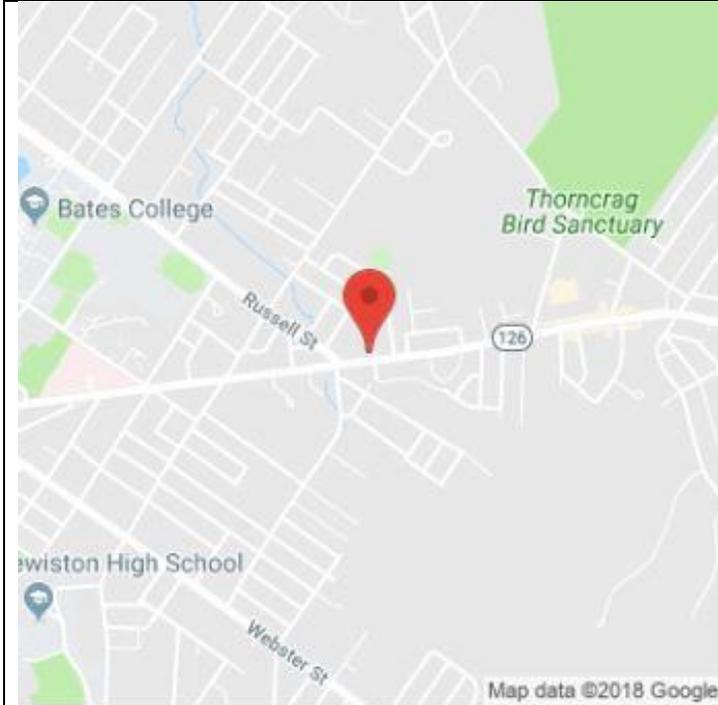
**Location:** Intersection of Sabattus Street and Fairlawn Avenue

**Description:** Signalized five-lane roadway with two through-lanes and dedicated left-turn lanes, crosswalks across side streets and one leg of Sabattus Street, sidewalks on both sides

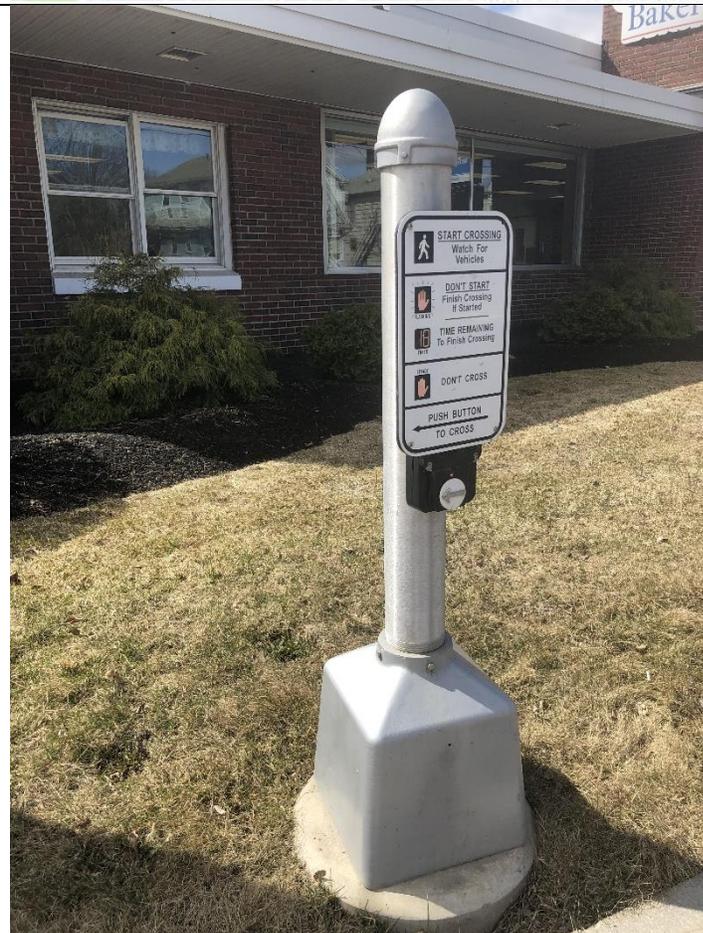
**Location:** Intersection of Sabattus Street and Fairlawn Avenue

**Description:** Pedestrian pedestal with push button

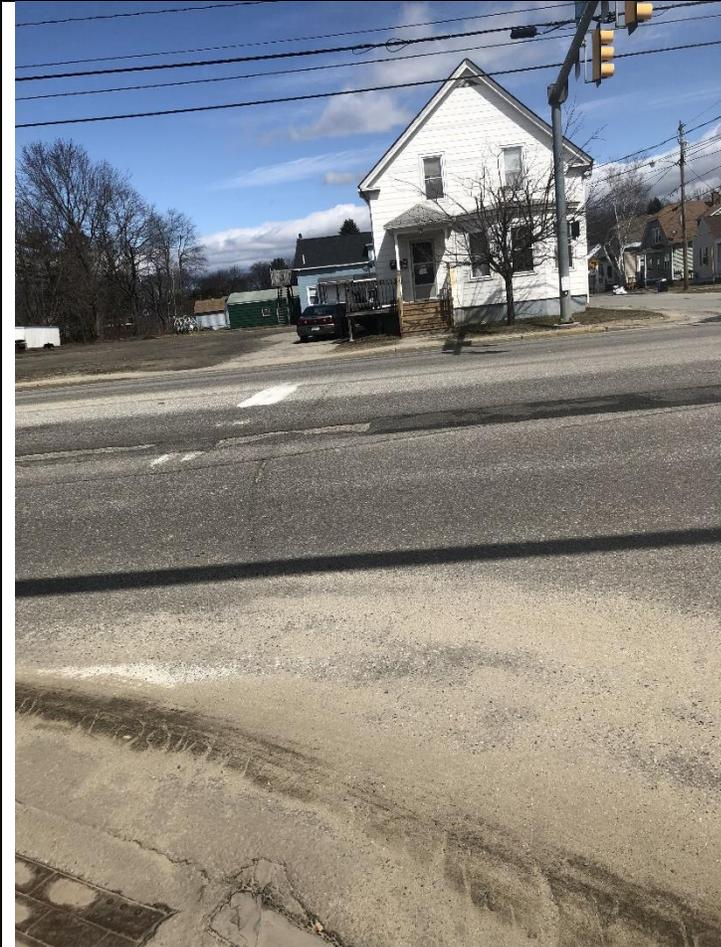
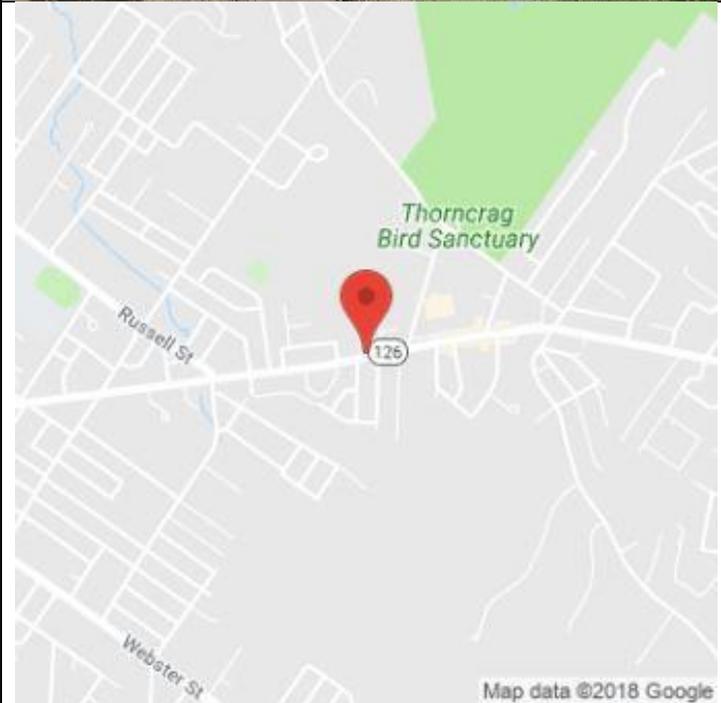
**Location:** Intersection of Sabattus Street and Furbush Street

**Description:** Four-lane roadway with sidewalks on either side, driveway access and side streets

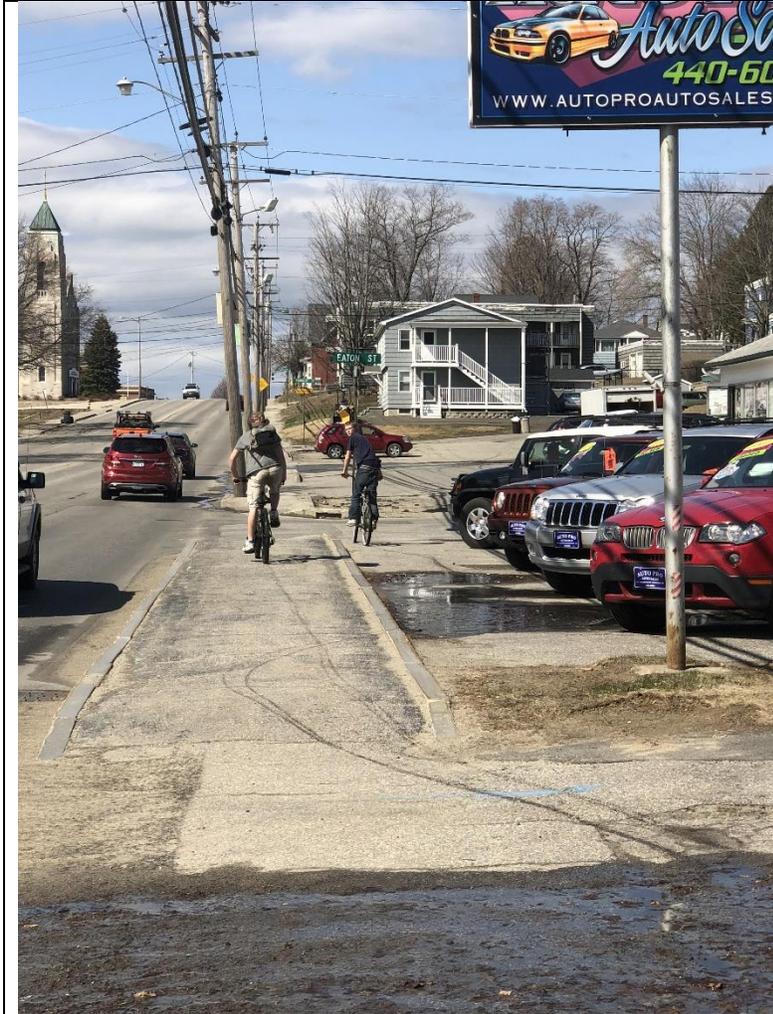
**Location:** Intersection of Sabattus Street and Furbush Street

**Description:** Sidewalk with abutting car dealership along Sabattus Street

**Problem:** Bicyclist using sidewalks, lack of bike lanes or markings

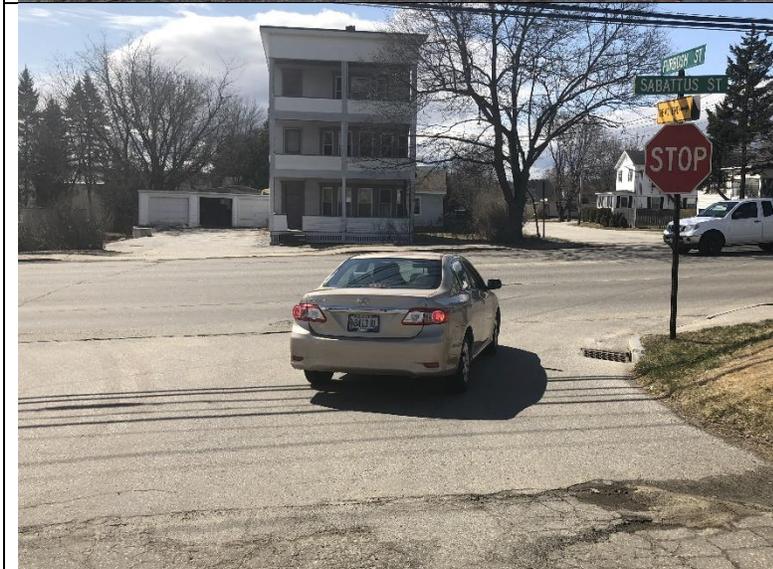
**Location:** Intersection of Sabattus Street and Furbush Street

**Description:** Side street access to Sabattus Street with crosswalk

**Problem:** Vehicle blocking crosswalk at stop intersection on Sabattus Street

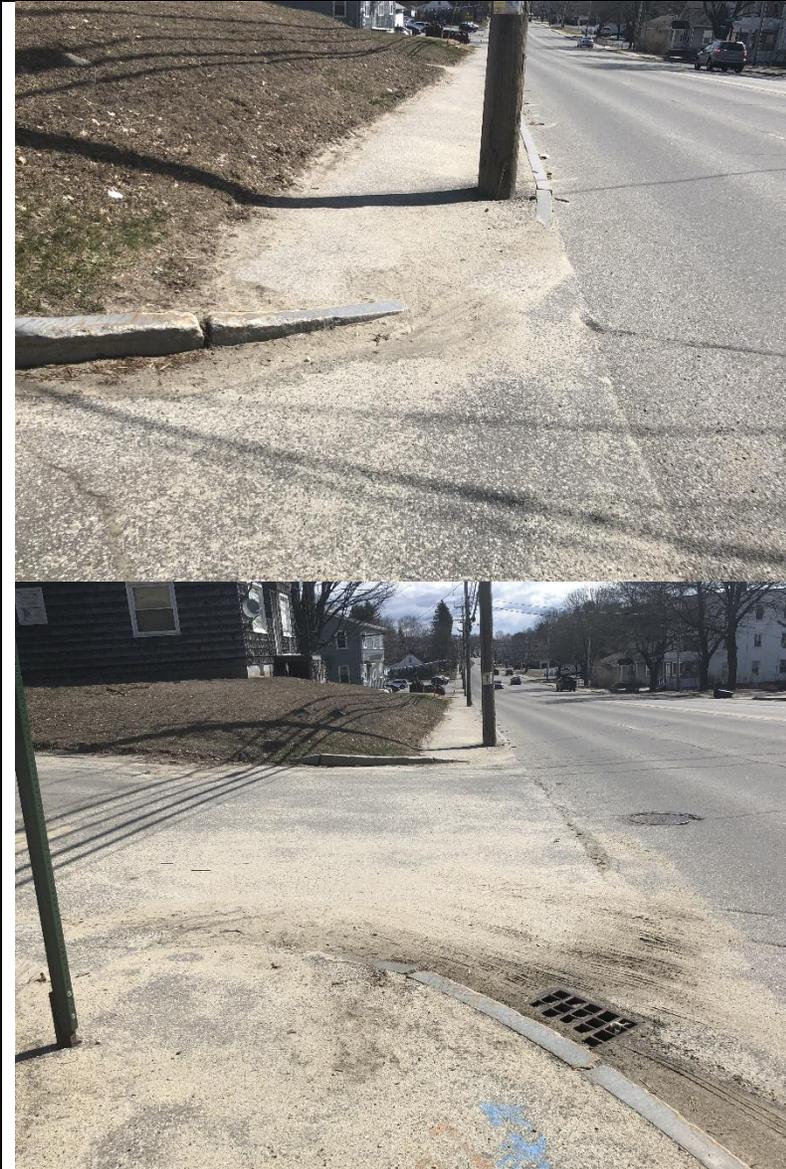
**Location:** Intersection of Sabattus Street and Furbush Street

**Description:** Crosswalk with ramp along Sabattus Street

**Problem:** No detectable warning surfaces, no pedestrian markings, signs or signals, obstructions and debris in sidewalk, not ADA compliant

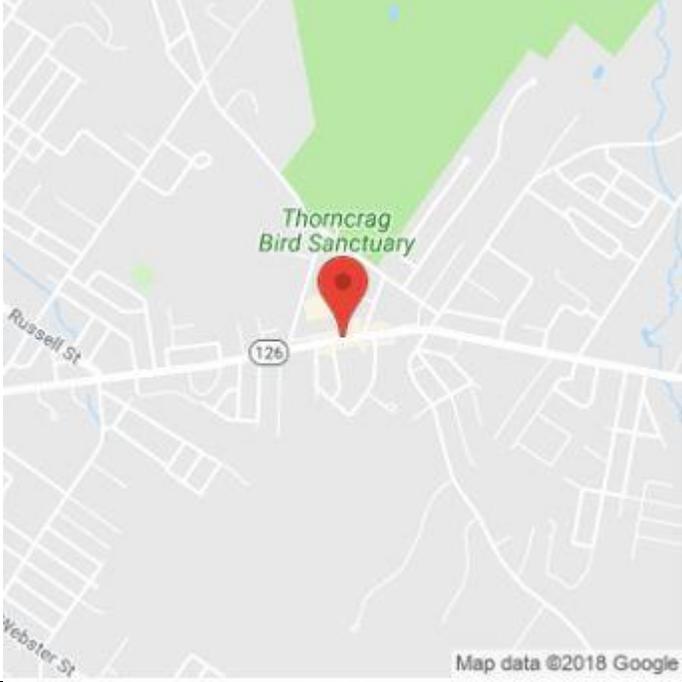
| | <p><b>Location:</b> Intersection of Sabattus Street and Hannaford</p> <p><b>Description:</b> Signalized intersection for four-lane roadway with crosswalks on three legs and sidewalks on both sides</p> |

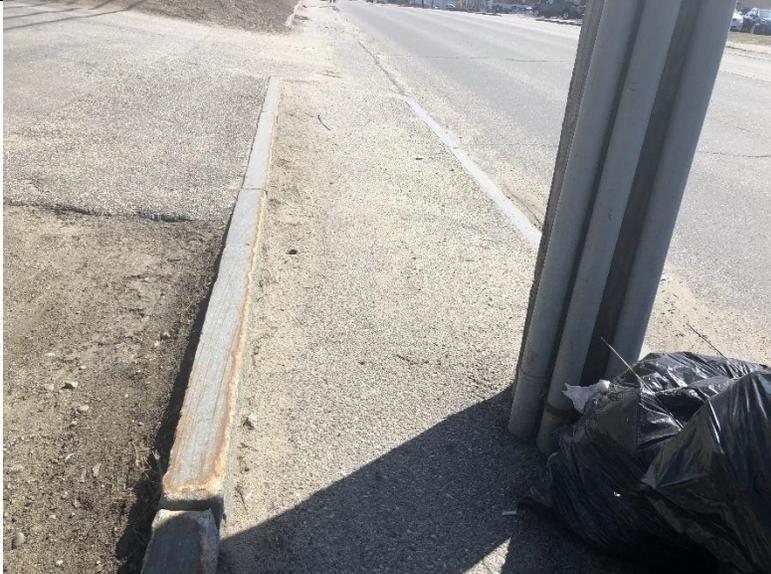
| | <p><b>Location:</b> Intersection of Sabattus Street and Hannaford</p> <p><b>Description:</b> Sidewalk along Sabattus Street with granite curb</p> <p><b>Problem:</b> Obstruction in sidewalk with debris</p> |
