# Lewiston Pedestrian Crossing Study

**HNTB**

4/15/2019

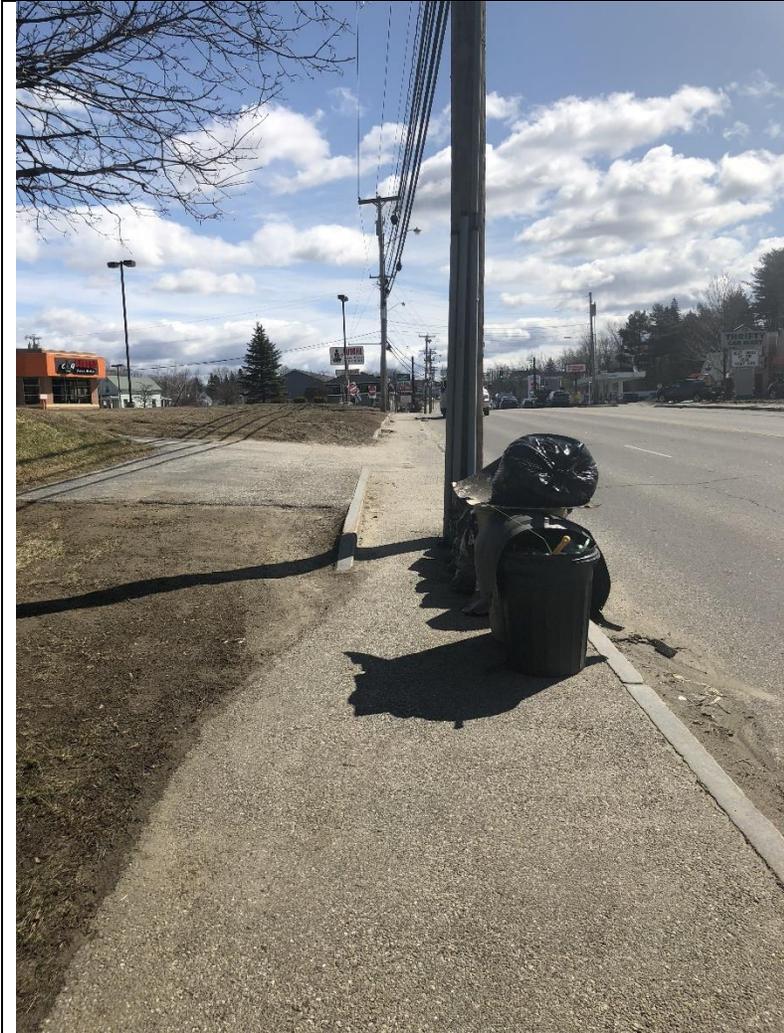
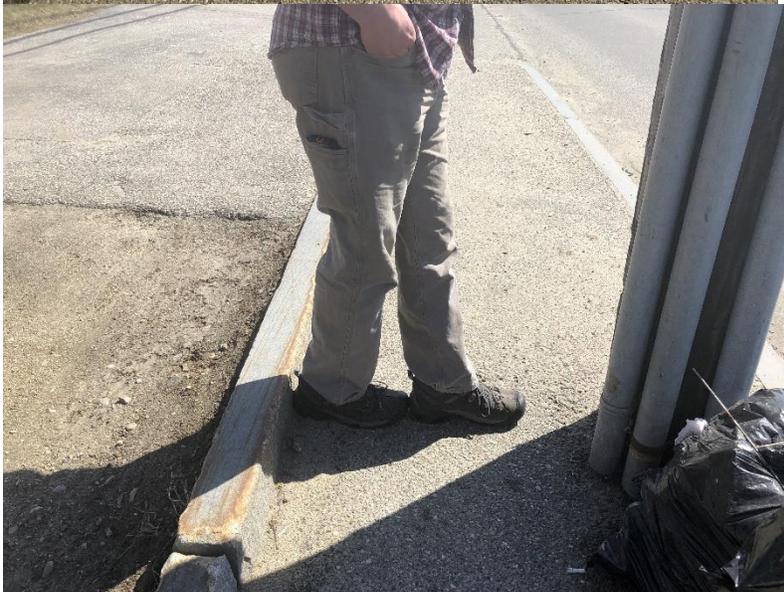
**Location:** Intersection of Sabattus Street and Hannaford

**Description:** Sidewalk along Sabattus Street with granite curb and driveway access

**Problem:** Obstruction in sidewalk with debris, not ADA compliant

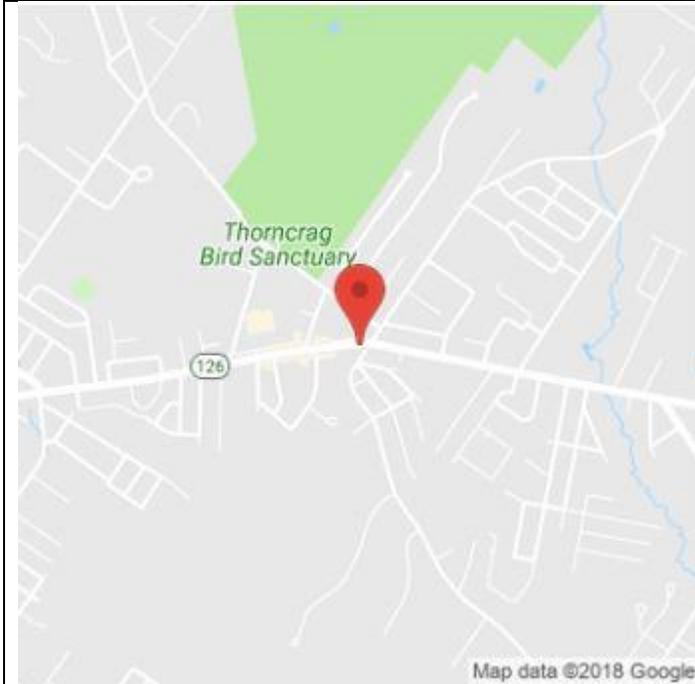
**Location:** Intersection of Sabattus Street and Old Green Road

**Description:** Skewed 4-way signalized intersection with crosswalks across all four legs and sidewalks on either side

**Problem:** Sidewalk pavement deteriorating

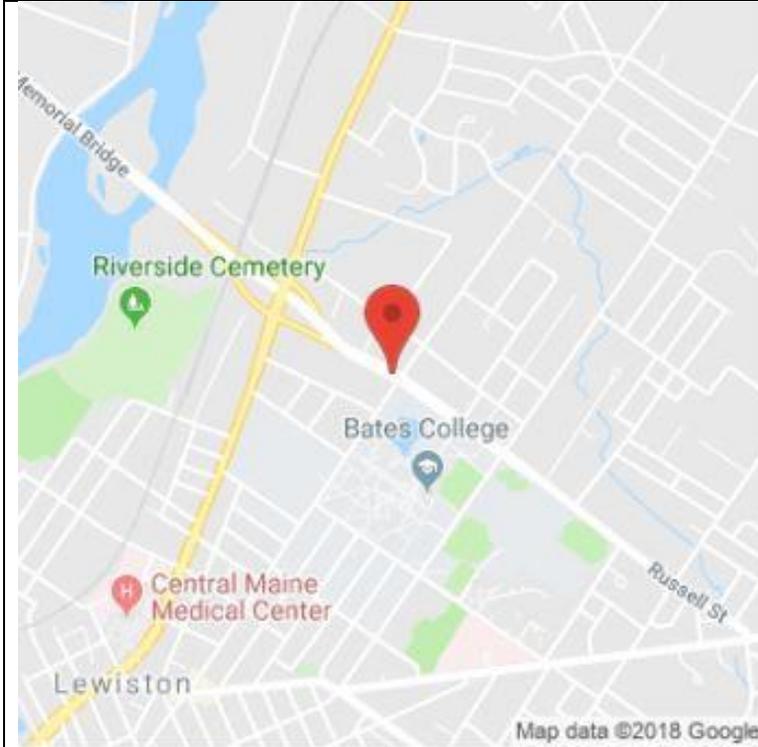
**Location:** Intersection of Russell Street and College Street

**Description:** Five-lane roadway with two through-lanes and left-turn lanes, next to Bates College, sidewalk on either side and crosswalks on all four legs

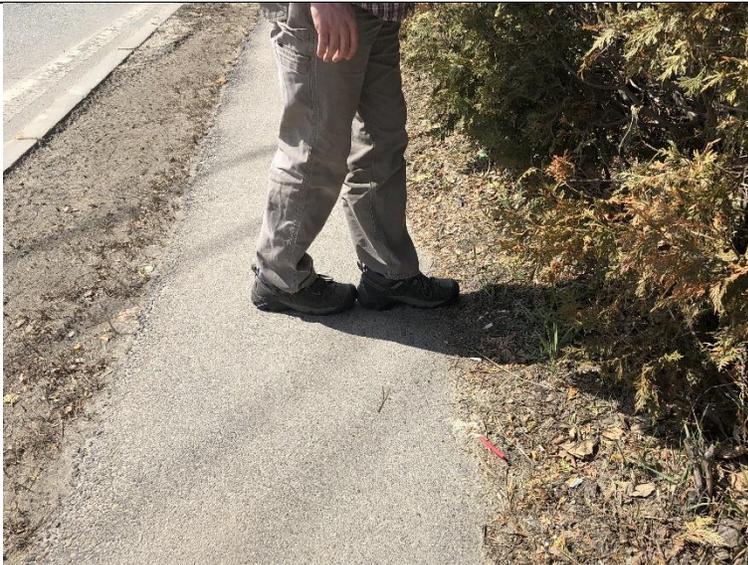
**Location:** Intersection of Russell Street and College Street

**Description:** Sidewalk along Russell Street

**Problem:** Sidewalk not wide enough, not ADA compliant

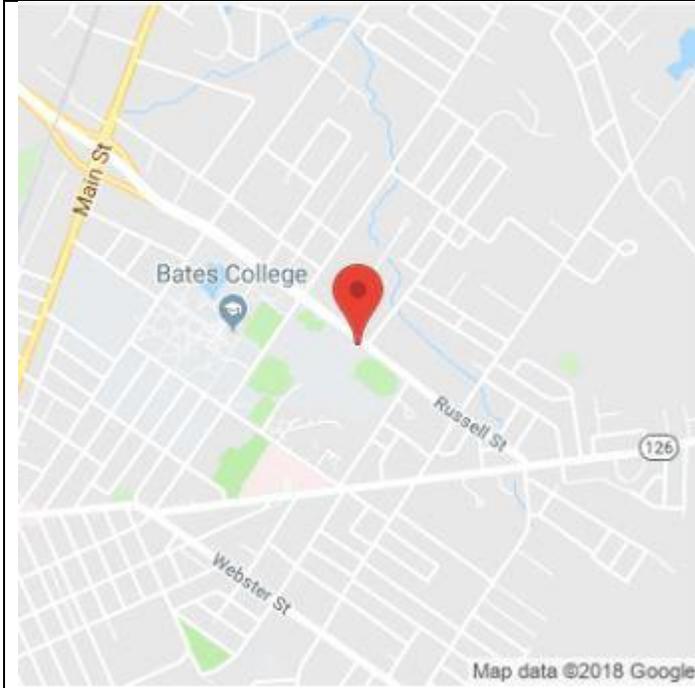
**Location:** Intersection of Russell Street and Morris Avenue

**Description:** Four-lane roadway with a sidewalk on one side of the road, driveway access to Bates athletic field and facility

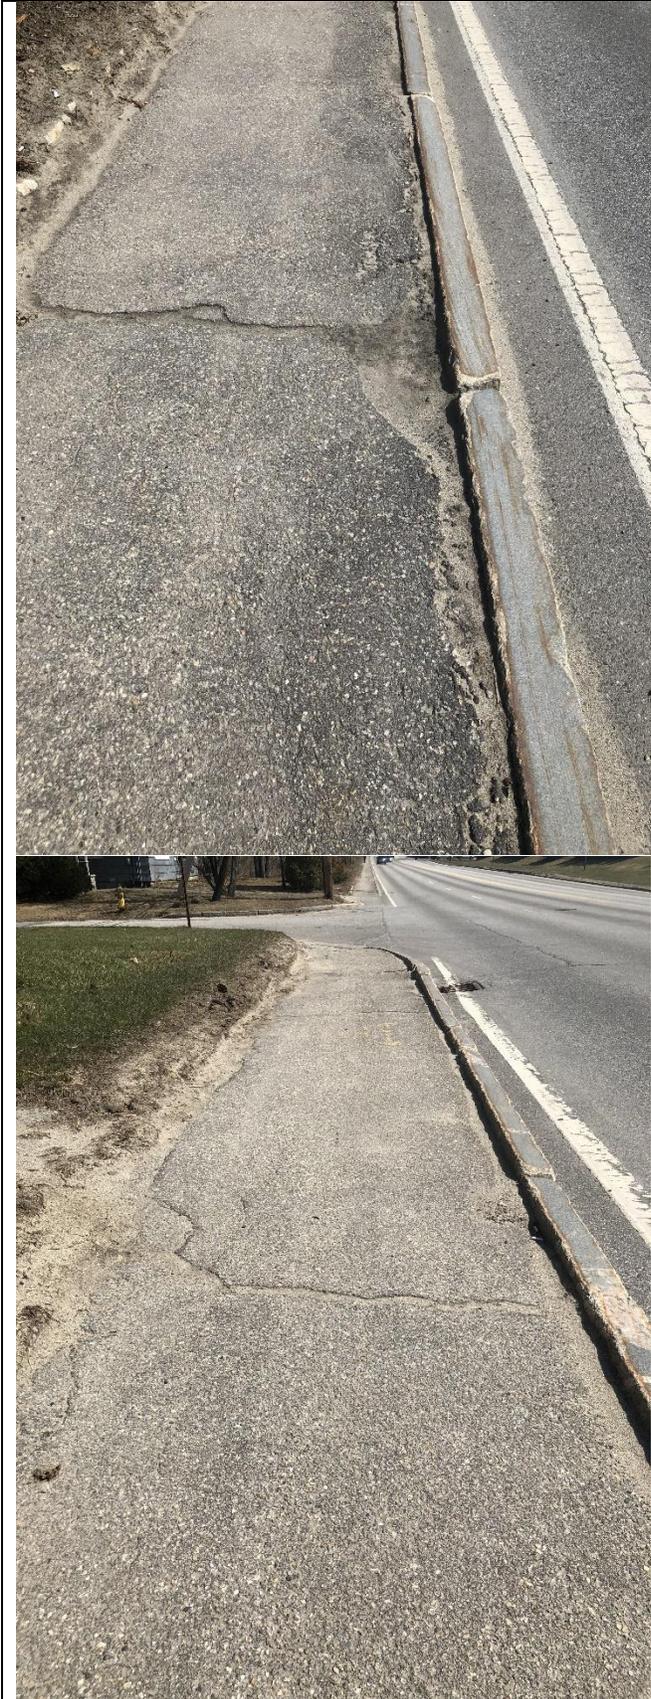
**Location:** Intersection of Russell Street and Morris Avenue

**Description:** Sidewalk with granite curb along Russell Street

**Problem:** Deteriorating sidewalk pavement

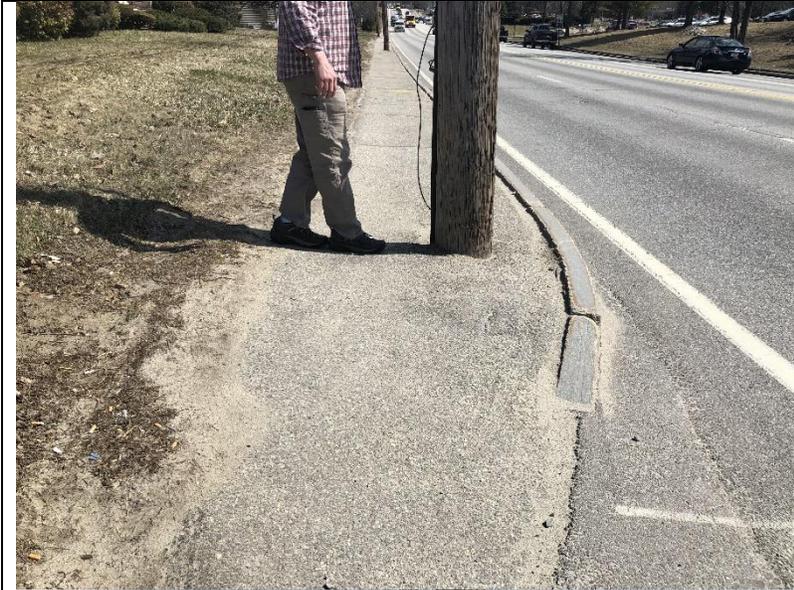
**Location:** Intersection of Russell Street and Morris Avenue

**Description:** Sidewalk and crosswalk with ramp along Russell Street

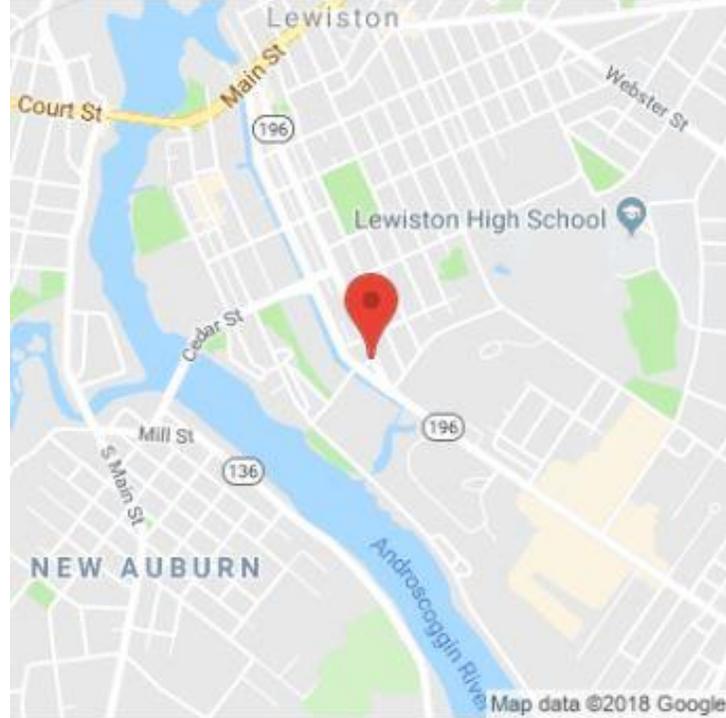
| | <p><b>Location:</b> Lisbon Street (Route 196) split near Canal Street</p> <p><b>Description:</b> One-way, two-lane street with sidewalks on either side and driveway access to local businesses</p> |

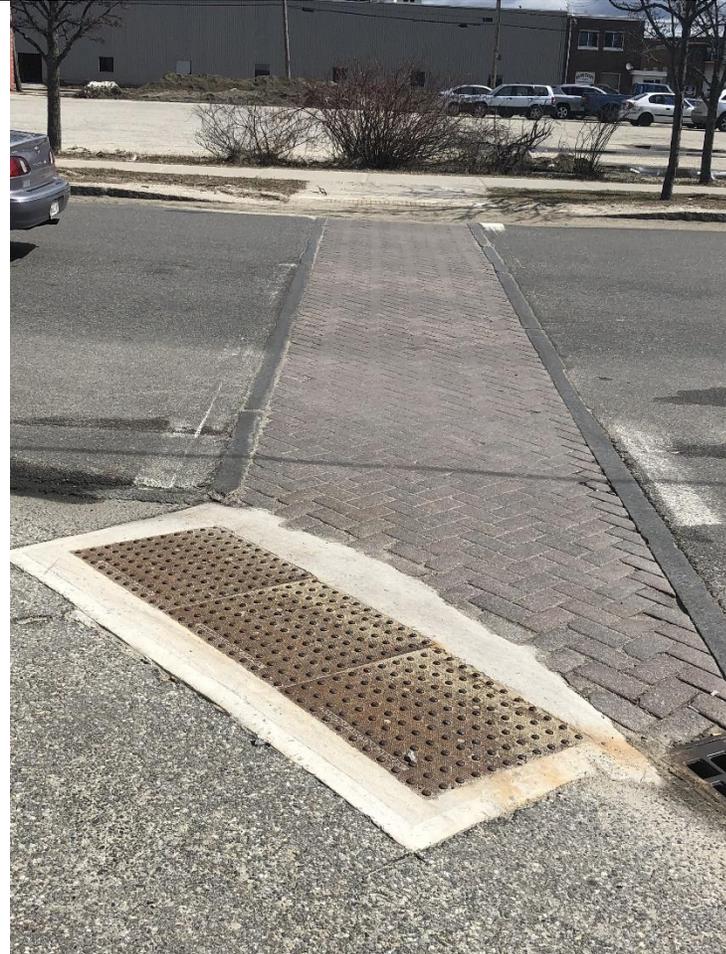
| | <p><b>Location:</b> Lisbon Street (Route 196) split near Canal Street</p> <p><b>Description:</b> Brick crosswalk across Lisbon Street</p> <p><b>Problem:</b> Faded cross walk markings, no pedestrian signs or signals, only one detectable warning surface</p> <p><b>Problem:</b> None</p> |

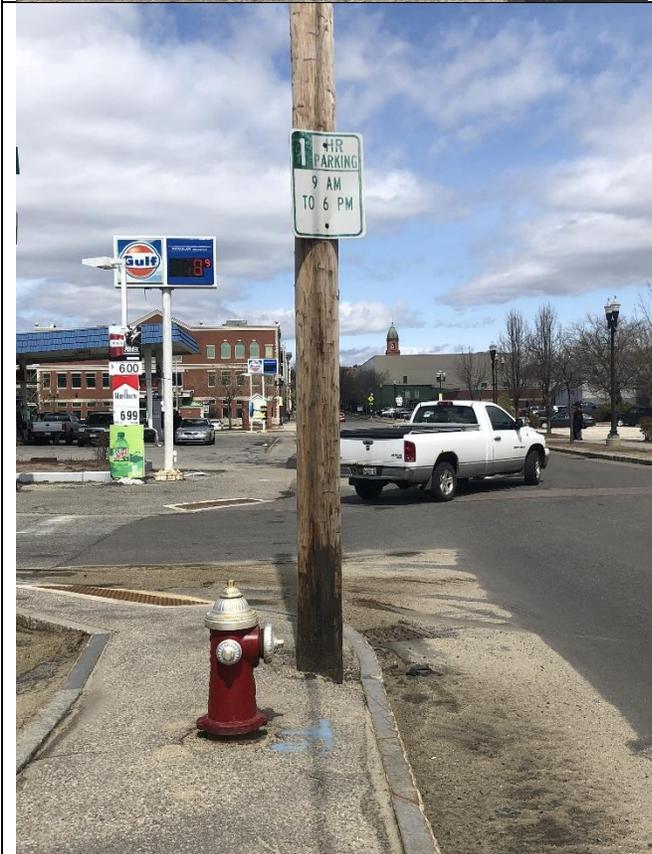
**Location:** Lisbon Street (Route 196) split near Canal Street

**Description:** Sidewalk and crosswalk across side street along Lisbon Street

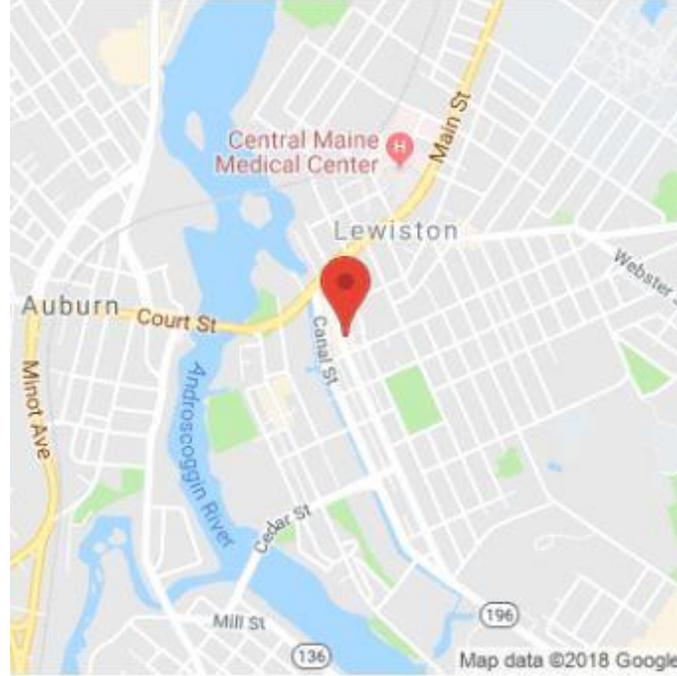
| | <p><b>Location:</b> Lisbon Street downtown</p> <p><b>Description:</b> Downtown Lewiston along Lisbon Street, on-street parking on both sides of roadway, large sidewalks, pedestrian plaza, and planters</p> |

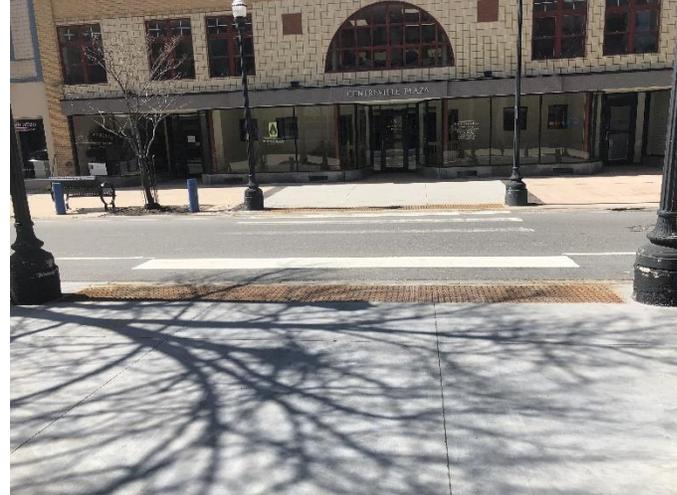
| | <p><b>Location:</b> Lisbon Street downtown</p> <p><b>Description:</b> Large crosswalk across Lisbon Street to Centreville Plaza with lighting</p> <p><b>Problem:</b> Faded crosswalk markings, no pedestrian signs or signals</p> |

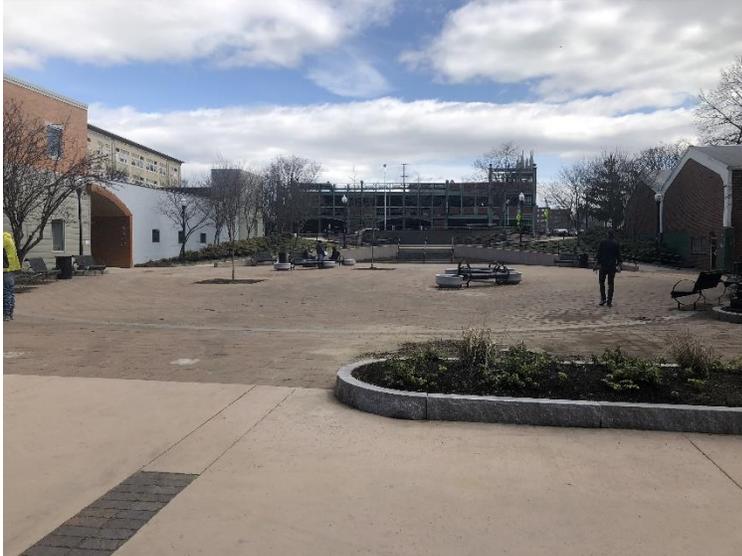
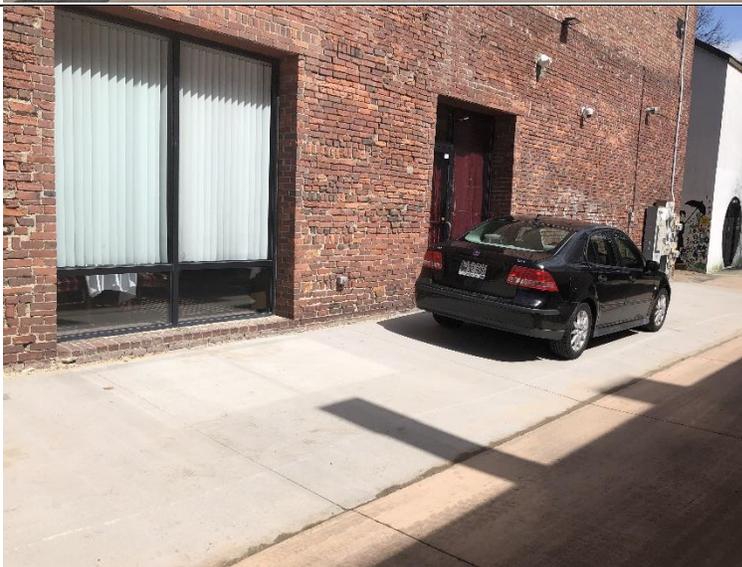
**Location:** Lisbon Street downtown

**Description:** Pedestrian area with back entrance to businesses

**Problem:** Vehicle parked in pedestrian area

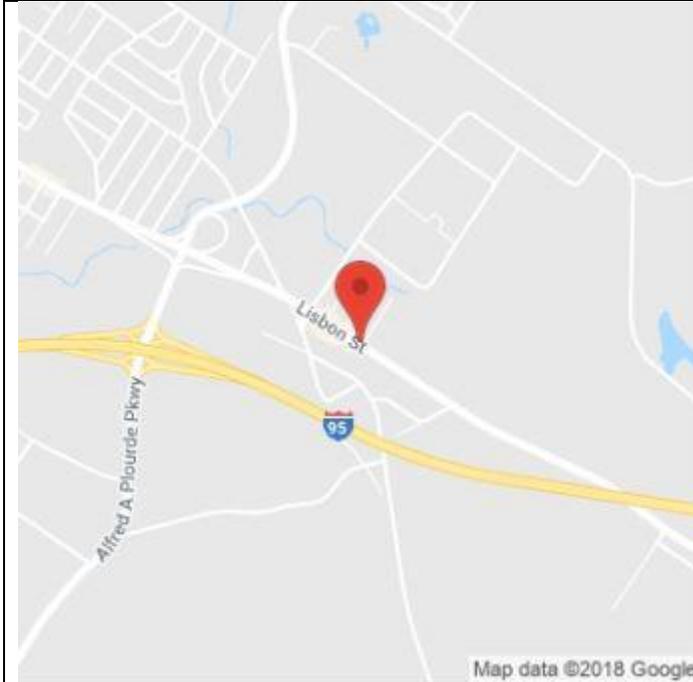
**Location:** Intersection of Lisbon Street and Drew Street

**Description:** Four-lane roadway with two lanes in each direction, driveway access to businesses and side street, sidewalks on both sides of roadway

**Problem:** Bike using sidewalk, lack of bike markings/lanes on road, degrading sidewalk pavement

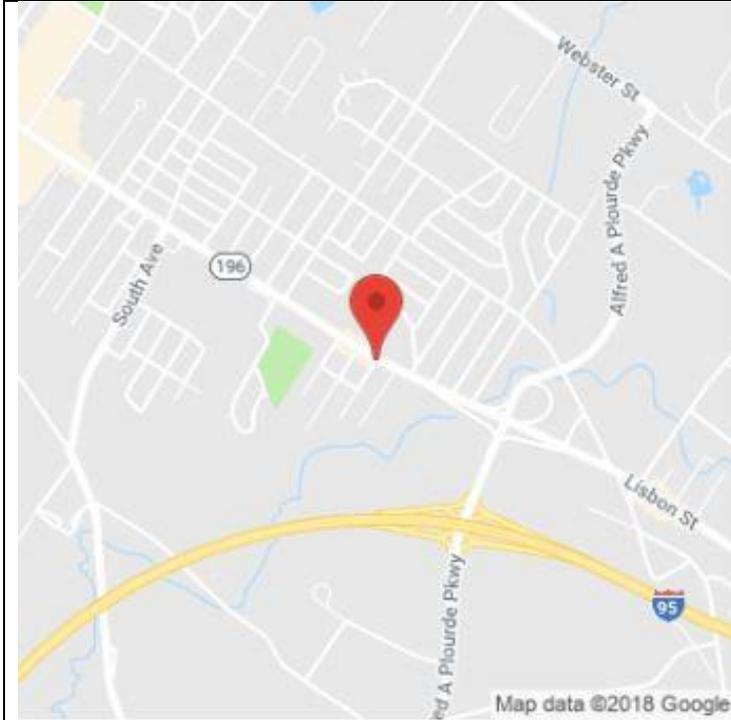
**Location:** Intersection of Lisbon Street and Louise Avenue

**Description:** Five-lane roadway with two lanes in each direction and one shared left-turn lane, sidewalk on both sides of roadway

**Problem:** Obstruction in sidewalk

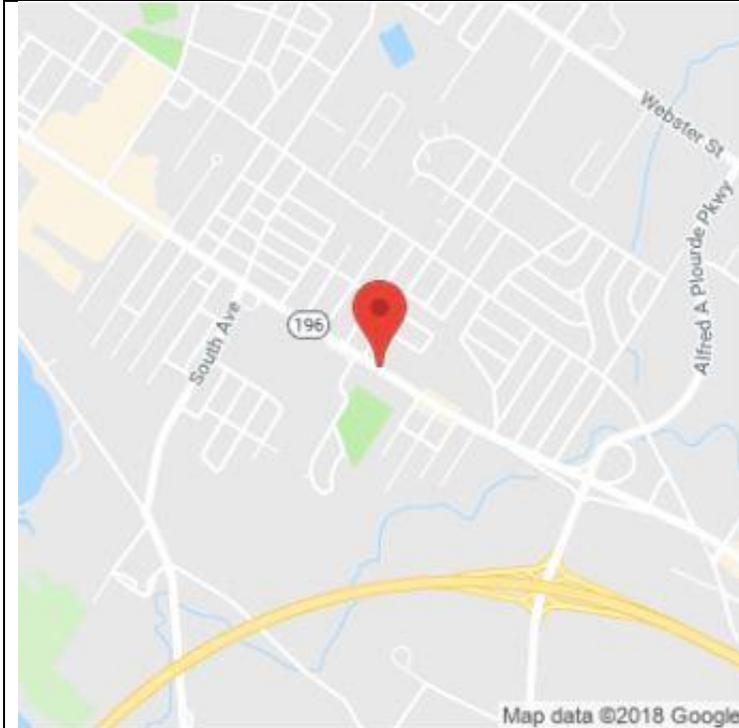
**Location:** Close to the intersection of Lisbon Street and Scribner Boulevard

**Description:** Five-lane roadway with two-lanes in each direction and one shared left-turn lane, sidewalk on both sides of roadway and driveway access to businesses

**Problem:** Degrading sidewalk pavement, large drop-off

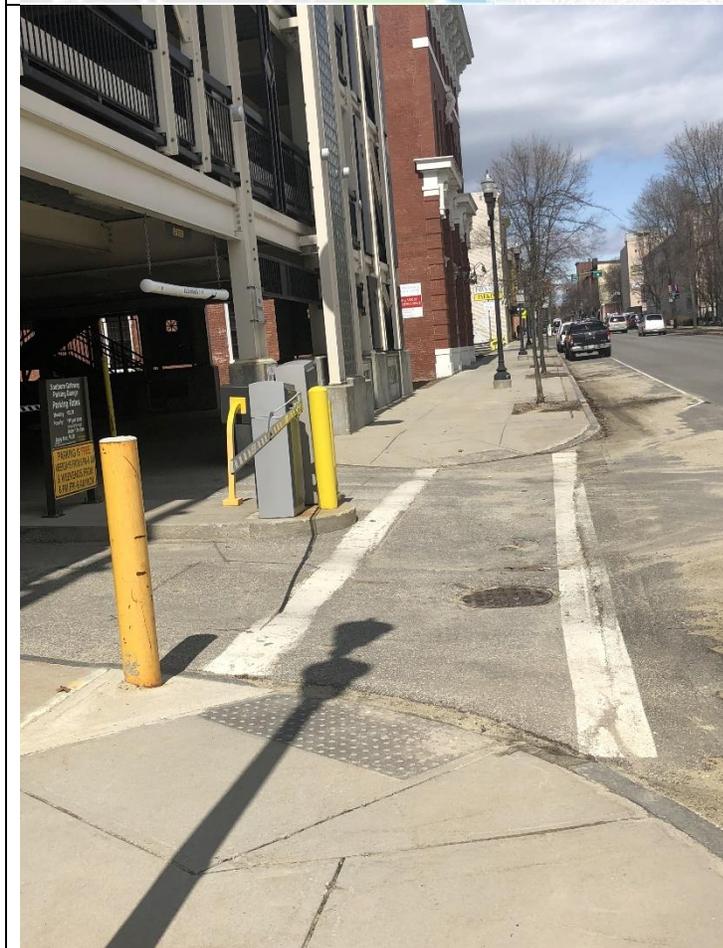
**Location:** Lisbon Street between intersection with Cedar Street, and intersection with Canal Street

**Description:** Pedestrian crosswalk in front of parking entrance, trees separating sidewalk and roadway

**Problem:** No pedestrian signs or signals

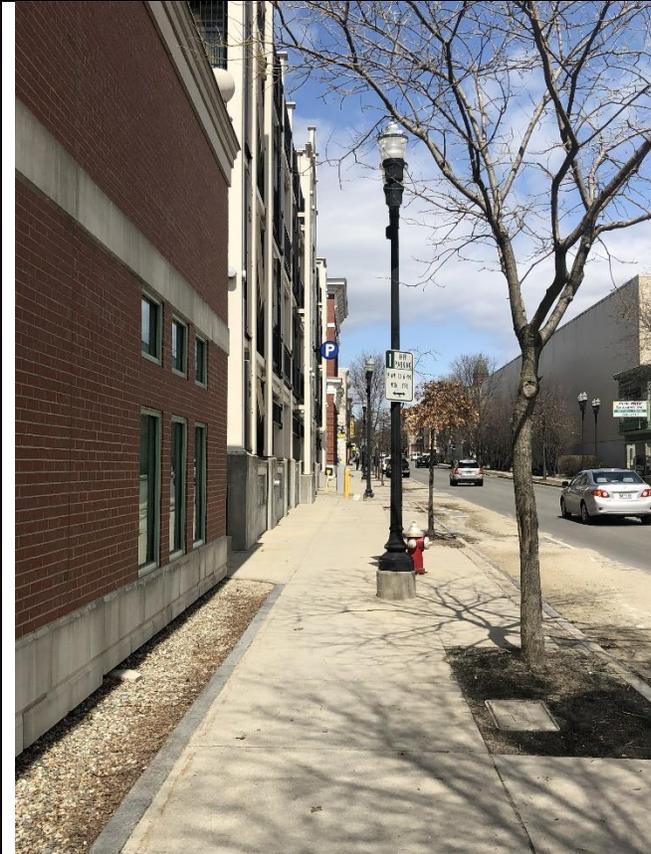
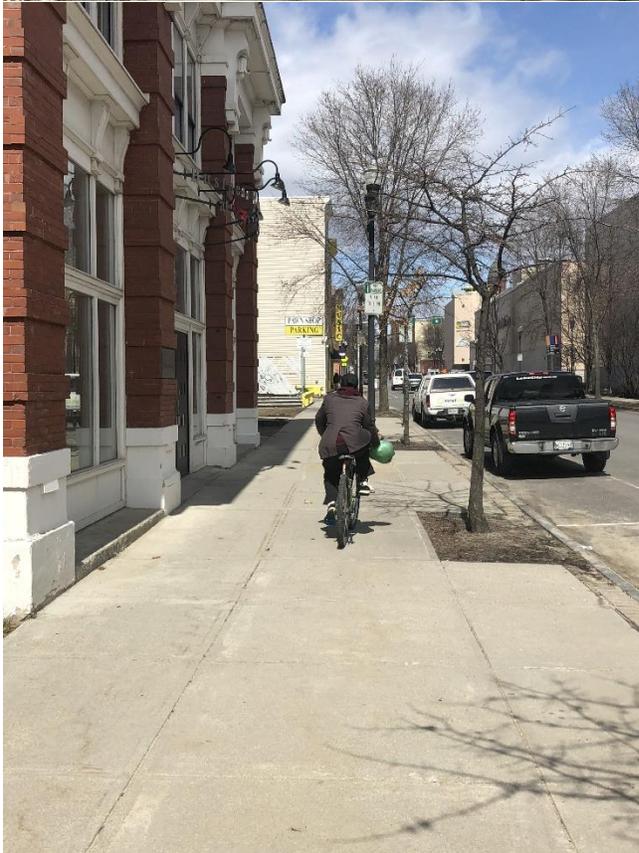
**Location:** Lisbon Street between intersection with Cedar Street, and intersection with Canal Street

**Description:** Sidewalk approaching parking garage, trees separating sidewalk and roadway

**Problem:** Obstruction in sidewalk, no bike lanes, cyclist in sidewalk

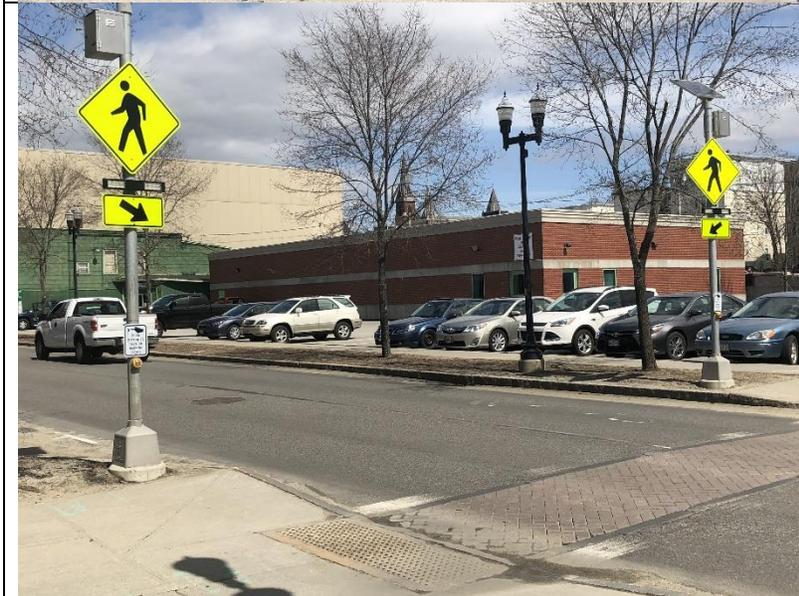
**Location:** Lisbon Street between intersection with Cedar Street, and intersection with Canal Street

**Description:** Crosswalk to parking area with pedestrian signs and signals

**Problem:** Faded crosswalk markings

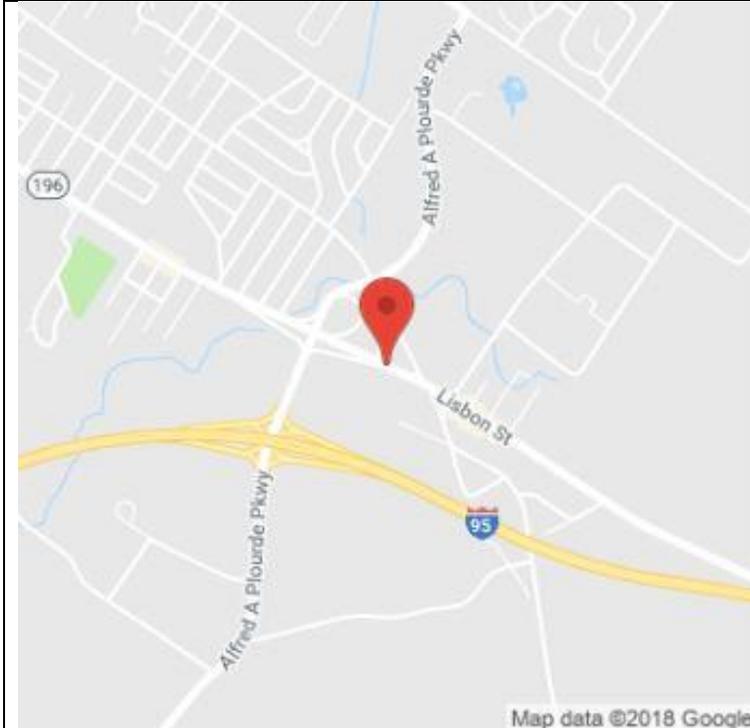
**Location:** Intersection of Lisbon Street and Alfred A. Plourde Parkway

**Description:** Two-lane roadway under Alfred A. Plourde Parkway bridge with a sidewalk on right side

**Problem:** No bike lanes or markings

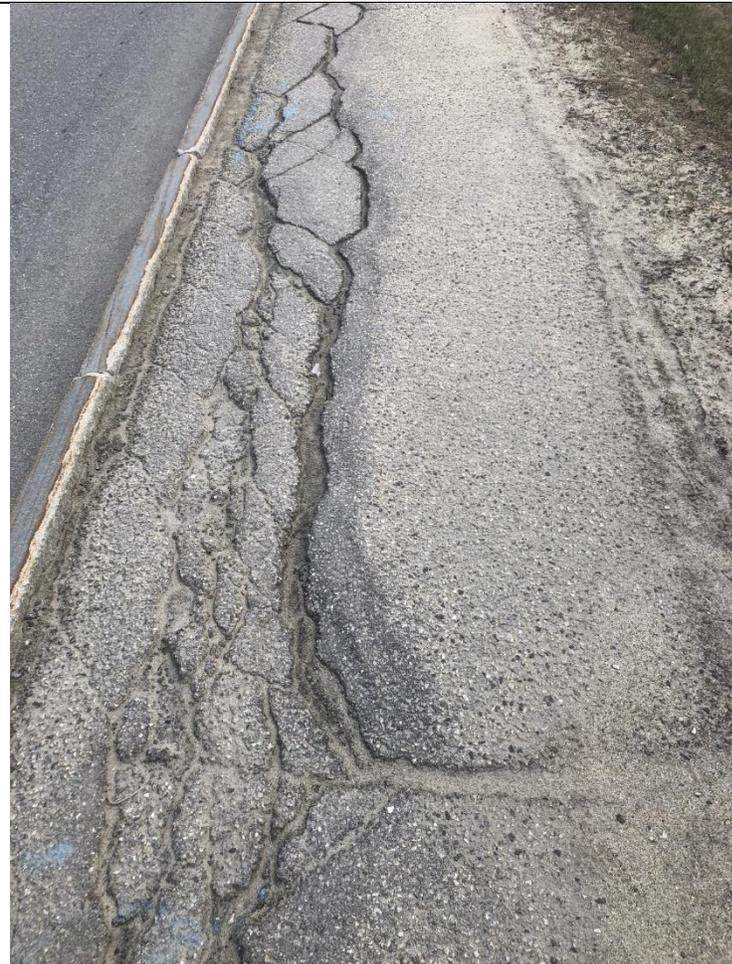
| | <p><b>Location:</b> Intersection of Lisbon Street and South Avenue</p> <p><b>Description:</b> Sidewalk along Lisbon Street</p> <p><b>Problem:</b> Sidewalk pavement deteriorating</p> |

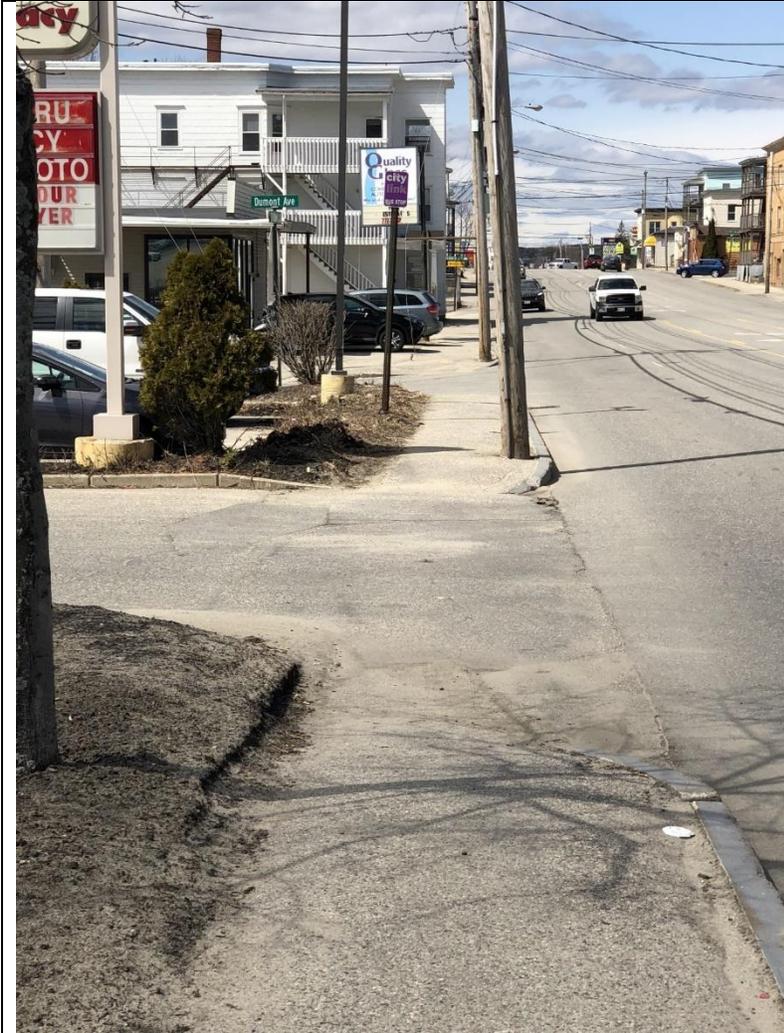
**Location:** Intersection of Lisbon Street and South Avenue

**Description:** Sidewalk along Lisbon Street

**Problem:** Frequent driveway access with no pedestrian signs, markings or signals, obstruction in sidewalk

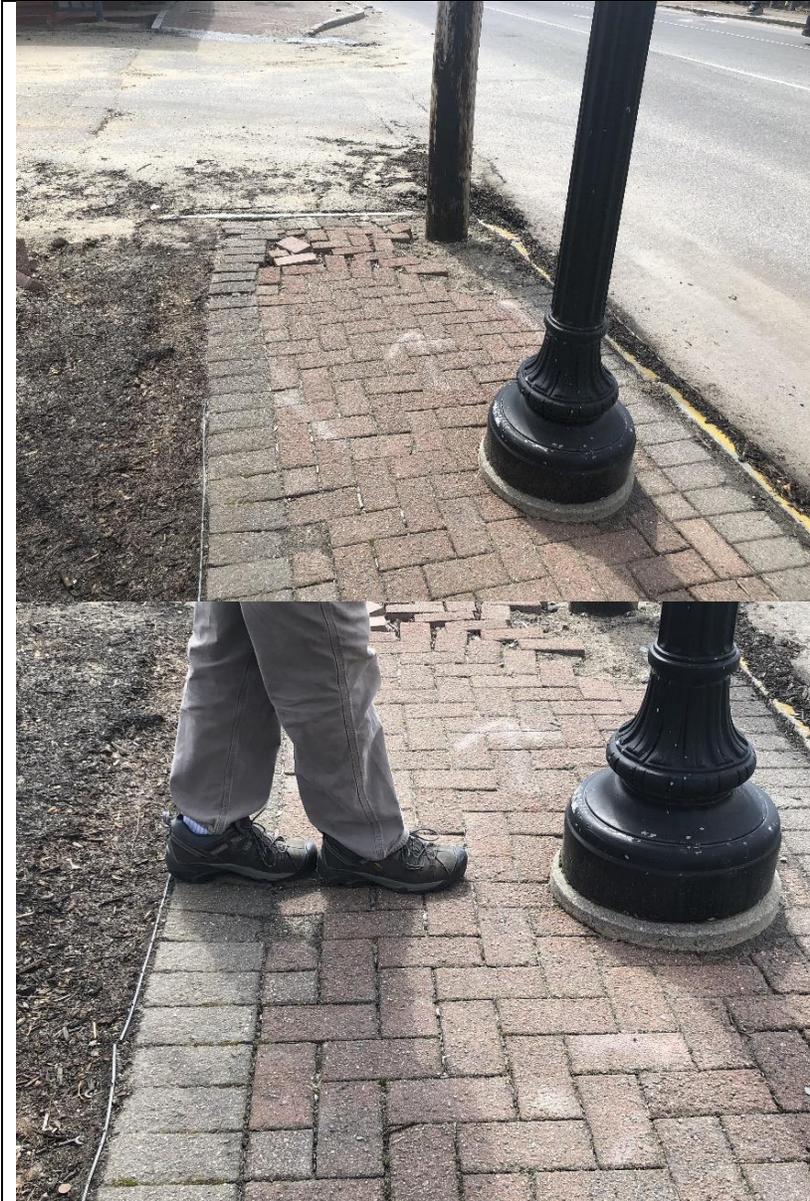
**Location:** Intersection of Canal Street and Cedar Street

**Description:** Brick sidewalk with utility poles

**Problem:** Degraded sidewalk with debris, no clear driveway signs or pedestrian markings, poles obstruct pedestrian movement, not ADA compliant

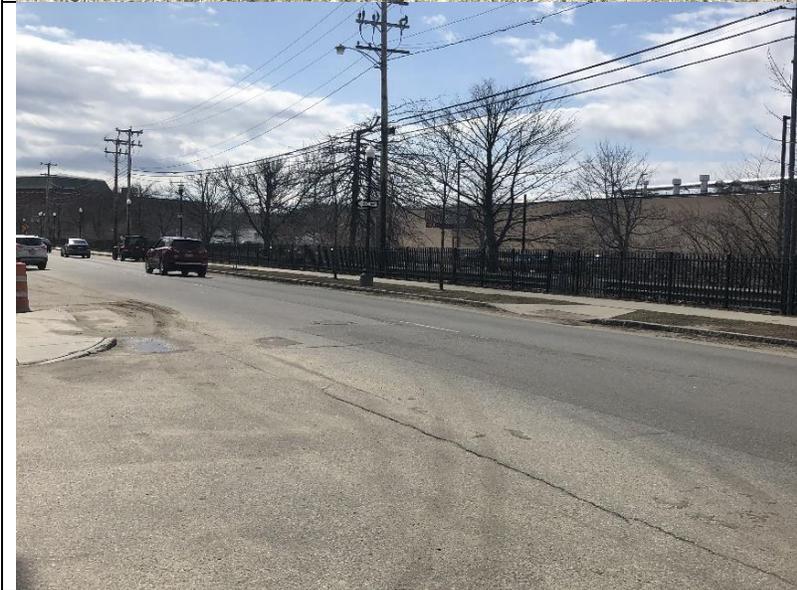
**Location:** Intersection of Canal Street and Cedar Street

**Description:** Pedestrian crossing across Canal Street at parking garage

**Problem:** Faded crosswalk, no pedestrian signs or signals, older detectable warning surfaces

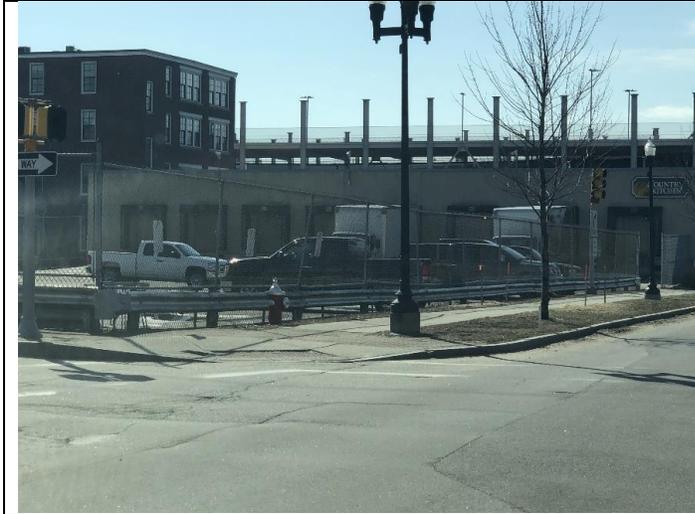
**Location:** Intersection of Canal Street and Cedar Street

**Description:** Pedestrian crossing across Canal Street at parking garage

**Problem:** Faded crosswalk, no pedestrian signs, older detectable warning surfaces, degradation of sidewalk

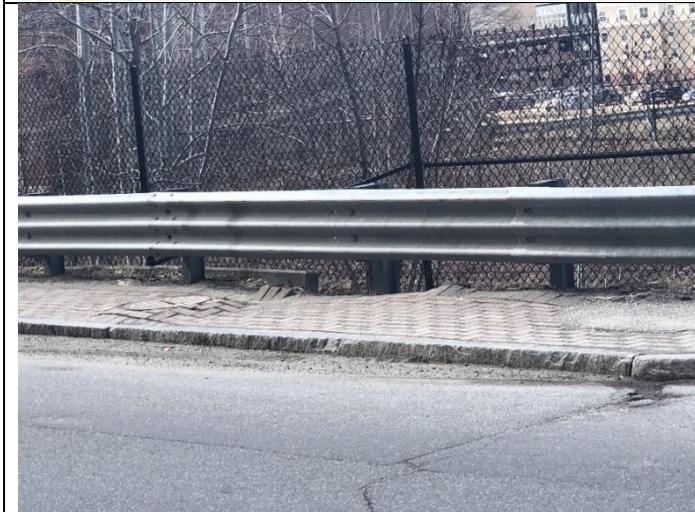
**Location:** Intersection of Canal Street and Main Street downtown

**Description:** Main Street brick sidewalk with guardrail

**Problem:** Degrading sidewalk

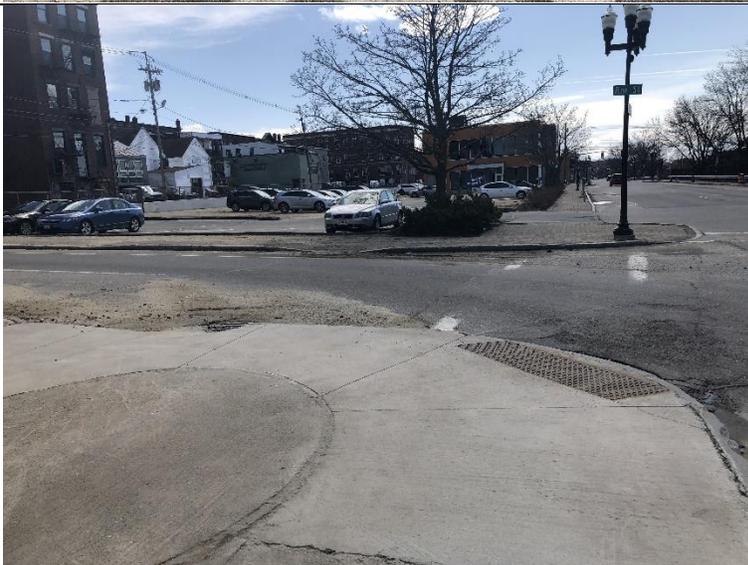
**Location:** Intersection of Canal Street and Main Street downtown

**Description:** Pedestrian crossing across three movements with parking garage

**Problem:** Faded crosswalk, older/no detectable warning surfaces, no ADA ramp on one of the movements, no pedestrian signs or signals

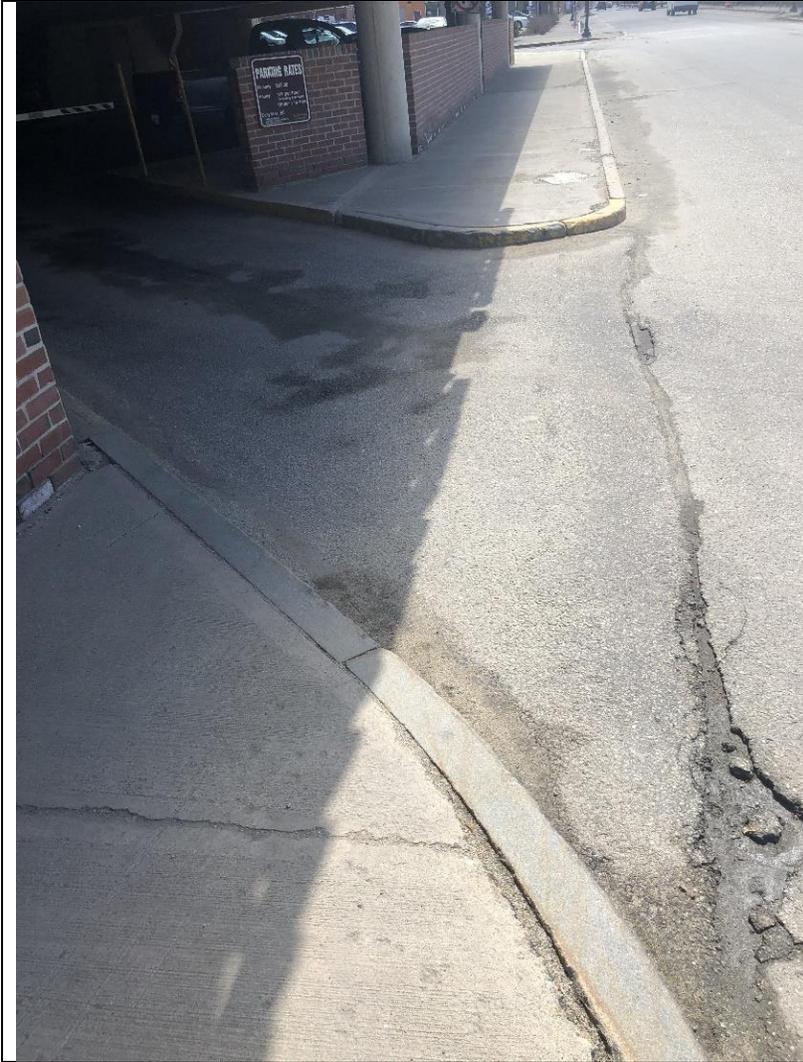
**Location:** Intersection of Canal Street and Main Street downtown

**Description:** Pedestrian crossing in front of parking garage entrance

**Problem:** No crosswalk, no ADA ramps, no pedestrian signs or signals

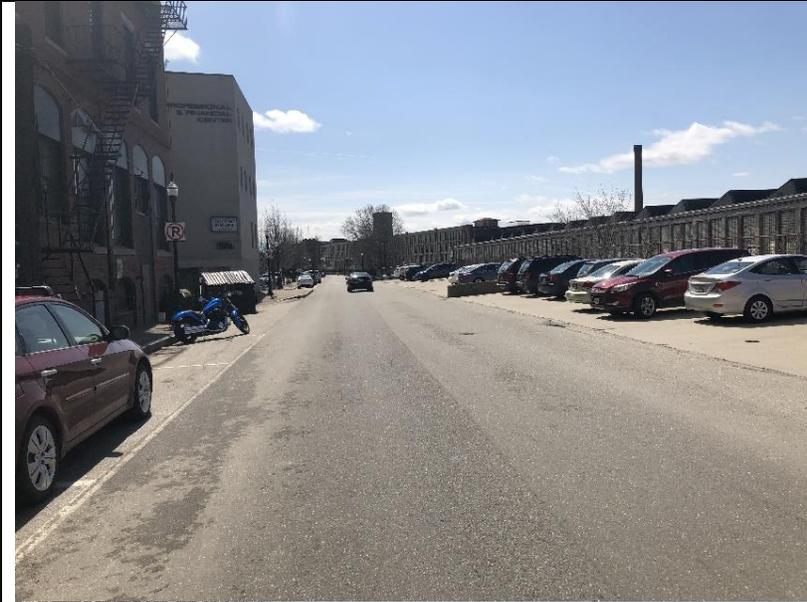
**Location:** Intersection of Canal Street and Main Street downtown

**Description:** Canal Street, one-way, on-street parking on either side

**Problem:** Lack of parking signs, excess pavement for one-way street

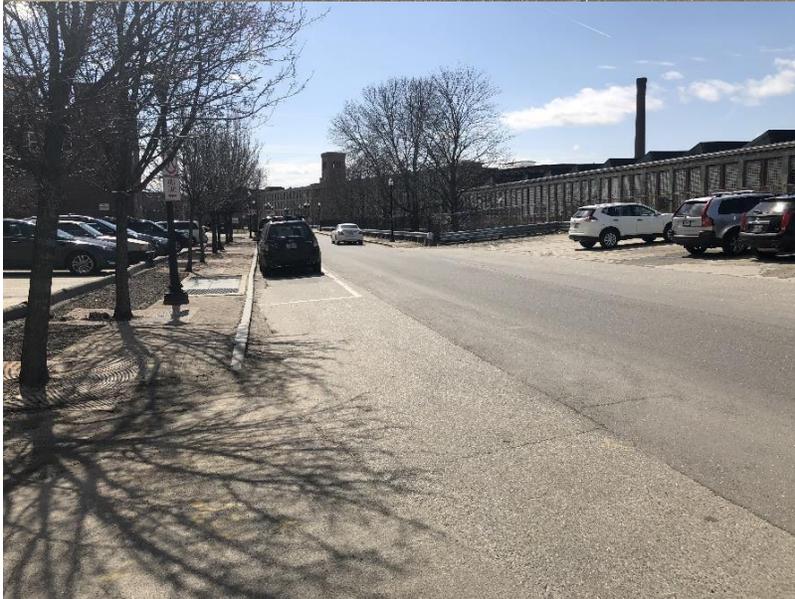
**Location:** Intersection of Canal Street and Main Street downtown

**Description:** Sidewalk on Canal Street with granite curb, guardrail and fire hydrant

**Problem:** Granite curb too low, degrading brick sidewalk, obstruction in sidewalk

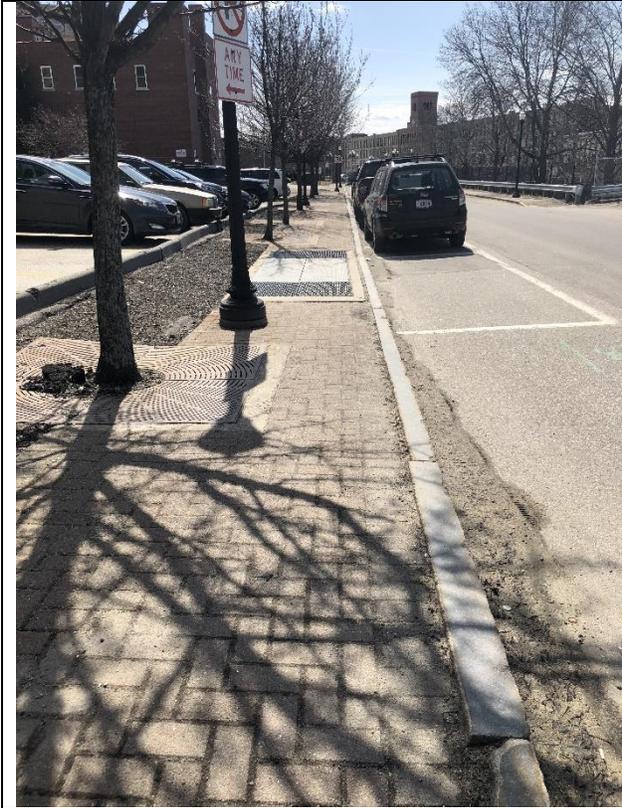
**Location:** Intersection of Canal Street and Main Street downtown

**Description:** Canal Street sidewalk with on-street parking, granite curb and planters

**Problem:** Obstruction in sidewalk

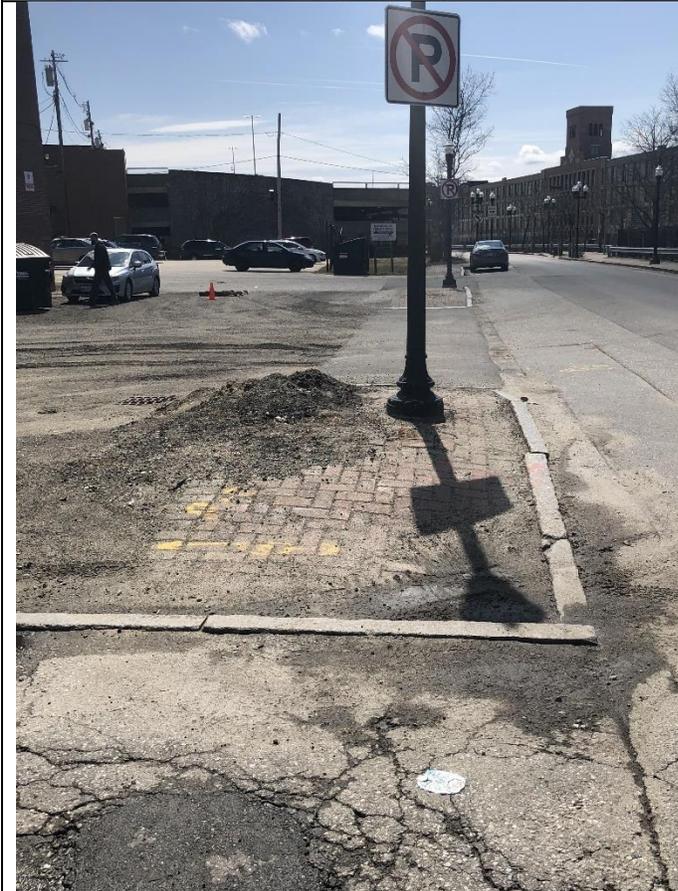
**Location:** Intersection of Canal Street and Main Street downtown

**Description:** Canal Street brick sidewalk with driveway, no on-street parking

**Problem:** Degrading sidewalk with debris, obstruction in sidewalk, low granite curb where a ramp should be, no clear driveway markings

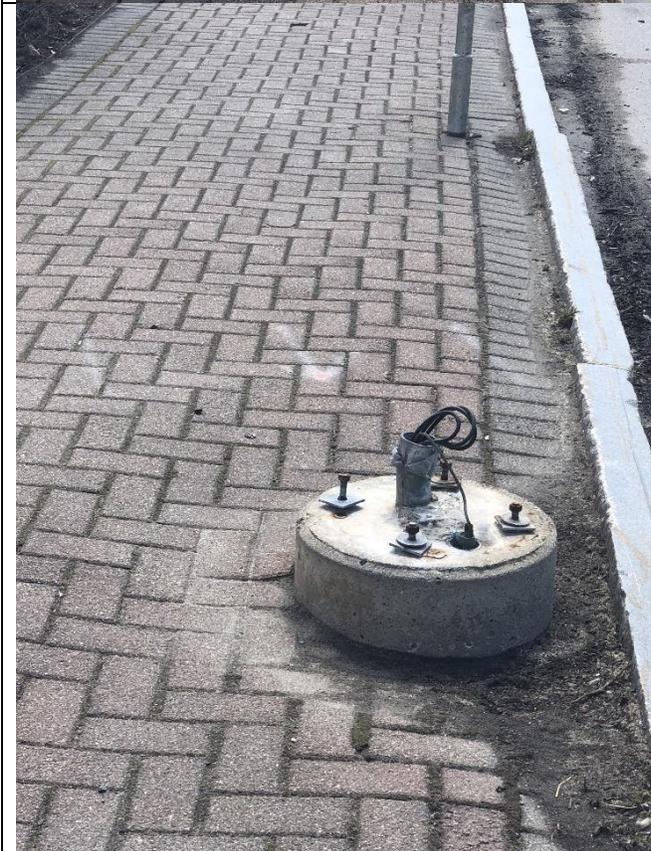
**Location:** Intersection of Canal Street and Main Street downtown

**Description:** Canal Street brick sidewalk with exposed utility pole

**Problem:** Exposed utility pole in sidewalk

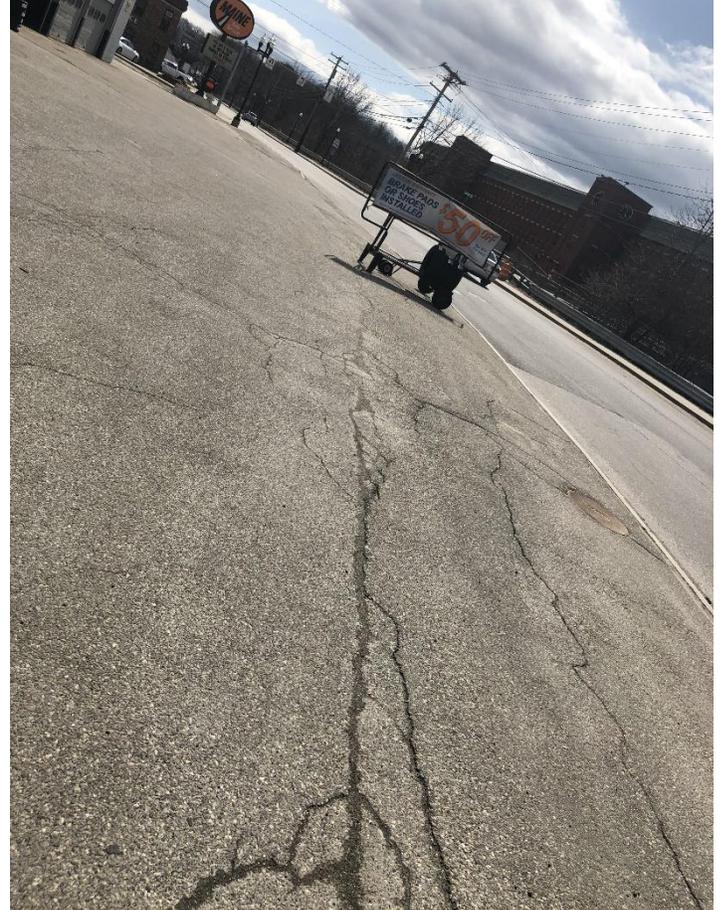
| | <p><b>Location:</b> Split of Canal Street and Route 196 (Lisbon Street)</p> <p><b>Description:</b> Asphalt sidewalk along Canal Street with driveway access to local business</p> <p><b>Problem:</b> Degrading sidewalk, no separation between sidewalk and parking for local business, obstruction in sidewalk</p> |
