# Lewiston Pedestrian Crossing Study

**HNTB**

4/15/2019

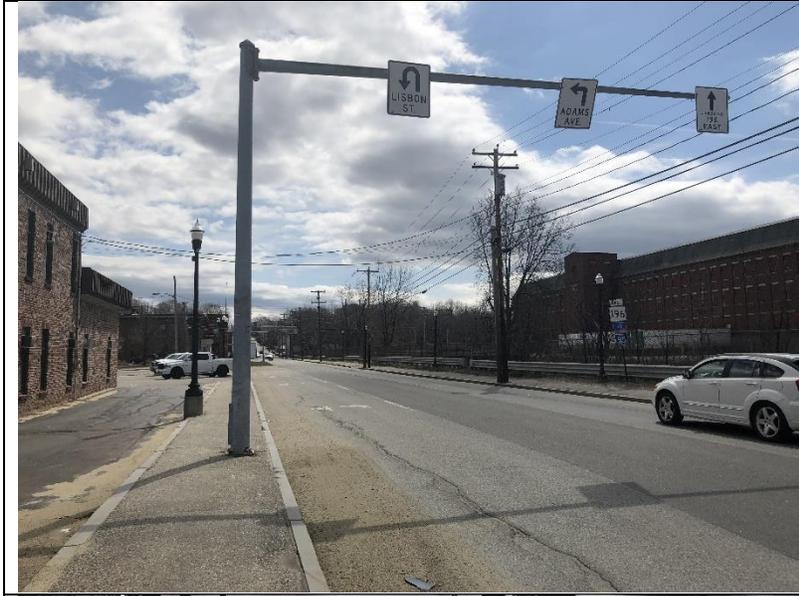
**Location:** Split of Canal Street and Route 196 (Lisbon Street)

**Description:** Sidewalk along Canal Street prior to Route 196 merge with mast arm

**Problem:** Mast arm obstruction in sidewalk

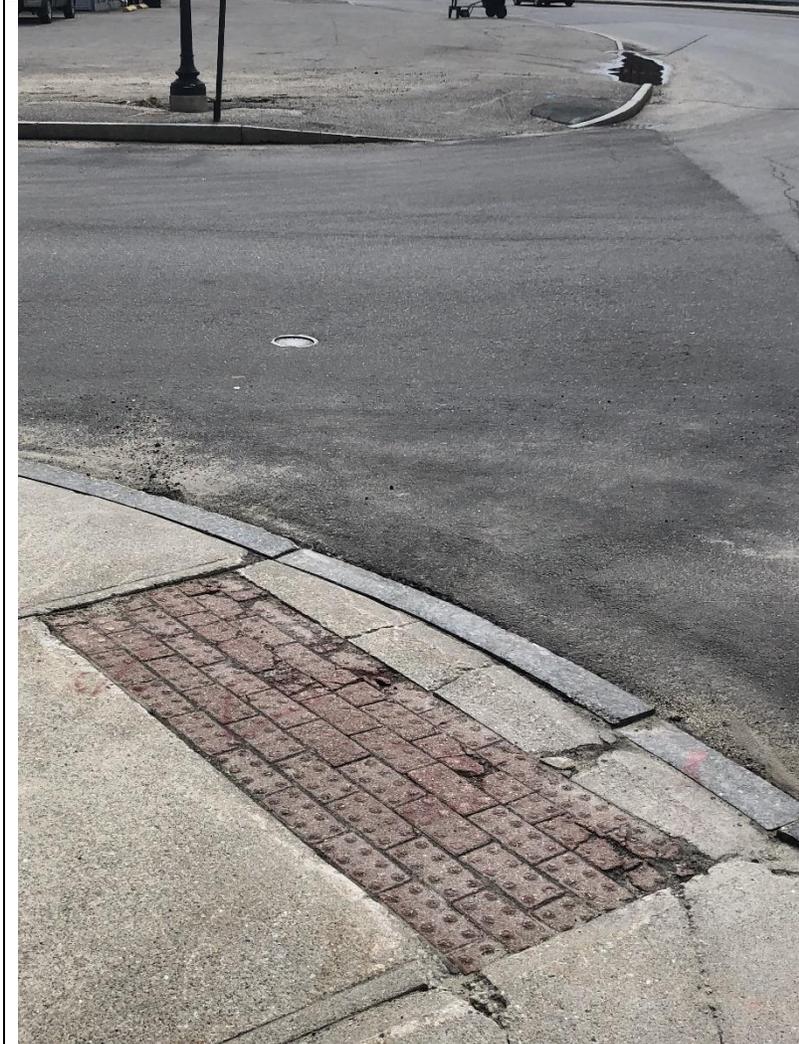
**Location:** Split of Canal Street and Route 196 (Lisbon Street)

**Description:** Crosswalk at the intersection of Canal Street and Maple Street

**Problem:** Degrading sidewalk and detectable warning surface, no detectable warning surface on opposite side, no crosswalk markings, no pedestrian signs or signals

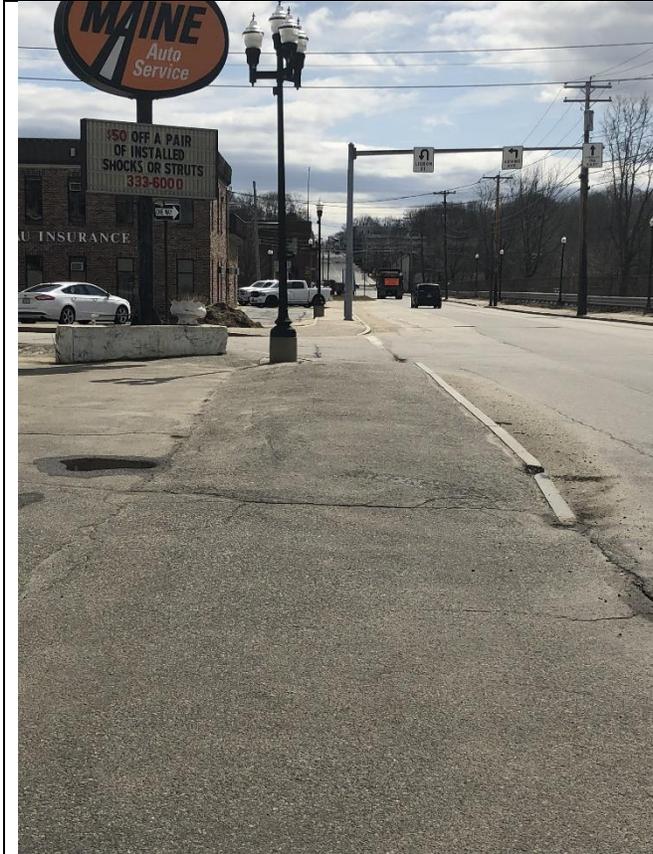
**Location:** Split of Canal Street and Route 196 (Lisbon Street)

**Description:** Asphalt sidewalk along Canal Street with driveway access to local business

**Problem:** Cracks in sidewalk, no clear pedestrians markings, signs or signals, no parking lot separation from sidewalk, no detectable warning surfaces, obstruction in sidewalk

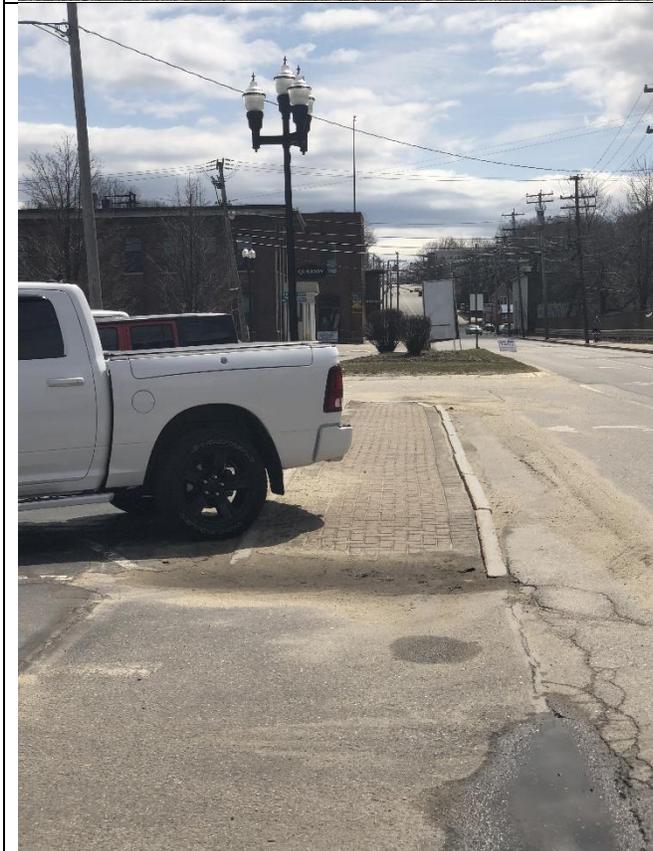
**Location:** Split of Canal Street and Route 196 (Lisbon Street)

**Description:** Brick sidewalk along Canal Street at merge into Route 196

**Problem:** Vehicle obstructing sidewalk

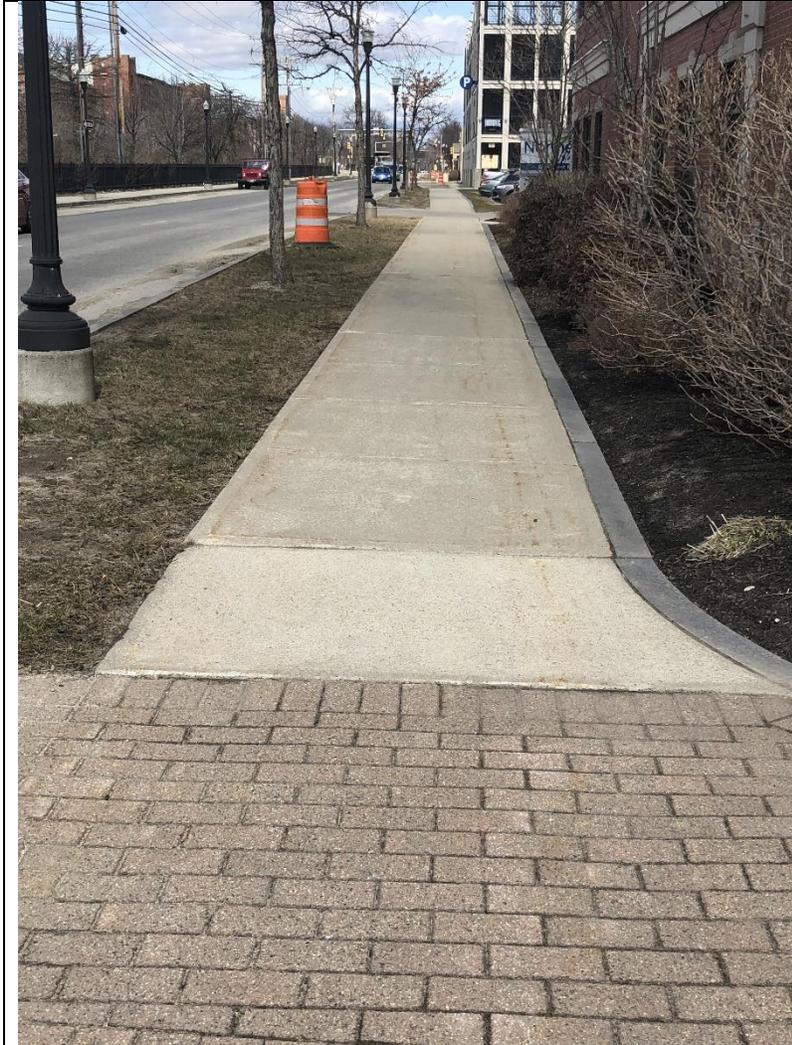
**Location:** Split of Canal Street and Route 196 (Lisbon Street)

**Description:** Canal Street sidewalk with separation from roadway and planters

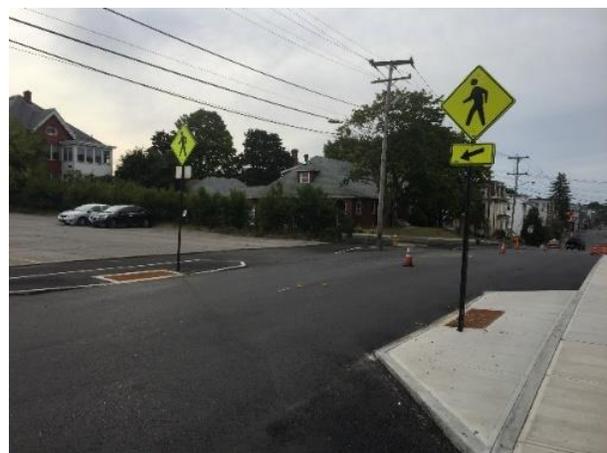
Figure 2 – Basilica Street View

The Basilica of Saints Peter and Paul crossing are shown in Figures 1 and 2 below. This midblock crossing was recently upgraded as shown in Figure 2 the picture to the right. The crossing is located on Bartlet Street between Ash Street and College Street, that providing a safe crossing from the parking lot to the Basilica of Saints Peter and Paul Church. The surrounding area is a mixture of single family housing, apartments and businesses. There is access to all five bus city link bus loops routes which are identified in Section 4, Figure 4.1 in the body of this report the Lewiston Pedestrian Crossing Study. The routes include the; Main Street, Sabattus Street, Lisbon Street, College Street and the Downtown Shuttle loops. There is also easy access to the Oak Street. Bus Station, which serves as the central hub for public transportation. Within the last three years, there are no recorded crashes, pedestrian or vehicle, at the crossing.

Because the crossing is used at very specific times of day with large quantities numbers of people, and because site distance is more than adequate at this location, beacons are not necessary for the current crossing use. If the church would like to place the signs with Rectangular Rapid Flashing Beacons (RRFBs), these could be added without detriment to safety. No additional improvements are recommended at this time.

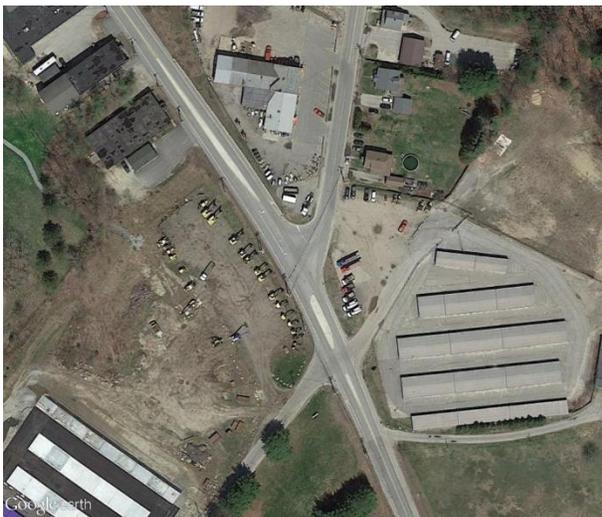
Figure 1 – Intersection Aerial

This potential new crossing is located at the intersection of Lincoln Street, River Road and South Avenue as shown in Figures 1 and 2. The surrounding area is a mix of single- family housing, small businesses and industrial. While there is no City bus route that passes through this corridor, it does have an existing school bus pick up location. Within the last three years, there have been four recorded crashes in the area of the Lincoln Street, River Road and South Avenue intersection. Two of the crashes resulted in property damage only, and two crashes resulted in an injury. No crashes resulted in a fatality nor did they involved a bicycle/pedestrian.

The additions of aA crossing with flashing beacons, striping, pedestrian signage and ADA compliant landings are recommended for the school bus stop location at the intersection of Lincoln Street, River Road and South Avenue. While adding a crosswalk to this location is not ideal due to estimated vehicular speeds, every effort should be taken to make the intersection safe. Overall a planning level cost of improvements would be approximately \$35,000.

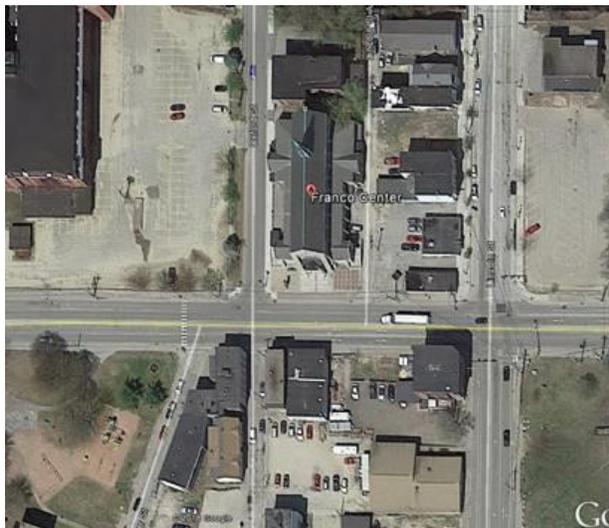
Figure 1 – Franco Center Aerial

The proposed location of the Franco Center crossing is shown in Figures 1 and 2 below. The potential new crossing is located on Oxford Street, from the parking lot to the Franco Center side entrance shown in Figure 2. The surrounding area is a mixture of single- family housing, apartments and businesses. There is access to one bus loop identified in Section 4, Ffigure 4.1 of this report; the Main Street loop. There is also easy access to a bus stop along the Main Street loop close to the Franco Center, and which is within a mile of the Oak Street Bus Station, which serveings as the central hub for public transportation. Within the last three years, there are no recorded crashes, pedestrian or vehicle, at the crossing potential new crossing location. However, there have been eight8 recorded crashes south of the new crossing location at the intersection of Oxford and Cedar Street, one involving a pedestrian, and one crash north of the new crossing at the Grace Street Recovery Services business.

Striping with proper pedestrian signage and full ADA compliaaince is recommended for the new crossing between the parking lot and the Franco Center. Because of the low volume on Oxford Street, a Rectangular Rapid Flashing Beacon (RRFB) is likely not necessary at this time. Overall a planning level cost of improvements, includng design, construction and contingency, would be approximately \$20,000.
