City of Lewiston

Fire Station Study

February 16, 2017 rev.

RE: 4137.00 / Lewiston Fire Station Study – Final Report

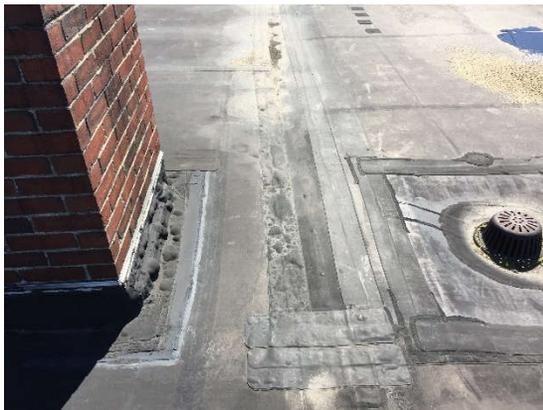
Roof System: The existing membrane roof system was last replaced in 1988. Roofing is placed over Precast Planks and Tee's. Signs of wear were observed around the base of the chimney. Moisture has infiltrated the insulation at the hose tower. The parapet cap flashing has been sealed which indicates there have been leaks. The current roof is in fair to poor condition, is nearing its useful life expectancy, and should be replaced in the next 1 to 5 years. Thermal improvements such as 3" or more of roof insulation over the roof deck would likely reduce energy cost. Insulating up the back side and over the top of the parapet will help reduce thermal bridging.

Photo CS-A1 – Membrane blisters

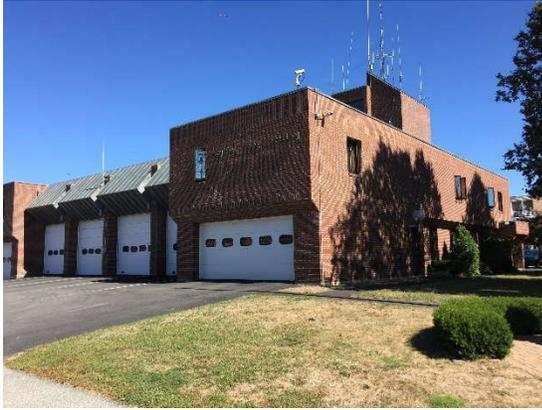
Exterior Wall System: Consists of 8" load bearing CMU with 2" air space and 4" face brick. Existing drawings indicate that the 2" air space has 1" +/- of cavity insulation. This insulation is likely a mineral wool or polystyrene as it is exposed to moisture. At best, the existing wall insulation R-value is R-5. Code minimum is R-13.3 continuous insulation. Based on the existing drawings, attached as "Exhibit A", wall and roof insulation do not connect. This creates a thermal bridge which allows moisture to build up inside the wall system. Wall system moisture damage was observed in Stair 1. The 4" face brick has weeps at the base of the wall and vents at the top of the wall which helps the 2" cavity to drain and dry out moisture. The exterior wall system is in fair condition but is poorly insulated. Envelope concerns such as deteriorated or open mortar joints, areas of moisture infiltration, fractured brick units, stress cracks in the masonry assembly and worn expansion joint materials need to be addressed. Thermal improvements to the exterior wall would likely reduce energy cost as well as reduce damage to interior finishes left by the formation of condensation within the CMU back-up wall. Thermal improvements could occur on the inside or

outside of the existing wall. Exterior improvement would be less obtrusive. Both options would be costly. From an envelope standpoint, this building is in need of a focused masonry maintenance program.

Photo CS-A3 – South Façade

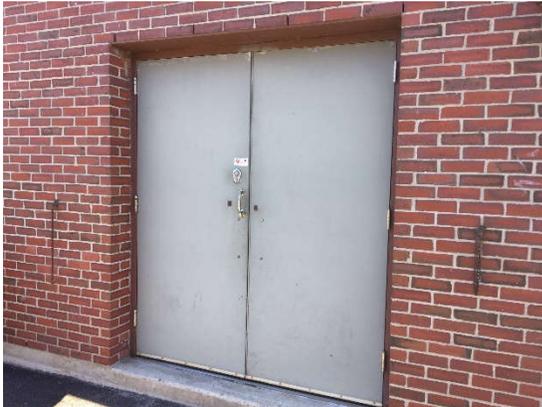
Exterior HM Doors: There are 3 exterior HM insulated doors which are in fair condition. These doors and frames were replaced on or about 1998 and are nearing the end of their useful life. Base of HM doors and frames are beginning to rust. All HM exterior doors should be replaced in the next 5 years.

Photo CS-A5 – View of Hose Tower HM door

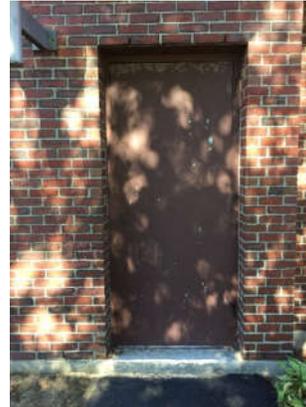
Photo CS-A6 – View of Stair 3 HM exit door

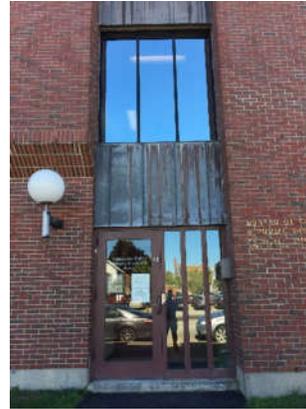
Exterior Aluminum Storefront: There are 2 exterior aluminum entry storefront doors which were replaced on or about 1998. Door in image A7 below is in good condition. Door in image A8 below is in poor condition. Storefront system in image A8 below is beginning to rust at the base. It should be replaced in the next 1 to 5 years.

Photo CS-A8 – West Entrance

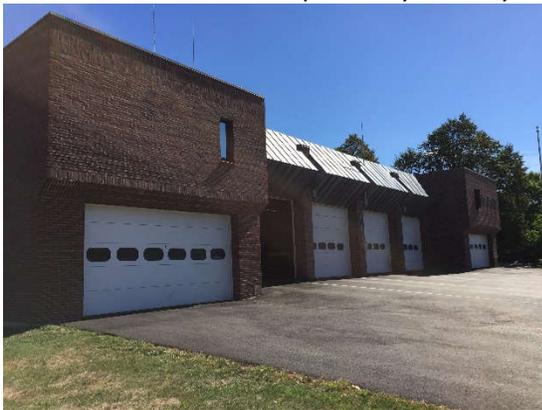
Exterior Overhead Doors: There are 7 exterior overhead doors. All of these doors are in good condition. Useful life expectancy is 10+ years with proper annual maintenance.

Photo CS-A9 – View of South Doors

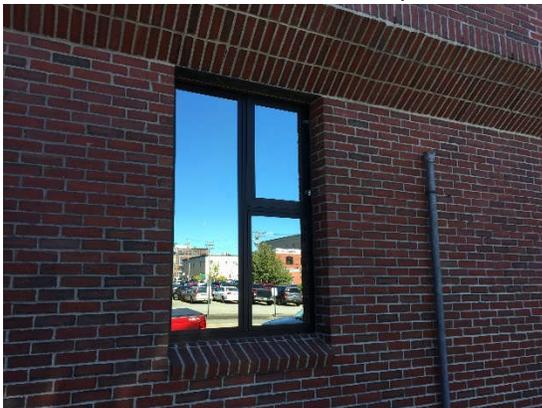
Exterior Window: All exterior windows are aluminum framed windows with ½" insulated glazing. The windows were replaced on or about 1998 and are in fair condition but thermally perform poorly. Window replacement is not an immediate concern however replacement to a window that has a lower U-factor and better perimeter sealant could reduce energy cost.

Photo CS-A11 – View of 1st Flr. window

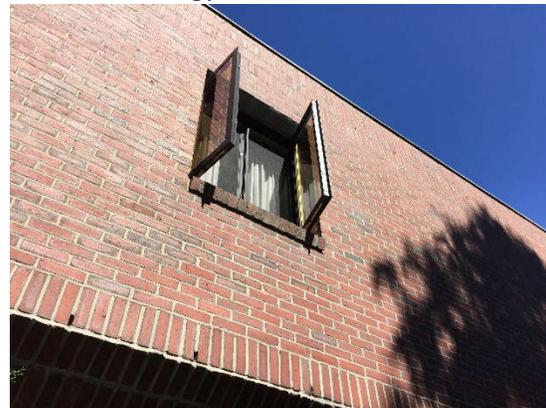
Photo CS-A12 – View of 2nd Flr. window

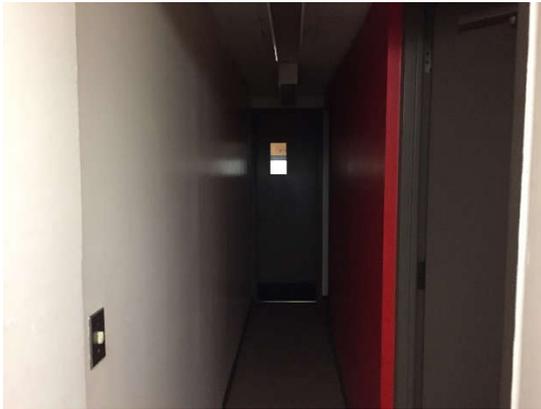
1. There is no elevator access.
2. Doors B-13 and B-18 are less than 36" wide.
3. Circulation corridors are less than 4'-8" wide and cannot accommodate required push and pull clearances.
4. Knob type door hardware is still used on some doors.
5. All toilet rooms including showers are non-compliant. These spaces would have to be enlarged to provide proper clearances.
6. Kitchen is not accessible.

Photo CS-A13 – Narrow corridor

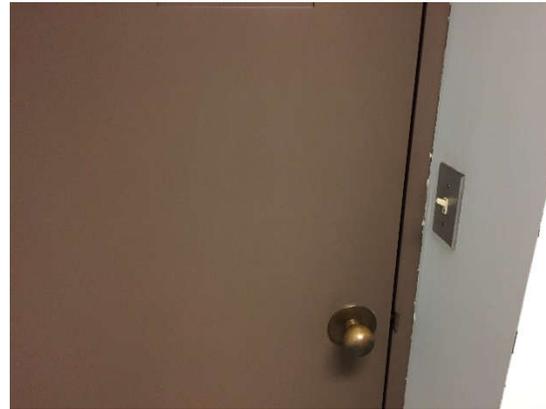
Photo CS-A14 – Knob type hardware

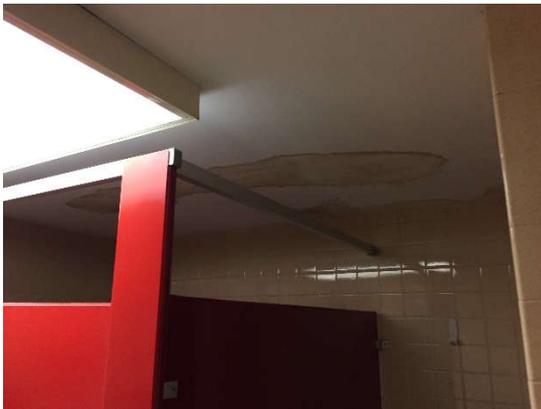
- Ceiling systems include 2x4 ACT (good condition), 1x1 AT (poor condition), and gypsum (poor condition). 1x1 AT appears to be original and has reached its useful life expectancy. Gypsum ceiling should be repaired where moisture damage has occurred.

Photo CS-A15 – Toilet room ceiling damage

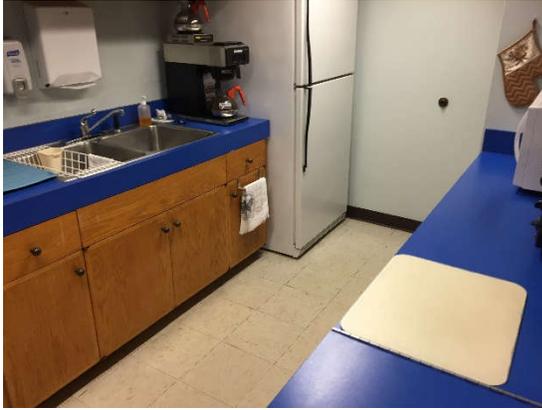
Photo CS-A17 – Non ADA compliant Kitchen

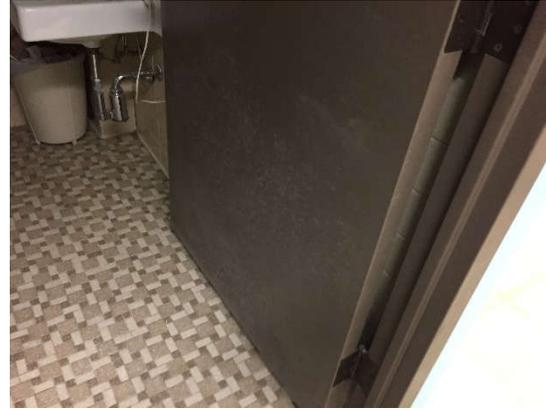
Photo CS-A18 – Mold on base of door

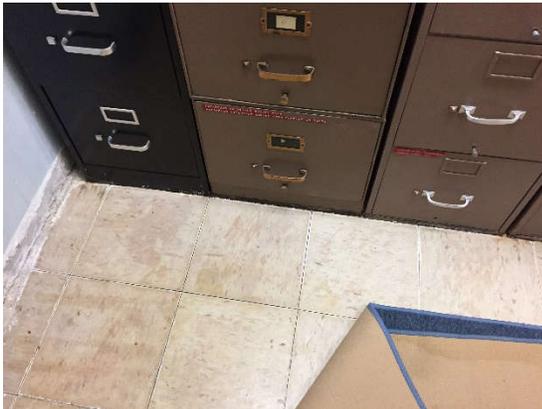
- Flooring consists of sealed concrete, VCT, carpet, and ceramic tile. VCT and carpet is wearing quickly as a result of slab moisture. There is likely no vapor barrier under the existing slab. We recommend installing a slab moisture mitigation system prior to any new flooring being installed. Ceramic tile likely is original.

Photo CS-A17 – Moisture damaged floor

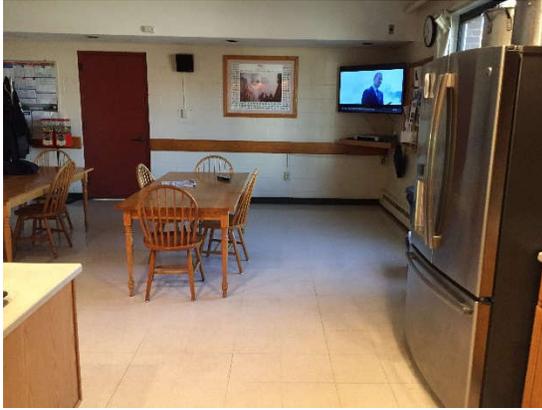
- Flooring consist of sealed concrete, epoxy coated concrete, VCT, carpet and ceramic tile. VCT is in fair to poor condition and is nearing it useful life expectancy. Carpet has floor traffic wear and is nearing it useful life expectancy.
- Walls are painted concrete, concrete block, metal stud with gypsum board sheathing and metal stud with gypsum board sheathing and tile in the toilet rooms. Walls are in good condition.
- Ceiling systems include 2x4 ACT, painted precast plank, and painted precast tee's. ACT should be repaired where moisture damage has occurred.
- Doors hollow metal. Doors are in good condition.
- Windows are all aluminum frames with ½" insulated glazing
- Stairs risers exceed code maximum by ½". Stair tread exceed code min minimum by 1". Handrails are not compliant.

Photo CS-A19 – Typical VCT condition

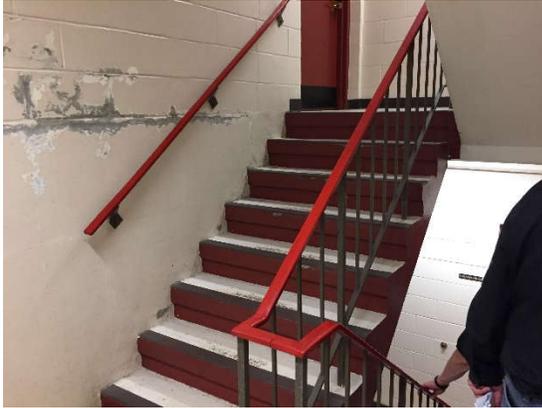
Photo CS-A21 – Railing does not extend beyond stair

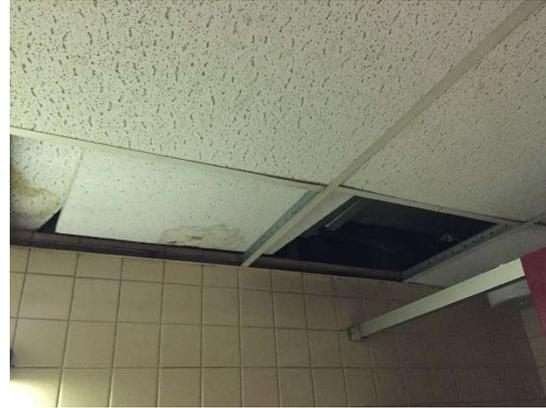
Photo CS-A22 – Toilet room ceiling damage

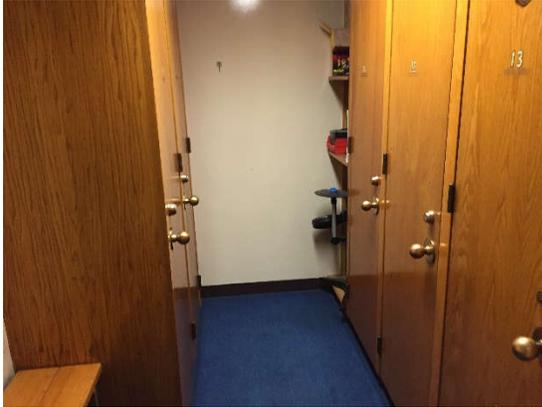
1. There is no elevator access.
2. Most of the doors are less than 36" wide.
3. Circulation corridors are less than 4'-8" wide and cannot accommodate required push and pull clearances.
4. Knob type door hardware is still used on some doors.
5. All toilet rooms including showers are non-compliant. These spaces would have to be enlarged to provide proper clearances.

Photo CS-A25 – Door Knobs

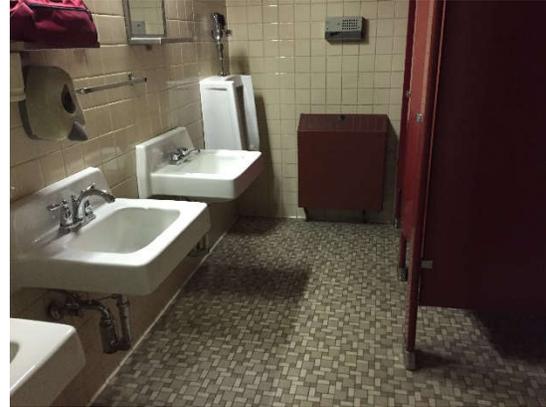
Photo CS-A26 – Clearance and privacy issues

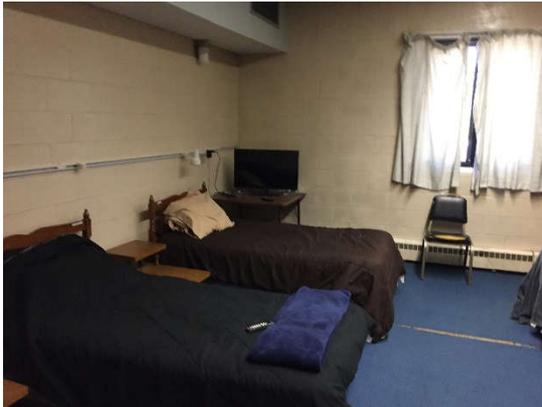
- Flooring consist of carpet and ceramic tile. Carpet is in fair to poor condition and should be replaced in the next 1 to 5 years.
- Walls are painted concrete, concrete block, metal stud with gypsum board sheathing and metal stud with gypsum board sheathing and tile in the toilet rooms. Walls are in good condition.
- Ceiling systems include 2x4 ACT and painted precast plank. ACT should be repaired where moisture damage has occurred.
- Doors are hollow metal. Doors are in fair condition.
- Windows are all aluminum frames with ½” insulated glazing.

Photo CS-A27 – Torn Carpet

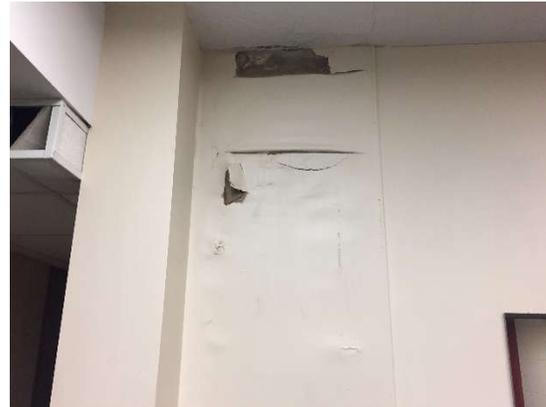
Photo CS-28 – Fitness moisture damage from Chimney

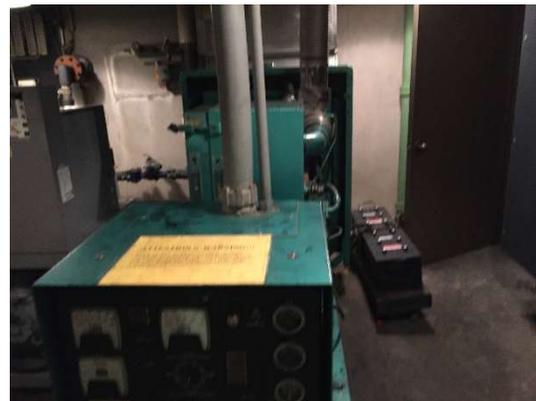
Facility is also provided with standby power via 125 kW generator also located in the basement mechanical room. Both the generator and associated transfer switch appear to be in good condition.

Photo E2 – Indoor Generator

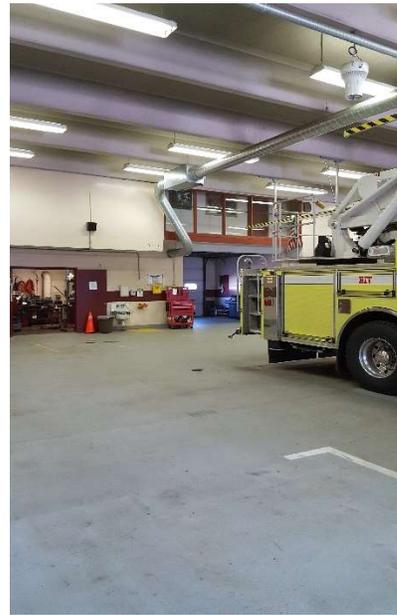
Most office and common area lighting appears to utilize T8 fluorescent lamps. However, there were several areas, such as the apparatus bays, where T12 fluorescent lamps were noted.

Photo E5 – Apparatus Bay Lighting

- Install arc-fault circuit breakers for branch circuits feeding bedroom, living area and kitchen loads.
- Install tamper-proof receptacles in bedrooms and living area.
- Replace existing lighting fixtures with new LED fixtures.
- Install emergency battery packs or a separate life safety transfer switch
- Install communication cabling support system
- Install fire alarm system.

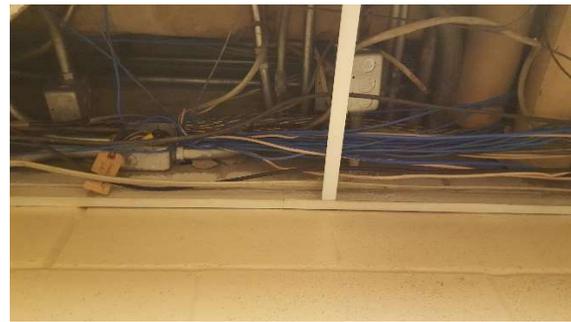
Communication services enter the building in the basement and are distributed out to individual work areas from single floor mounted rack. Communication rack does not appear to be well organized or labeled, making future installation and maintenance difficult. Cabling above ceiling does not appear to be supported properly, relying only on the ceiling tiles. This lack of support could like to degradation of cabling performance. Communication cabling in many rooms is run exposed and is looped over obstructions.

Photo E8 – Above Ceiling Cabling

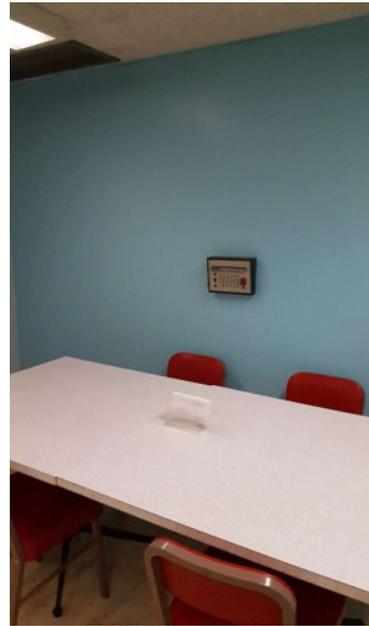
Most spaces are provided with speakers for the public address system. System and associated components are functional but outdated. Public address system is currently used to page locally utilizing phone system or receive calls through Lewiston-Auburn 911 dispatch services. Speakers vary in condition from good to poor throughout the facility. Bedrooms are also provided with antiquated intercom system call boxes although system does not appear functional.

Photo E10 – Intercom Station

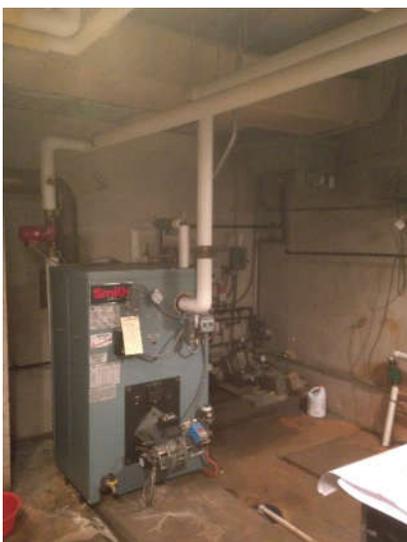
Facility is served by a central hot water boiler plant located in the basement. The existing boiler plant consists of an older cast iron HB Smith 19A-4 section oil-fired boiler and a recently installed Burnham condensing, direct-vent natural gas-fired boiler. HB Smith boiler is vented through the existing masonry chimney with proper breeching and draft damper. Chimney appears to be clay lined and has sufficient area now that one boiler has been removed. The Burnham boiler is vented with PVC through the ground floor and out the exterior wall. We have seen issues when venting condensing boilers using PVC pipe which has a relatively low rated temperature. Boiler venting should be replaced with polypropylene which is rated for boiler service. Piping is primarily copper and appears to be in fair to good condition and is well insulated throughout the facility.

Photo M1 – HB Smith Oil-Fired Boiler

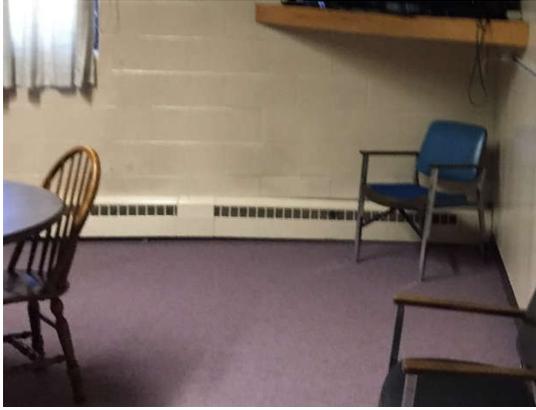
Hot water heating terminals consist of mostly baseboard radiation with convectors and cabinet unit heaters in vestibules, toilet rooms, stair towers and the apparatus garage bays. Baseboard and other heating terminal units appear to be mostly original and are in fair condition.

Photo M3 – Typical HW Baseboard

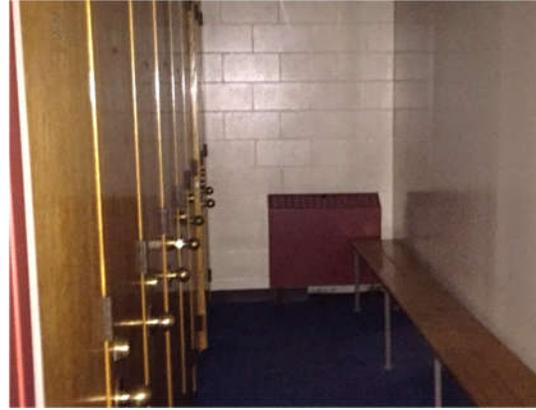
Photo M4 – Hot Water Wall Convectors

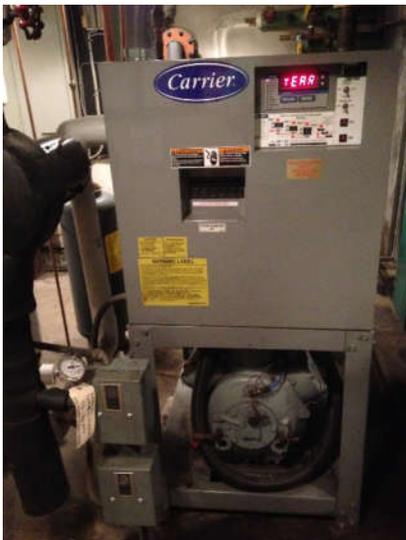
Chilled water plant is comprised of a Carrier reciprocating chiller located in the basement which rejects heat to a remote roof mounted dry cooler. Chiller only contains a single compressor. Chiller operates with R-22 refrigerant. Copper piping between the chiller and dry cooler is high pressure refrigerant. Chiller and remote condenser are in fair to good condition. R-22 refrigerant is becoming more and more difficult to obtain since it is not permitted in new equipment. Chilled water is circulated by a pair of constant volume pumps. Consideration should be given to a phase-out plan to remove the R-22 equipment and install an R-410a air-cooled multiple scroll chiller on the roof.

Photo M9 – Carrier Chiller

- Replace chiller system with higher efficiency R-410a air-cooled unit with multiple scroll compressors. – \$150,000.
- Consider installation of energy recovery unit to exhaust toilet rooms and provide tempered ventilation to fan coil units. – \$45,000.
- Modify hot water loops to add zone valves and provide variable speed pumps. – \$65,000.

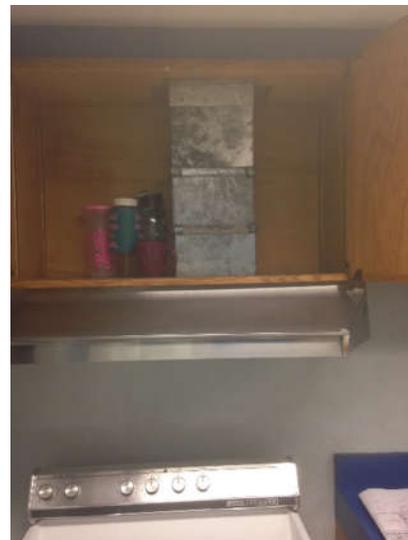
Photo M14 –Basement Kitchen Hood

- Replace condensing boiler venting with polypropylene certified for boiler service. – \$5,000.
- Install commercial kitchen range hood with integral fire suppression system in basement kitchen. – \$10,000.

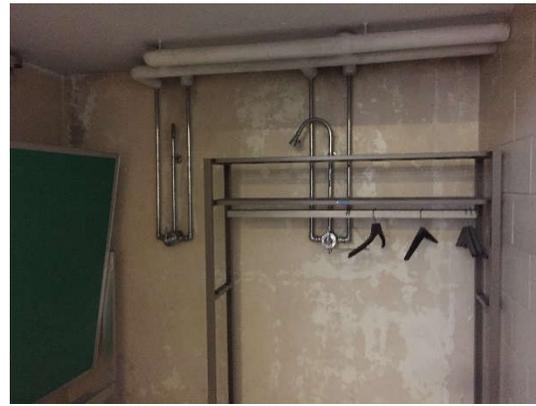
At the bottom of both stair towers there are a pair of exposed shower heads and valves. It is reported these showers were intended for decontamination for fire fighters returning from events. These fixtures are no longer used, and should be removed.

Photo P8 – Decontamination Showers

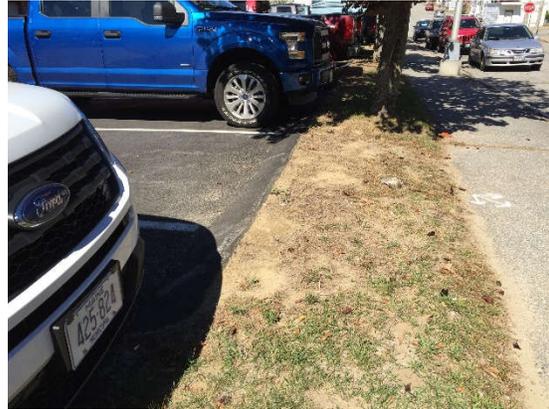
Photo C10 – Asphalt curb in parking lot along Blake Street.

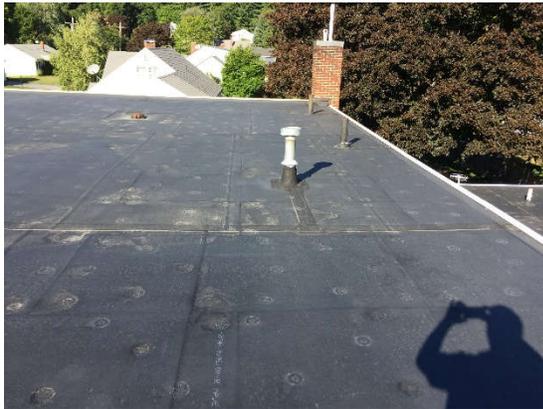
Roof System: The existing membrane roof system and edge flashing was last replaced in 2011 and is in good condition. Roofing is placed over 2" wood plank and steel bar joist. The 2011 roof replacement likely improved the thermal performance of the roof by increasing the insulation thickness from 1" to potentially 3".

Photo LS-A1 – View of High Roof

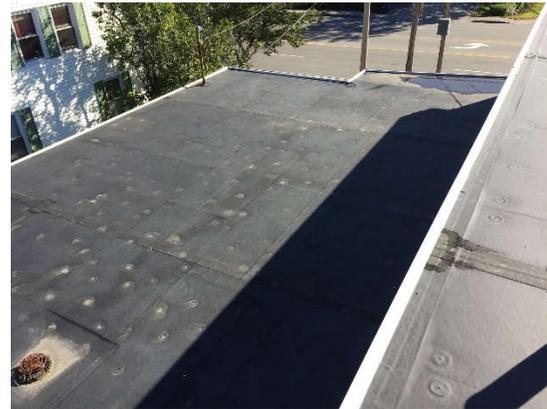
Photo LS-A2 – View of Low Roof

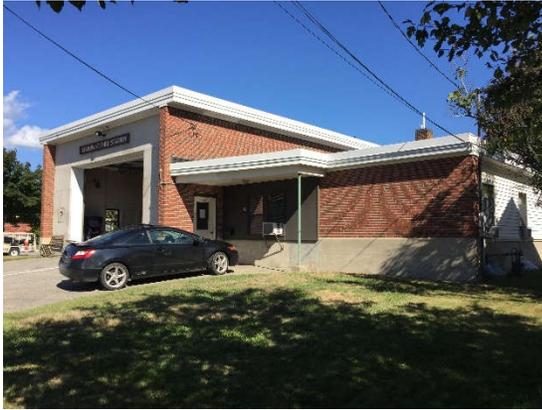
Exterior Wall System #1: Located on the North, West, and South sides of the building and consists of uninsulated 8" load bearing CMU with 4" brick veneer. R-15.2 continuous insulation is required for this wall system to comply with the current Energy Code. This could be achieved by applying a new wall system to the interior face of the existing masonry wall. It would consist of horizontal wood strapping, 3" rigid board insulation, and 5/8" gypsum sheathing. In the apparatus bay location, gypsum should be abuse, moisture, and mold resistant. The exterior wall system is in good condition but is poorly insulated. Envelope concerns such as deteriorated or open mortar joints, areas of moisture infiltration, fractured brick units, stress cracks in the masonry assembly and worn expansion joint materials need to be addressed. Thermal improvements to the exterior wall would likely reduce energy cost as well as reduce damage to interior finishes left by the formation of condensation within the CMU back-up wall. Thermal improvements could occur on the inside or outside of the existing wall. Exterior improvement would be less obtrusive. Both options would be costly. From an envelope standpoint, this building is in need of a focused masonry maintenance program.

Photo LS-A3 – View of South Façade

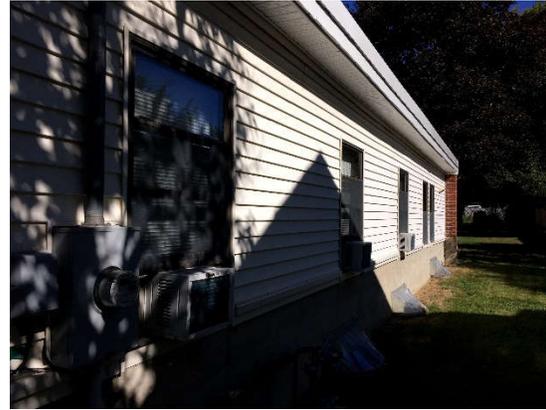
Exterior Wall System #2: Located on the East side of the building, this system consists of 8" concrete stem wall to an elevation 2'-5" above finish floor and 3/4" of insulation under wood paneling on the interior face of the wall. Above the stem wall is 2x6 wood framed wall with 3 1/2"

cavity batt insulation. Interior side of wall is finished with 3/4" of insulation under wood paneling. Exterior side of wall is finished with asbestos cement board, which was covered in 1998 with vinyl siding and break metal trim. R-15.2 continuous insulation at the stem wall and R-13 + R-7.5 continuous insulation above the stem wall is required to comply with the current Energy Code. This could be achieved by replacing the 3/4" rigid insulation with new 3" rigid board insulation at the stem wall and removing the interior system to the interior face of the existing masonry wall that consists of horizontal wood strapping, 3" rigid board insulation and 5/8" gypsum sheathing. In the apparatus bay location, gypsum should be abuse, moisture and mold resistant.

Photo LS-A4 – View of East Façade

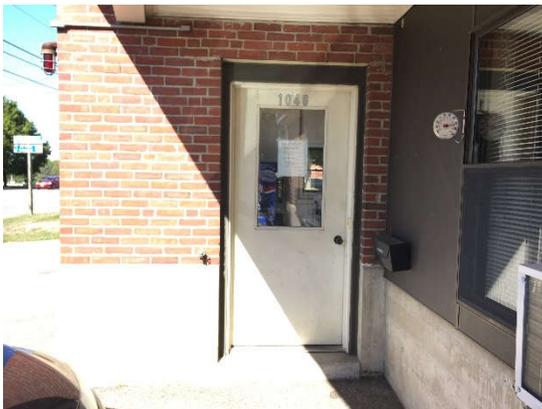
Exterior Fiberglass Doors: There are 3 exterior fiberglass insulated doors in metal frames which are in good to fair condition. These doors and frames are not original. Door hardware is knob type which should be replaced with lever type to comply with ADA. Useful life expectancy is 10+ years with proper annual maintenance.

Photo LS-A5 – View of Apparatus Bay South Entry

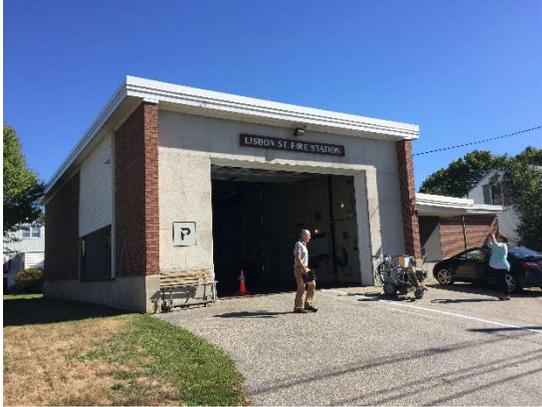
Exterior Overhead Door: There is 1 exterior overhead door which is in good condition. Useful life expectancy is 10+ years with proper annual maintenance.

Photo LS-A7 – View of South Facade

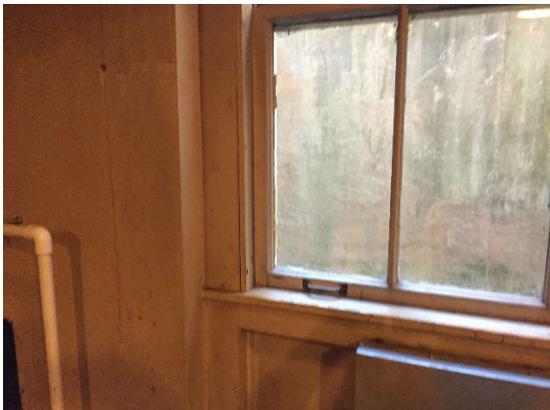
Exterior Window: First floor windows are aluminum framed windows with insulated glazing. The windows appear to have been replaced within the last 15yrs and are in good condition. Most basement windows are newly replaced vinyl windows that are in good condition. There is 1 window in the mechanical room which is an original wood window. This window has met its useful life expectancy and should be replaced within the next 2 years.

Photo LS-A11 – View of Mechanical Room Window

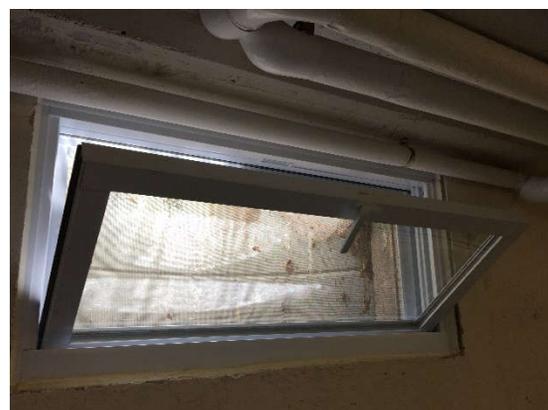
Photo LS-A12 – View of Basement window

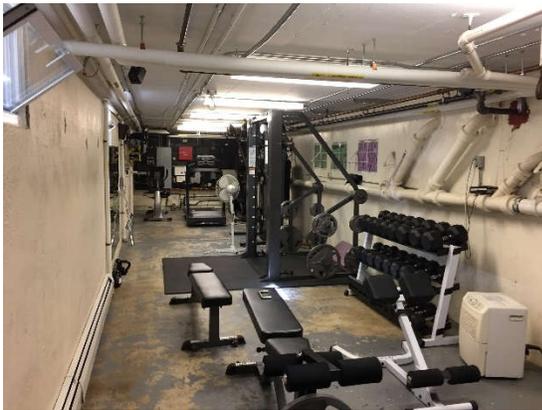
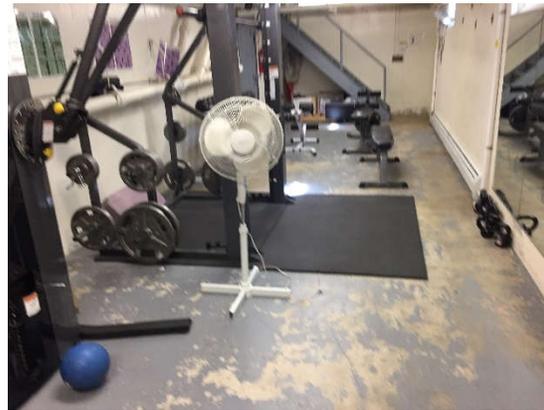
1. There is no elevator access to fitness room.

Photo LS-A13 – South view of Fitness Room

Photo LS-A14 – North view of Fitness Room

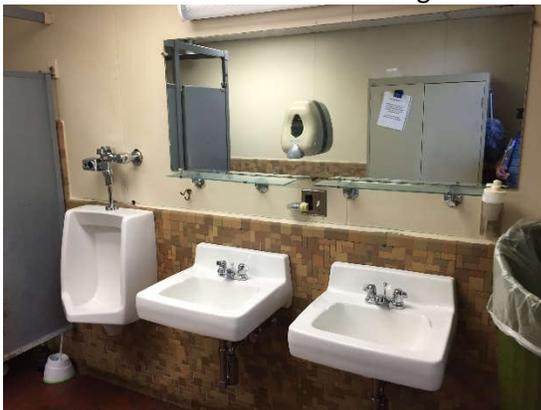
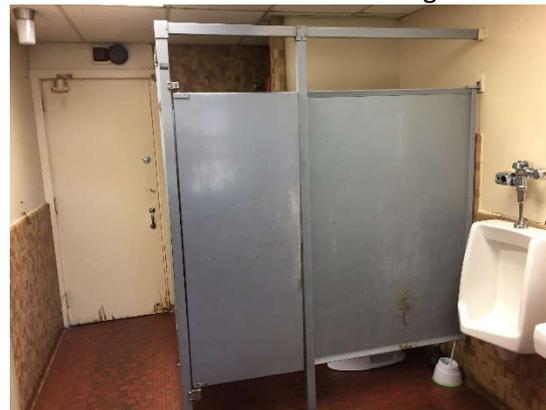
- Ceramic tile flooring in bathroom is in fair condition and has met its useful life expectancy.
- Walls:
 - Painted CMU walls in Apparatus bay are in good condition. Repointing of mortar joint in several areas recommended.

Photo LS-A17 – View of Bathroom

Photo LS- A18 – View of Bathroom

1. Elevator access to basement Fitness Room
2. Kitchen cabinets and appliances are non-conforming. New countertop, base and upper cabinets that comply with ADA are recommended.
3. Bathroom access clearances.
4. Kitchen Bathroom and Bedroom doors cannot accommodate required push and pull clearances and are not 36" wide.
5. Knob type door hardware should be replaced with lever type hardware
6. Bathroom plumbing fixtures are non-conforming. Two new gender specific bathrooms that comply with ADA are recommended.

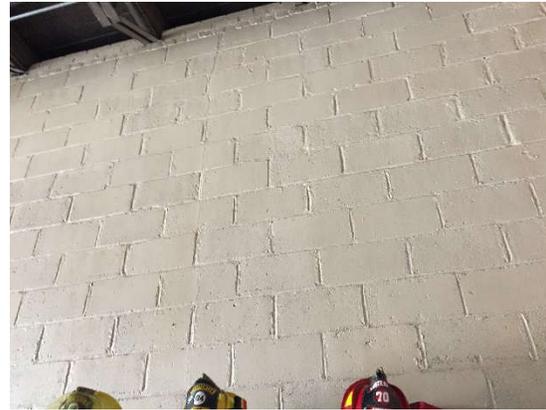
Photo LS-A22 – View of CMU wall

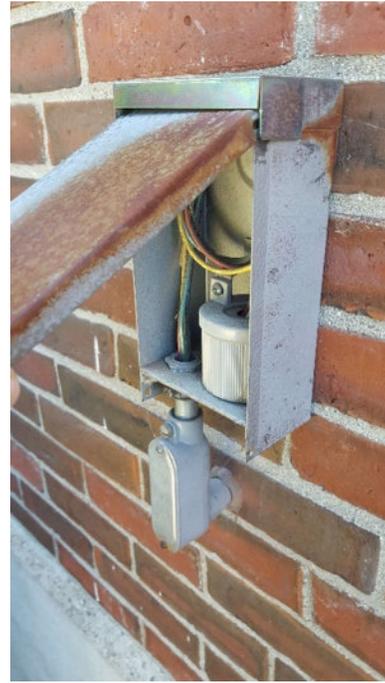
Standby power is provided to facility via portable 5kW generator that is kept in a locked storage container. Upon loss of normal power, the generator must be plugged into the receptacle located on the deck and power gets transferred to the select circuits. Receptacle generator connection appears to be a flexible cord extended through the exterior wall of the building and located in hinged enclosure to shield it from weather. Installation of flexible cord through wall does not meet Code (*NEC, Article 400.8*) and exterior box is in poor condition.

Photo E2 – Generator Connection

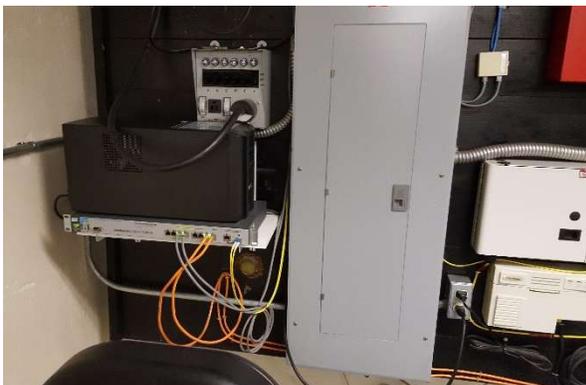
Telecommunication services for the facility enter aerially and extend to an equipment located in the basement fitness room. Telecommunication equipment appears to be in good condition. In current location, equipment does not appear to be well protected from physical damage.

Photo E5 – Telecomm Equipment.

- Install tamper-proof receptacles in bedrooms and living area.
- Replace existing lighting fixtures with new LED fixtures.
- Install emergency lighting and exit signage.
- Relocate network equipment to secure location.
- Install fire alarm system.

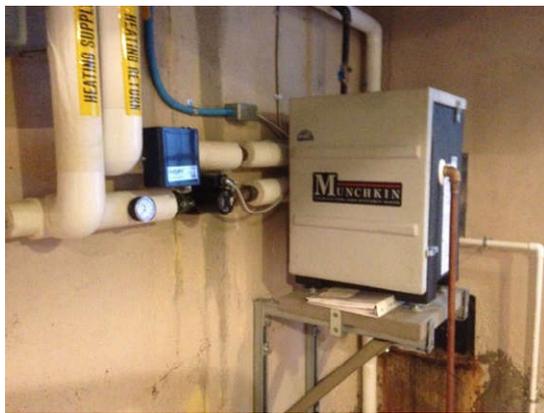
Facility is served by a central natural gas-fired hot water boiler plant. The existing boiler plant consists of a single Munchkin condensing, direct-vent boiler piped with primary and secondary loops located in the basement. Boiler plant was recently renovated in 2010 and is in good condition. Boiler is vented with PVC into the existing masonry chimney. We have seen issues when venting condensing boilers using PVC pipe which has a relatively low rated temperature. Boiler venting should be replaced with polypropylene which is rated for boiler service. There appear to be two zones of heat off the secondary loop, each with an individual pump. Pumps are controlled through a relay box. Secondary hot water heating loops are located in the basement and are suspended from the floor above. Piping is primarily copper pipe and appears to be in fair to good condition and is well insulated throughout the facility.

Photo M1 – Gas Boiler and Primary Pump

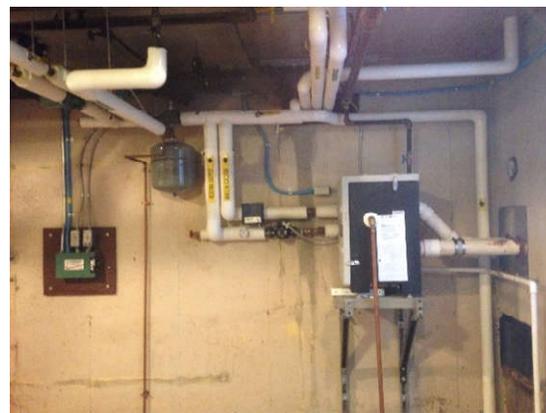
Photo M2 – HW Piping and PVC Venting

- Replace boiler venting with polypropylene certified for boiler service. – \$5,000.
- Install commercial kitchen range hood with integral fire suppression system. – \$10,000.

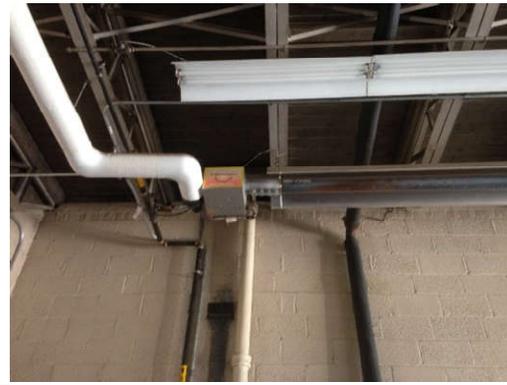
Hot water unit heaters originally provided in the apparatus bay have been removed and replaced with gas-fired infrared tube heaters at each end of the apparatus bay. Combustion air for the burners enter through a wall cap and are vented through the roof. Units are in good condition.

Photo M4 – Gas-Fired Infrared Tube Heater

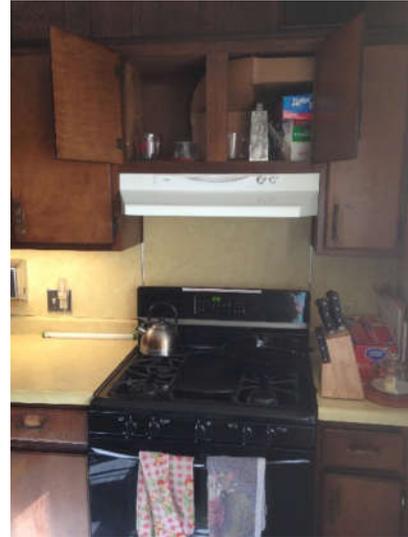
Photo M6 –Vented range hood

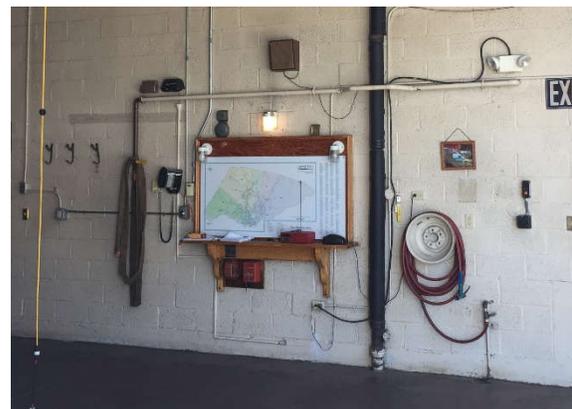
Facility is served with public water supply from the street. Water enters the facility through the basement. Service appears to be large enough for the current facilities demand. A truck fill hose is located in the apparatus bay. It was explained that refilling the tank truck takes approximately 15 minutes, which was acceptable. If the truck was completely empty staff would fill the truck from a street fire hydrant.

Photo P2 – Truck Fill and Interior Hose Bib

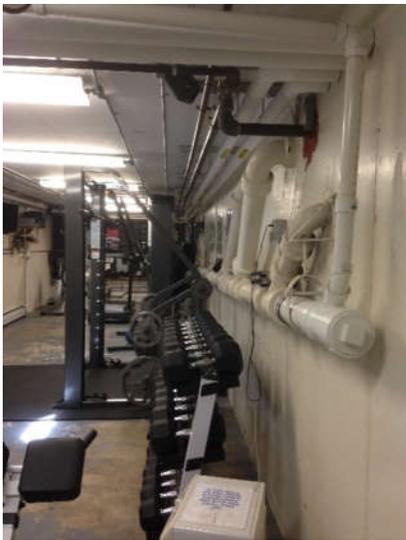
Existing sanitary piping is entirely below the ground floor, visible in the basement. The sanitary piping consists of a mix of original cast iron pipe and more recently added PVC piping. Sanitary leaving the building appears to be 5" cast iron to the main at the street. Piping appears to be of sufficient size for facility's current usage and appears to be in fair to good condition. It appears that storm drainage is connected to the building sewer as well. Future renovations should separate storm drainage from sanitary. The underground original sanitary piping to the street should be inspected to determine its condition.

Photo P3 – Sanitary Sewer Main

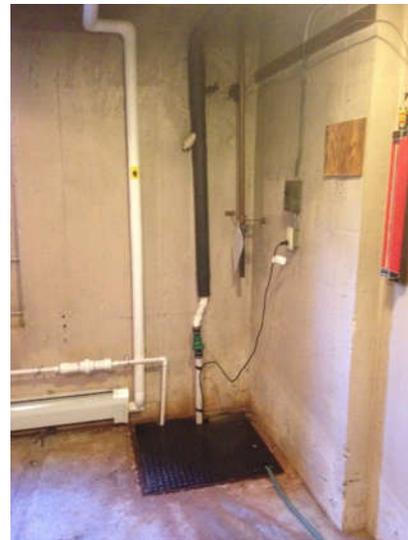
There is a sump pit in the basement boiler room which is pumped up onto the sanitary main. Pump appears to be in fair condition.

Photo P4 – View of Basement Sump Pump

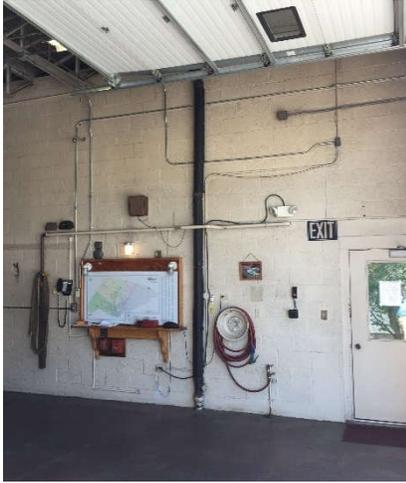
There appear to be two roof drains serving the high roof and one installed on the low roof. Secondary means of drainage appears to be overflow over the roof edge, which does not have a parapet. Drainage piping appears to be original cast iron piping. Exposed roof drain leader in the apparatus bay may have had some condensate issues, leading to partial installation of closed cell foam pipe insulation. Piping should be properly insulated including hubs and bells and jacketed. Cast iron baskets on the existing roof drains are in fair condition. Roofing was recently replaced and both roofs appear to drain well. As previously mentioned, storm drainage should be separated from sanitary sewer to prevent issues during heavy rain.

Photo P5 – Roof Drain Leader (center)

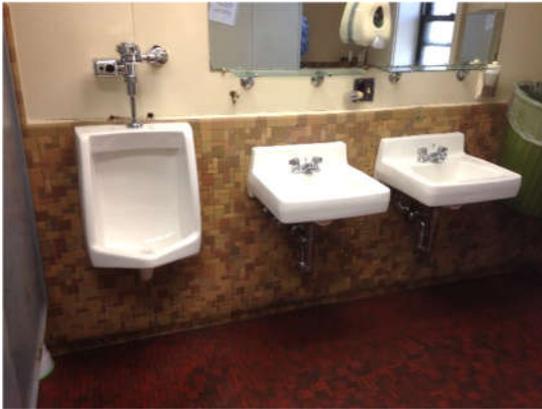
The plumbing fixtures in the building appear to be original. The fixtures are in fair to good condition however none of the fixtures appear to be water conserving type. Fixtures also do not appear to meet ADA requirements for height, access or operator type. Approach to built-in shower and toilet are very troublesome to achieve ADA access. If this were to become a single-user bathroom, walls and fixtures could be removed and access improved. The number of fixtures provided appears to be adequate for the current use of the facility. See Architectural section for more information on ADA access and fixture quantity.

Photo P7 – Toilet Room Fixtures

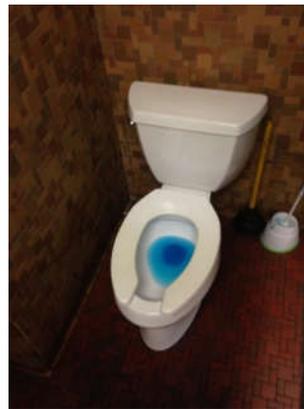
Photo P8 – Toilet Fixture

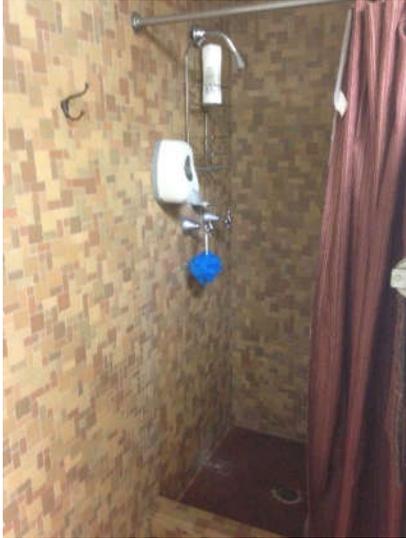
Photo P9 – Built-in Shower Stall

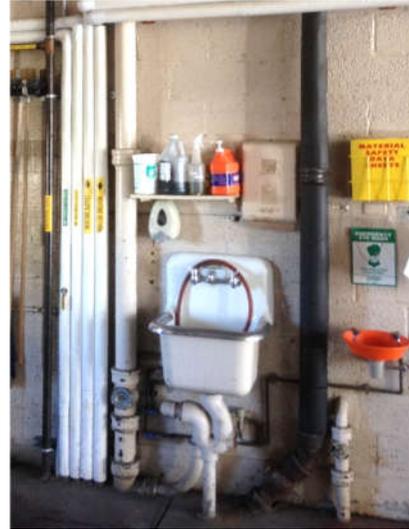
The apparatus bay is served with a cast iron service sink and emergency eye wash. It appears the eye wash includes a tempering valve to deliver tepid water to fixture as required.

Photo P10 – Service Sink and Eyewash

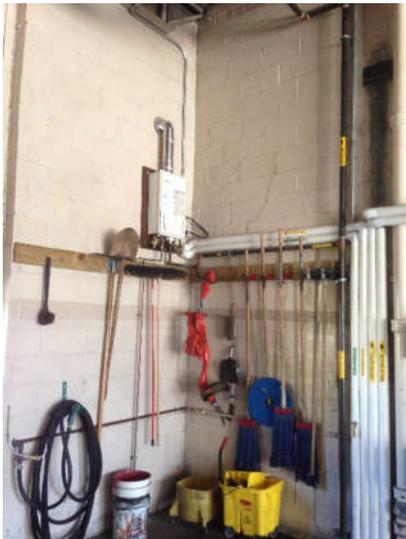
Domestic hot water is generated by a wall mounted instantaneous gas-fired water heater located in the apparatus bay. Unit is vented directly through the wall with stainless steel vent piping. Unit appears to be sized adequately for the current fixtures in the building and is in good condition. Reducing water usage at lavatories, sinks and shower would reduce load on hot water heater. Water heater is located directly adjacent to the toilet room, delivery time to fixtures should not be an issue. Hot water piping where visible appeared to be copper and well insulated.

Photo P11 – Domestic Water Heater

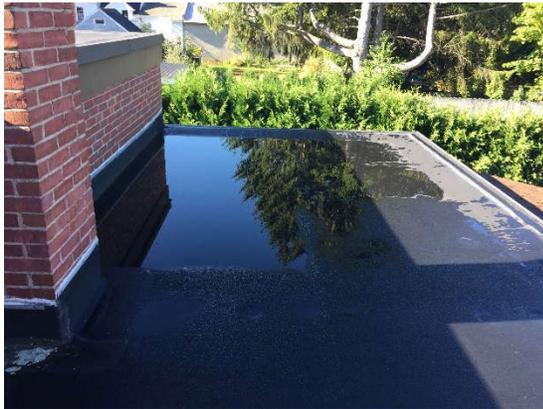
Roof System: The existing membrane roof system was last replaced in 1990 and is in good to fair condition. At the low roof, roofing is placed over a plywood deck which is supported by 10" wood joists. At the high roof, roofing is placed over a tongue and groove plank deck which is supported by steel joists. The roof is nearing its useful life expectancy and should be replaced in the next 5 to 10yrs.

Photo MS-A1 – View of low roof - ponding

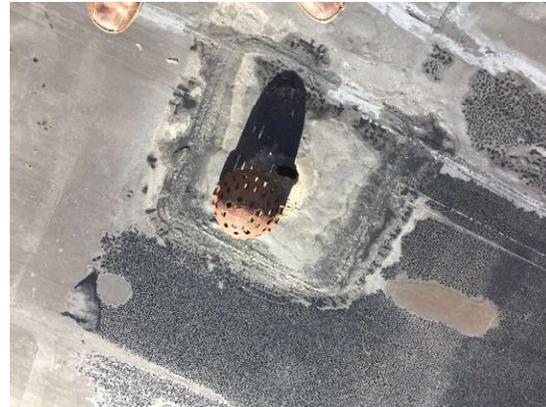
Photo MS-A2 – View of low roof drain

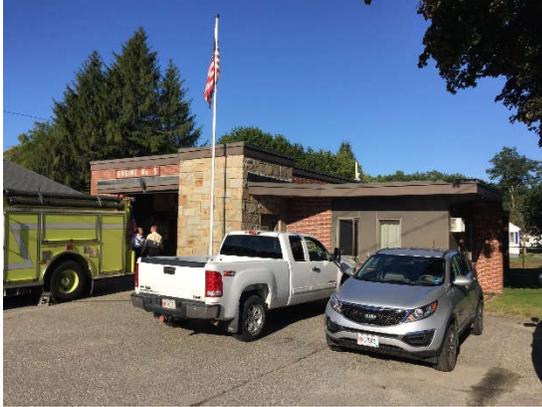
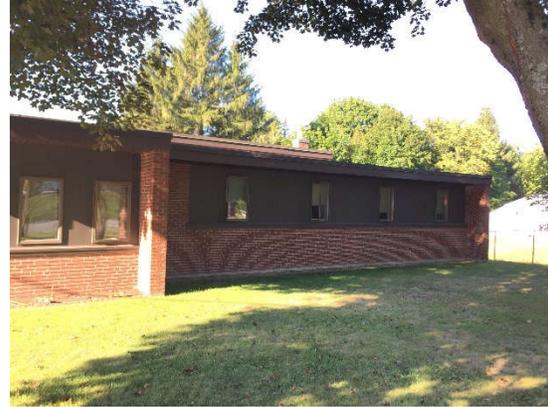
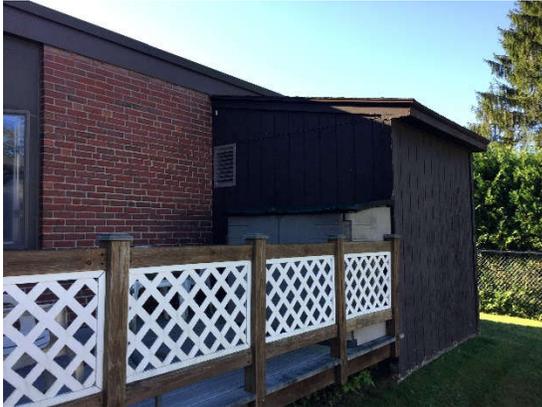
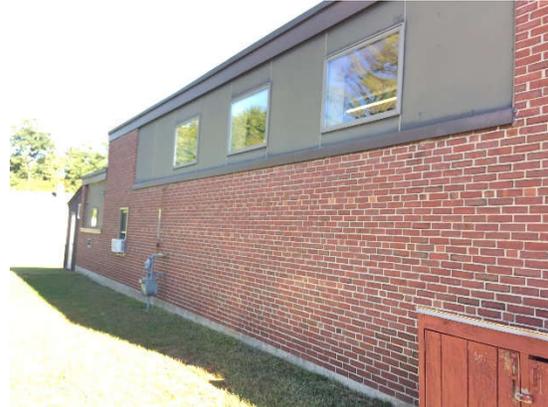
Exterior Wall System: Overall, the exterior masonry is in good condition. The wall consists of uninsulated 4" brick and 8" CMU mass wall constructions. Envelope concerns such as deteriorated or open mortar joints on the brick and natural stone masonry, small areas of moisture infiltration, small areas of fractured brick units, and worn expansion joint materials need to be addressed. R-15.2 continuous insulation is required for this wall system to comply with the current Energy Code. This could be achieved by applying a new wall system to the interior face of the existing mass wall

From an envelope standpoint, this building is in need of a focused masonry maintenance program.

that consists of horizontal wood strapping, 3" rigid board insulation, and 5/8" gypsum sheathing. In the Apparatus Bay, gypsum should be abuse, moisture and mold resistant.

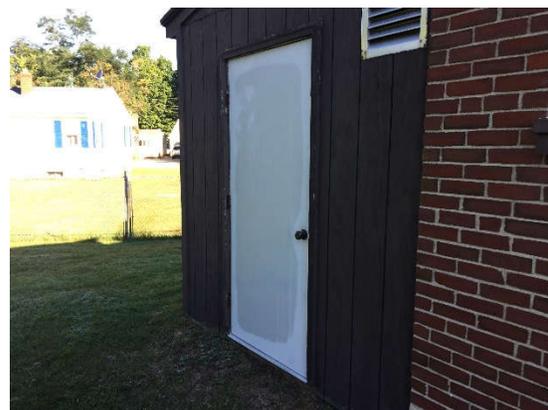
Exterior Fiberglass Doors: There are 3 exterior fiberglass insulated doors in metal frames which are in fair condition. These doors and frames are not original. Door hardware is knob type which should be replaced with lever type to comply with ADA. Useful life expectancy is 5 to 10 years with proper annual maintenance.

Photo MS-A6 – View of Storage door

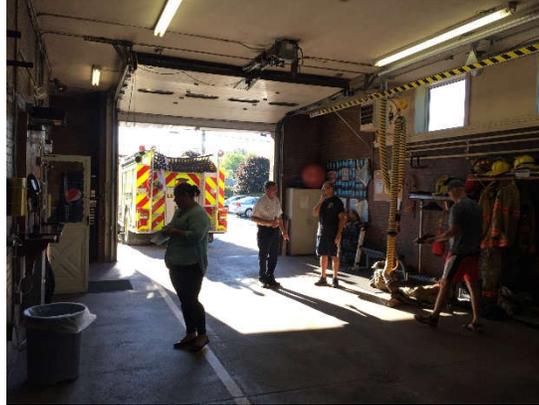
Exterior Overhead Door: There are 7 exterior overhead doors. All of these doors are in good condition. Useful life expectancy is 10+ years with proper annual maintenance.

Photo MS-A7 – View of Apparatus Bay doors

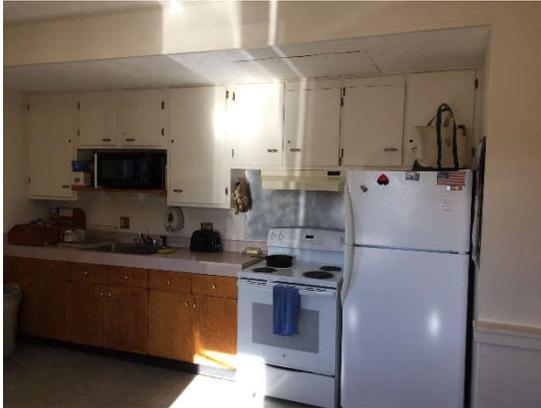
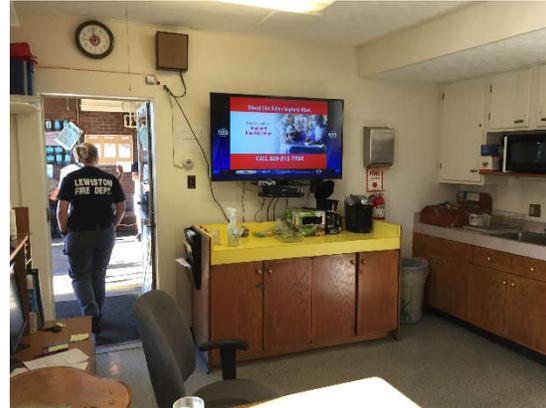
1. Kitchen cabinets and appliances are non-conforming. New countertop, base, and upper cabinets that comply with ADA are recommended.
2. Bathroom access clearances and plumbing fixtures are non-conforming. Two new gender specific bathrooms that comply with ADA are recommended.
3. Bunk Room doors cannot accommodate required push and pull clearances and are not 36" wide.
4. Bunk Room door is not 36" wide.
5. Knob type door hardware should be replaced with lever type hardware

Photo MS-A15 – View of Kitchen
