City of Lewiston

Fire Station Study

February 16, 2017 rev.

RE: 4137.00 / Lewiston Fire Station Study – Final Report

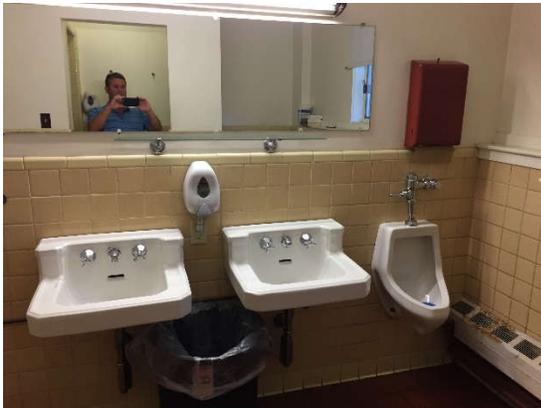
1. Kitchen cabinets and appliances are non-conforming. New countertop, base, and upper cabinets that comply with ADA are recommended.
2. Bathroom access clearances and plumbing fixtures are non-conforming. Two new gender specific bathrooms that comply with ADA are recommended.
3. Bunk Room doors cannot accommodate required push and pull clearances and are not 36" wide.
4. Bunk Room door is not 36" wide.
5. Knob type door hardware should be replaced with lever type hardware

Photo MS-A17 – View of Bathroom

The building has met the intent of its original design, however it would not comply with today's design standards. The thermal envelope is below minimum allowable insulation requirements. Existing bathroom should be replaced with 2 new bathrooms to comply with ADA and local codes. This would more than double the bathroom program area requiring the loss of existing program space. Kitchen cabinets, countertop, and appliance improvements are required to comply with ADA and local codes. Bunkroom doors should be increased to 3'-0" wide to comply with ADA. Apparatus Bay corridor does not meet the minimum corridor width requirements. Knob type door hardware should be replaced with lever type hardware.

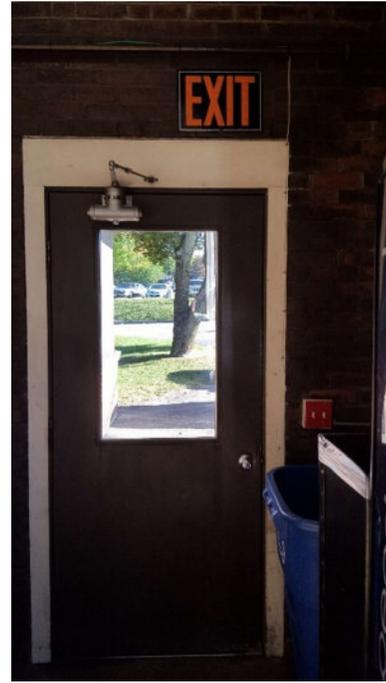
Building exits are currently marked only with non-luminescent paper signage. Constantly illuminated exit signage, either ac powered or photoluminescent, is required by Code (*NFPA 101, Chapter 7.8*).

Photo E4 – Exit Signage

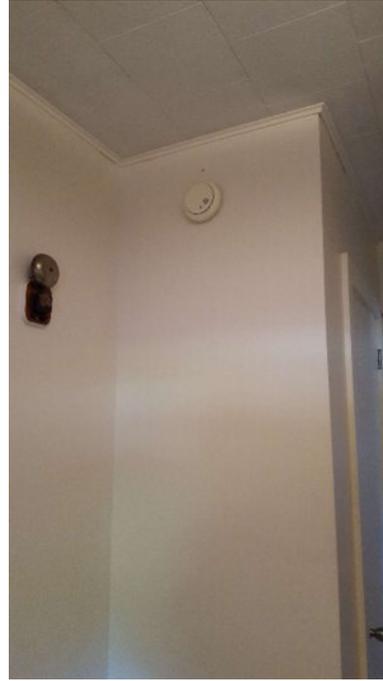
There is no fire alarm system present in the building. Bedrooms are provided with single station smoke detector that provide audible notification only. A single carbon monoxide detector was also noted in the hallway outside the boiler room and bedroom area.

Photo E6 – Non-system Smoke Detector.

- Install arc-fault circuit breakers for branch circuits feeding bedroom, living area and kitchen loads.
- Install generator permanently connected to building electrical system.
- Install tamper-proof receptacles in bedrooms and living area.
- Replace existing lighting fixtures with new LED fixtures.
- Install emergency lighting and exit signage.
- Relocate telecommunication equipment to a dry, protected location.
- Install fire alarm system.

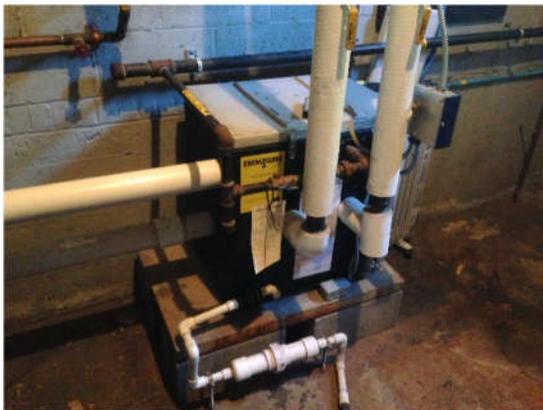
Facility is served by a central natural gas-fired hot water boiler plant. The existing boiler plant consists of a single Munchkin condensing, direct-vent boiler piped with primary and secondary loops. Boiler plant was recently renovated in 2010 and is in good condition. Boiler is vented with PVC into the existing masonry chimney. We have seen issues when venting condensing boilers using PVC pipe which has a relatively low rated temperature. Boiler venting should be replaced with polypropylene which is rated for boiler service. There appear to be three zones of heat off the secondary loop, each with an individual pump. Pumps are controlled through a relay box. Hot water heating piping in the boiler room is generally well insulated. However, the piping outside the boiler room is largely uninsulated. Piping is mostly black iron pipe with threaded fittings. Piping appears to be original and in fair condition.

Photo M1 – Gas Boiler

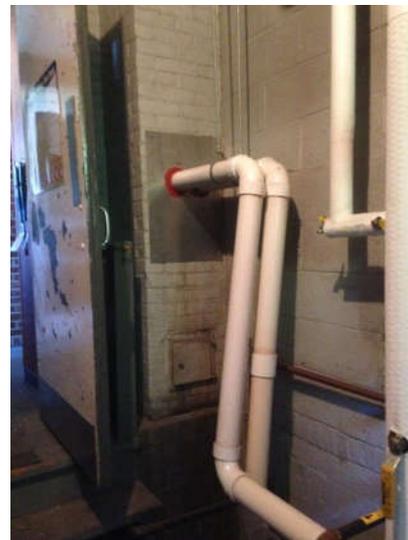
Photo M2 – PVC Boiler Venting

- Replace boiler venting with polypropylene certified for boiler service. – \$5,000.
- Install commercial kitchen range hood with integral fire suppression system. – \$10,000.

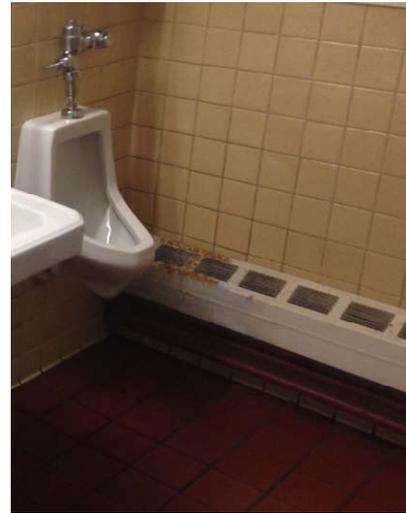
Hot water heating plant provides heat to bedrooms and lounge areas with baseboard radiation. Baseboard appears to be mostly original and in fair condition. In the bathroom, proximity to fixtures has caused oxidation on the cover of the baseboard and is in poor condition. Replace this section of heat with an aluminum or stainless steel cover to prevent future oxidation.

Photo M4 – Oxidized Baseboard Cover

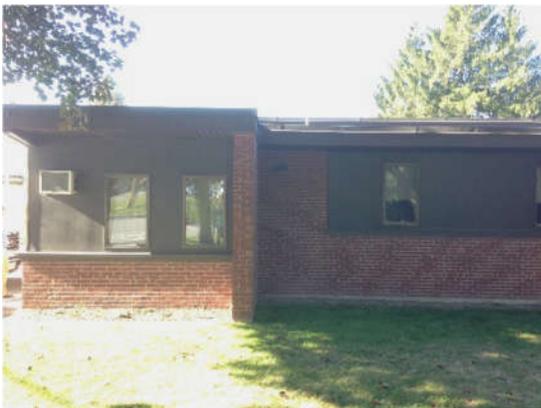
There are a few window air conditioners located in a bedroom and the lounge. The installed units are in fair condition. Window type (casement) does not allow other bedrooms to be fitted with window air conditioners. A multi-unit heat pump system could be installed to provide high efficiency cooling and shoulder season heating while maintaining individual control.

Photo M5 – Thru-wall air conditioner

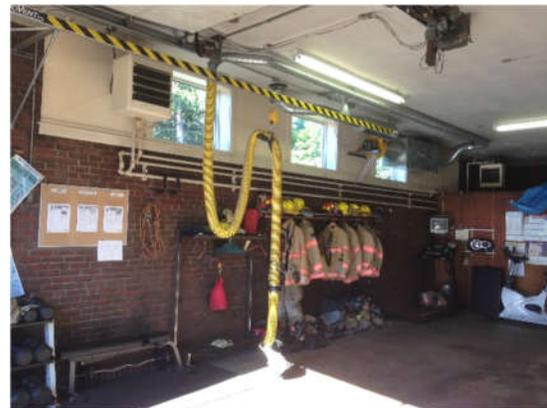
A Plymovent vehicle exhaust system located in the apparatus bay connected to the fire trucks tailpipe to directly exhaust combustion fumes out of the building. System consists of high temperature hose, track with roller guide so hose can follow truck out of the building, auto release, exhaust fan, and filters. System was installed in 2009 and is in good condition.

Photo M6 – Plymovent hose and track

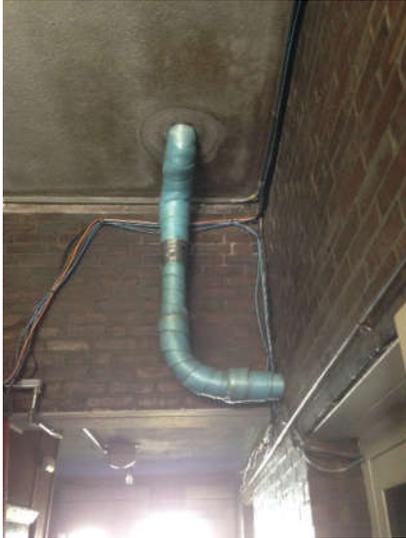
There appear to be only two roof drains serving roof drainage. One installed on the low roof and one installed on the high roof. Secondary means of drainage appears to be overflow over the roof edge, which does not have a parapet. Drainage piping appears to be original cast iron piping. Exposed roof drain leader in the apparatus bay may have had some condensate issues, leading to installation of foam wrap. Piping should be properly insulated and jacketed. Roof drain bodies appear to be embedded in the concrete roof structure and are assumed to be original. Cast iron baskets on the roof are in fair condition. High roof appears to drain well, but there was ponding evident on the lower roof. As previously mentioned, storm drainage should be separated from sanitary sewer to prevent issues during heavy rain.

Photo P1 – Apparatus Bay Roof Drain Leader

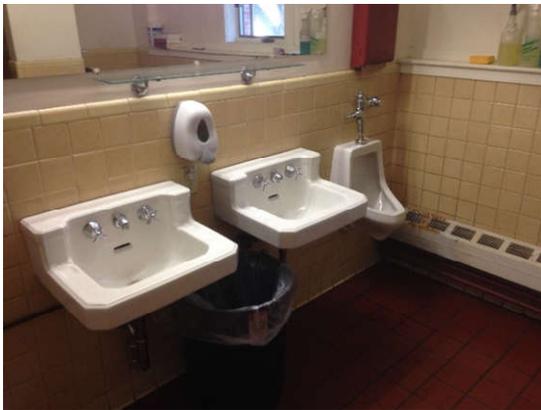
The plumbing fixtures in the building appear to be original. The fixtures are in fair to good condition however none of the fixtures appear to be water conserving type. Fixture also do not appear to meet ADA requirements for height, access or operator type. Approach to built-in shower and toilet are very troublesome to achieve ADA access. Given that this is operated as a single-user bathroom, walls and fixtures could be removed and access improved. The number of fixtures provided appears to be adequate for the facility. See Architectural section for more information on ADA access and fixture quantity.

Photo P3 – Toilet Room Fixtures

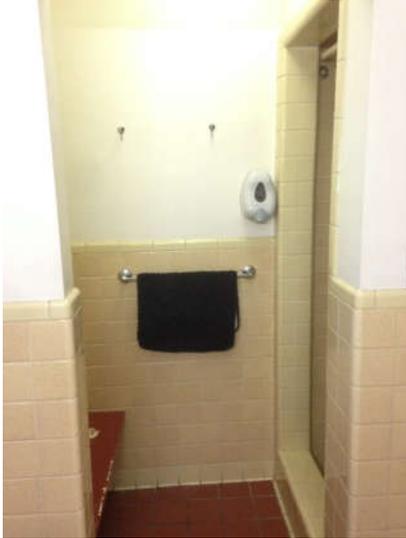
Photo P5 – Shower access

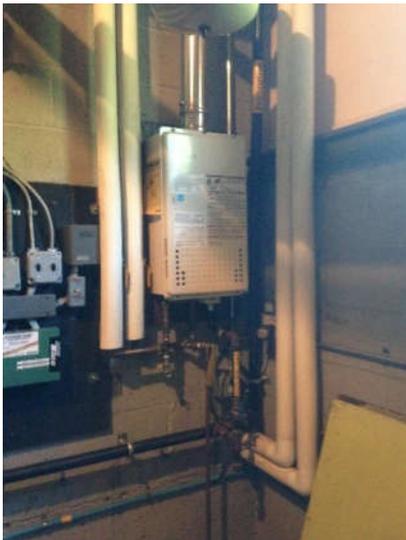
Domestic hot water is generated by a wall mounted instantaneous gas-fired water heater located in the boiler room. Unit is vented directly through the wall with stainless steel vent piping. Unit appears to be sized adequately for the current fixtures in the building. Reducing water usage at lavatories, sinks and shower would reduce load on hot water heater. Distance to the toilet room could delay hot water delivery as it did not appear there was a hot water recirculation pump or any temperature maintenance tape.

Hot water piping in the boiler room appeared to be copper and well insulated. Piping outside the boiler room was existing and did not appear to be insulated. Insulating this pipe will aid in reducing hot water delivery time.

Photo P6 – Domestic Water Heater

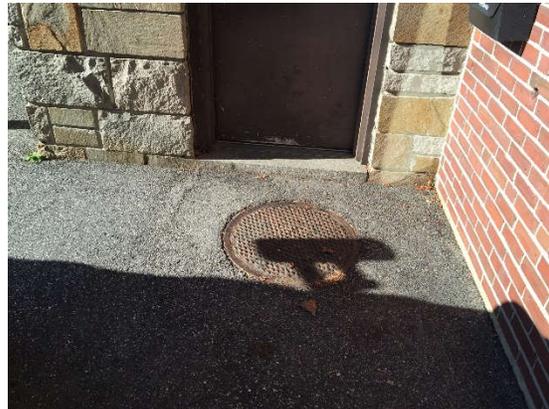
Photo C04 – Building entrance. Not ADA accessible.

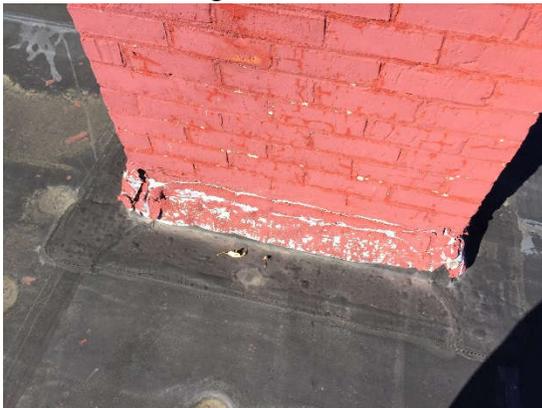
Roof System: The existing membrane roof system was last replaced in 2010. Roofing is placed over wood deck and framing. Blistering and delamination of membrane was observed in several areas. Roof maintenance is recommended to improve the life of the roof.

Photo SS-A1 – Membrane blisters at Chimney

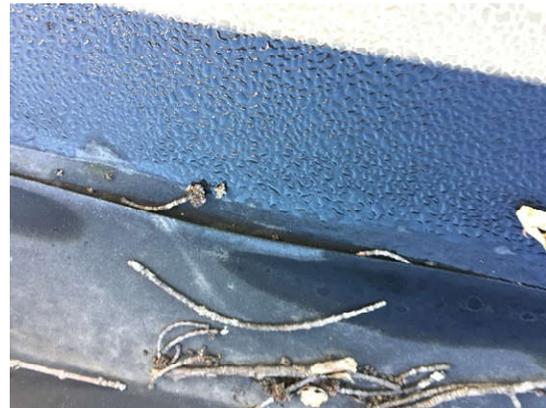
Photo SS-A2 – Membrane delamination

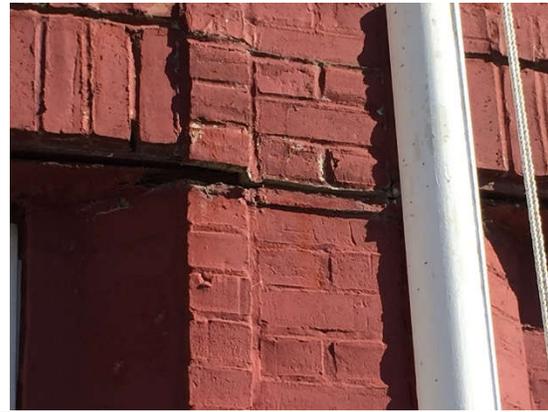
Photo SS-A3 – East Façade

Exterior Wall System: Consists of uninsulated multi-wyath 4" brick mass wall constructions that is in poor condition. Envelope concerns such as deteriorated or open mortar joints, areas of moisture infiltration, fractured brick units, stress cracks in the masonry assembly, buldges in the masonry assembly, deteriorated steel window lintals and worn expansion joint materials need to be addressed. R-15.2 continuous insulation is required for this wall system to comply with the current Energy Code. This could be achieved by applying a new wall system to the interior face of the existing mass wall that consists of horizontal wood strapping, 3" rigid board insulation, and 5/8" gypsum sheathing. Apparatus Bay gypsum should be abuse, moisture and mold resistant.

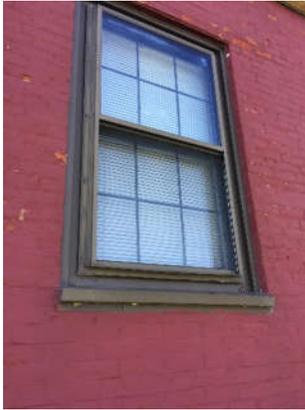
Photo SS-A9 – View of typ. 1st floor window

Exterior Window: First floor windows are aluminum framed windows with insulated glazing. The windows appear to have been replaced within the last 15yrs and are in good condition. Basement windows appear to be original single pane wood windows which have exceeded their useful life expectancy and should be replaced within the next 2 years.

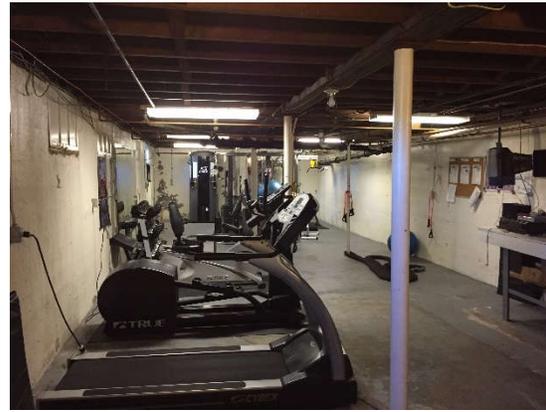
1. Flooring consists of painted concrete and raw concrete. There is likely no vapor barrier under the existing slab.
2. Fitness room walls are painted.
3. Mechanical room walls are unfinished
4. Fitness room ceiling is exposed first floor wood framing.
5. Mechanical room ceiling is metal lath and plaster which is in poor condition and should be replaced with a 1 hr rated ceiling system.
6. Doors to bathroom appear to be original and have met their useful life expectancy. New 1 hr rated doors and hardware are recommended.
7. Stairs treads, risers and railing do not comply with local codes.
8. Moisture has infiltrated this space but appear to have been repaired 2012
9. Mold may have been observed in mechanical room. Black walls in photo SS-A14 could be tested to confirm if mold is present.

Photo SS-A14 – Fitness Room

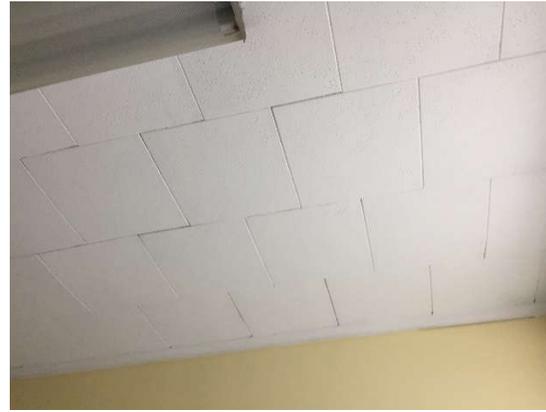
Photo SS-A22 – Toilet room ceiling damage

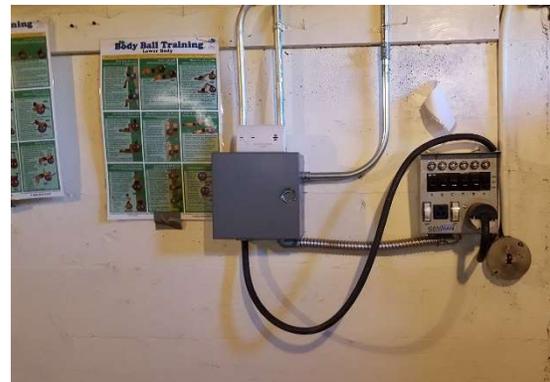
Photo E2 – Generator Connection

Standby power is provided to facility via portable 5kW generator that is kept in a locked storage container. Upon loss of normal power, the generator must be plugged into the receptacle located on the deck and power gets transferred to the select circuits. Receptacle generator connection appears to be a flexible cord extending to junction box. Connection transitions to conduit in metallic conduit which feeds the receptacle located in a hinged enclosure at the exterior of the building to shield it from weather. Both the plug and exterior box are in very poor condition and present a safety concern in their current state.

- Install arc-fault circuit breakers for branch circuits feeding bedroom, living area and kitchen loads.
- Install generator permanently connected to building electrical system.
- Install tamper-proof receptacles in bedrooms and living area.
- Install weather proof devices/boxes in apparatus bay.
- Replace existing lighting fixtures with new LED fixtures.
- Install emergency lighting and exit signage.
- Provide additional telecommunication outlets throughout space.
- Install fire alarm system.

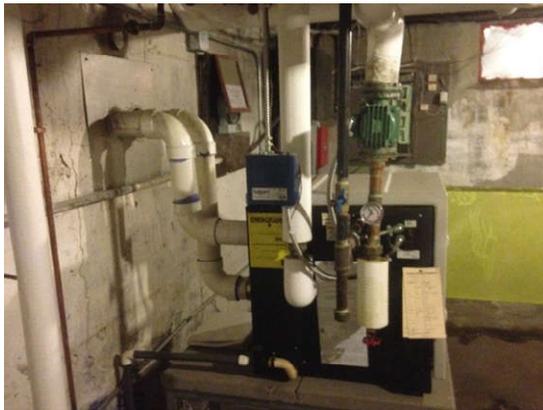
Photo M1 – Gas Boiler with PVC Venting

- Replace boiler venting with polypropylene certified for boiler service. – \$5,000.
- Install commercial kitchen range hood with integral fire suppression system. – \$10,000.

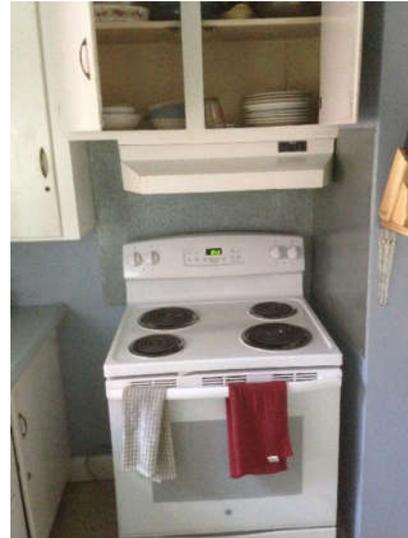
A kitchen range hood is located in the lounge. Unit is not vented to the exterior. However, since this residential range is installed in a commercial building, a UL listed commercial hood is required, including a fire suppression system.

Photo M6 – Unvented range hood

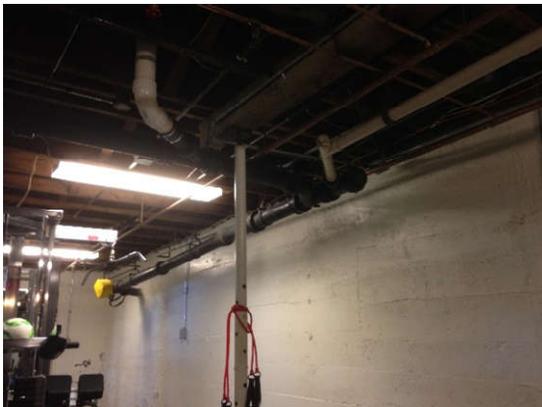
Photo P2 – Sanitary Sewer Main

Existing sanitary piping is entirely below the ground floor, visible in the basement. The sanitary piping consists of a mix of original cast iron pipe and more recently added PVC piping. Sanitary leaving the building appears to be 4" cast iron to the main at the street. Piping appears to be of sufficient size for facility's current usage and appears to be in fair to good condition. The underground original sanitary piping to the street should be inspected to determine its condition.

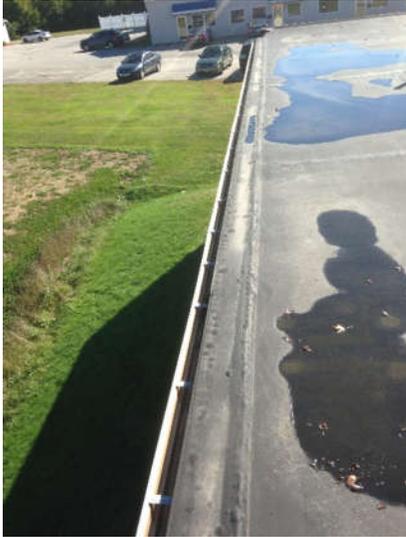
Photo P4 – Roof Gutter

It appears that the high roof over the apparatus bay is pitched to drain onto the lower roof. The lower roof is pitched to the back edge where there is a continuous gutter. Gutter has 3 downspouts connected to underground piping. It is unclear whether these downspouts connect to a daylight pipe or are connected to the sanitary piping outside the building. If the roof drainage is connected to the sanitary main, it should be disconnected and piped to the proper storm drainage system.

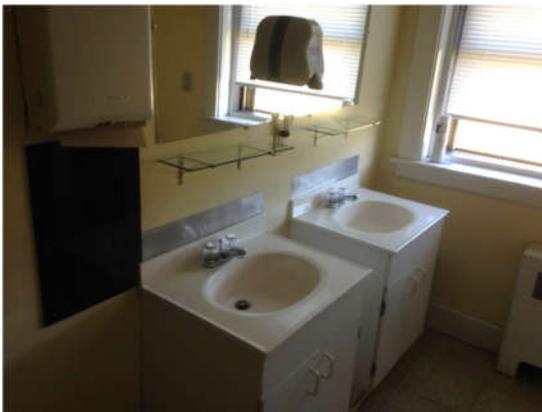
Photo P6 – Toilet Room Lavatories

The plumbing fixtures in the building appear to be original. The fixtures are in fair to good condition however none of the fixtures appear to be water conserving type. Fixtures also do not appear to meet ADA requirements for height, access or operator type. Cabinets under lavatories do not allow proper knee space. Approach to built-in shower and toilet are very troublesome to achieve ADA access. Given that this is operated as a single-user bathroom, walls and fixtures could be removed and access improved. The number of fixtures provided does not appear to be adequate for the number of beds provided at the facility. See Architectural section for more information on ADA access and fixture quantity.

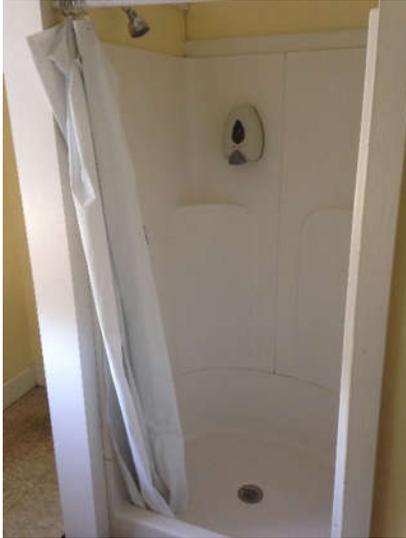
Photo P8 – Non-ADA Shower Stall

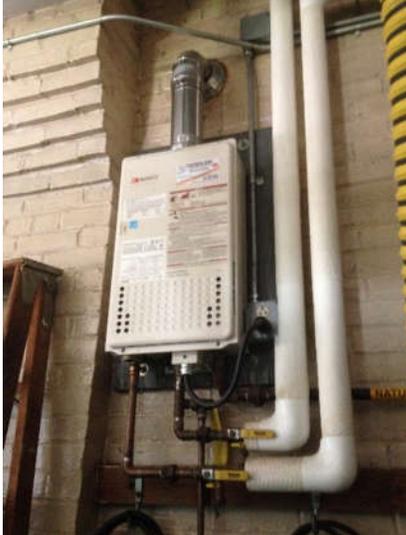
Domestic hot water is generated by a wall mounted instantaneous gas-fired water heater located in the apparatus bay. Unit is vented directly through the wall with stainless steel vent piping. Unit appears to be sized adequately for the current fixtures in the building and is in good condition. Reducing water usage at lavatories, sinks and shower would reduce load on hot water heater. Distance to the toilet room could delay hot water delivery as it did not appear there was a hot water recirculation pump or any temperature maintenance tape. Hot water piping where visible appeared to be copper and well insulated.

Photo P9 – Domestic Water Heater

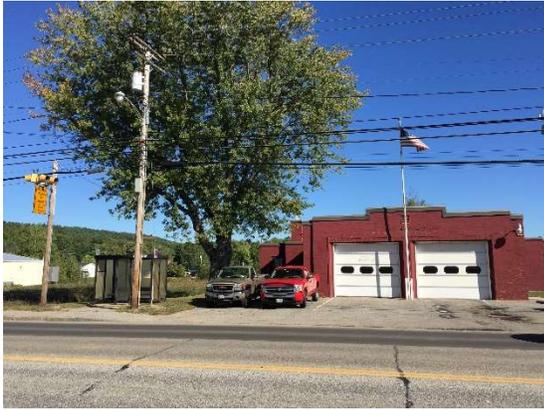
Photo C01 – Emergency vehicle driveway and parking on Sabattus Street.

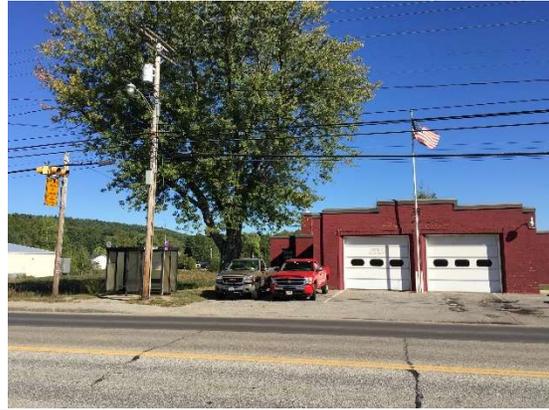
Photo C02 – Emergency vehicle driveway and parking on Sabattus Street.

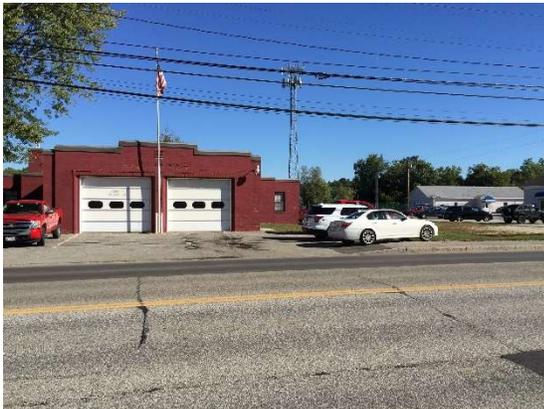
Photo C03 – Emergency vehicle driveway and parking on Sabattus Street.

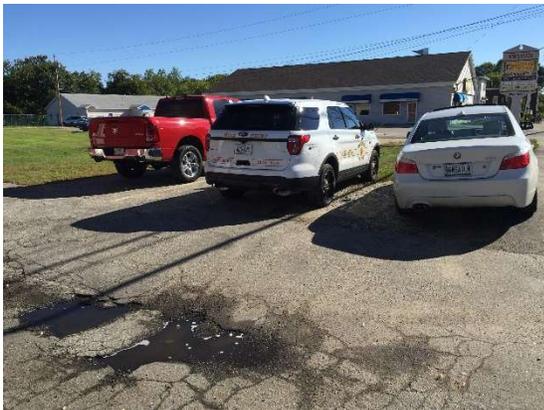
Asphalt pavement is located between Sabattus Street and the fire station and provides parking for four (4) vehicles, access to the emergency vehicle bays and access to the main building entrance (± 2000 SF). Pavement is in poor condition with large areas of alligator cracking and pavement deterioration. A 60' long curb cut is provided, with no pavement delineation for safe pedestrian access along the Sabattus Street sidewalk. The main building entrance is not ADA accessible and no ADA parking spaces are provided.

Photo C05 – Pavement condition in parking area.

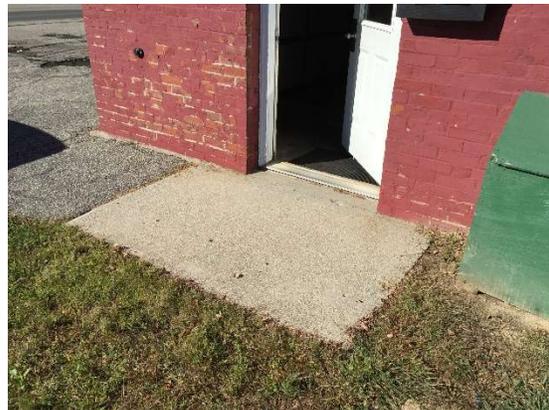
Photo C06 – Main building entrance.

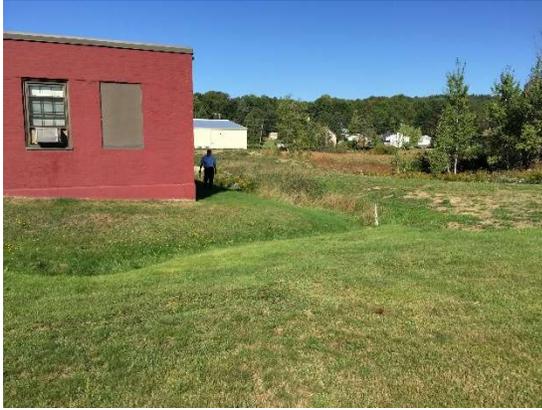
Photo C07 – Grass swale along east side of building.

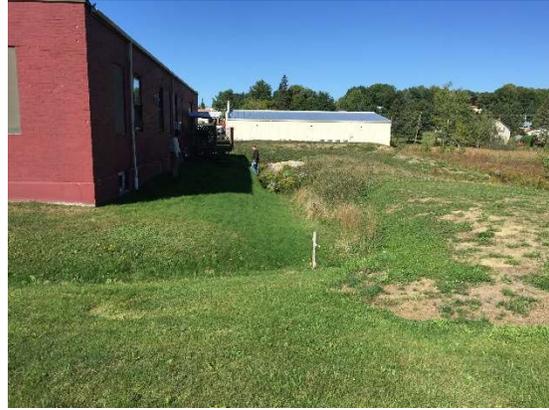
Photo C08 – Grass swale along north side of building.

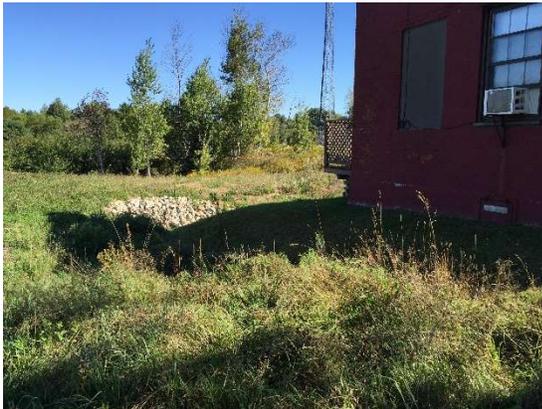
Photo C09 – View along west side of building toward corrugated HDPE culvert riprap inlet protection.

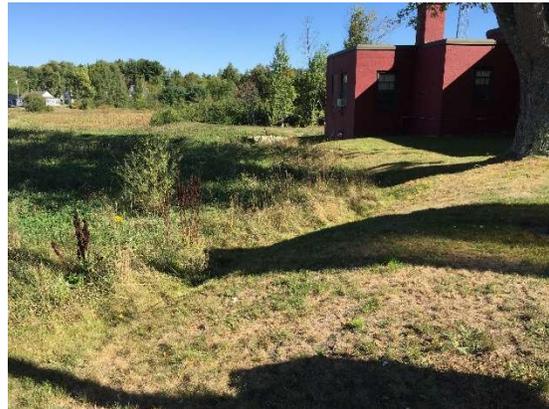
Photo C10 – View along west side of building.
