CITY OF LEWISTON HISTORIC PRESERVATION REVIEW BOARD

MEMORANDUM

RE: Lewiston Canal and Water Power Historic District

A copy of the National Register of Historic Places Registration Form and associated documents for the Lewiston Mills and Water Power System Historic District

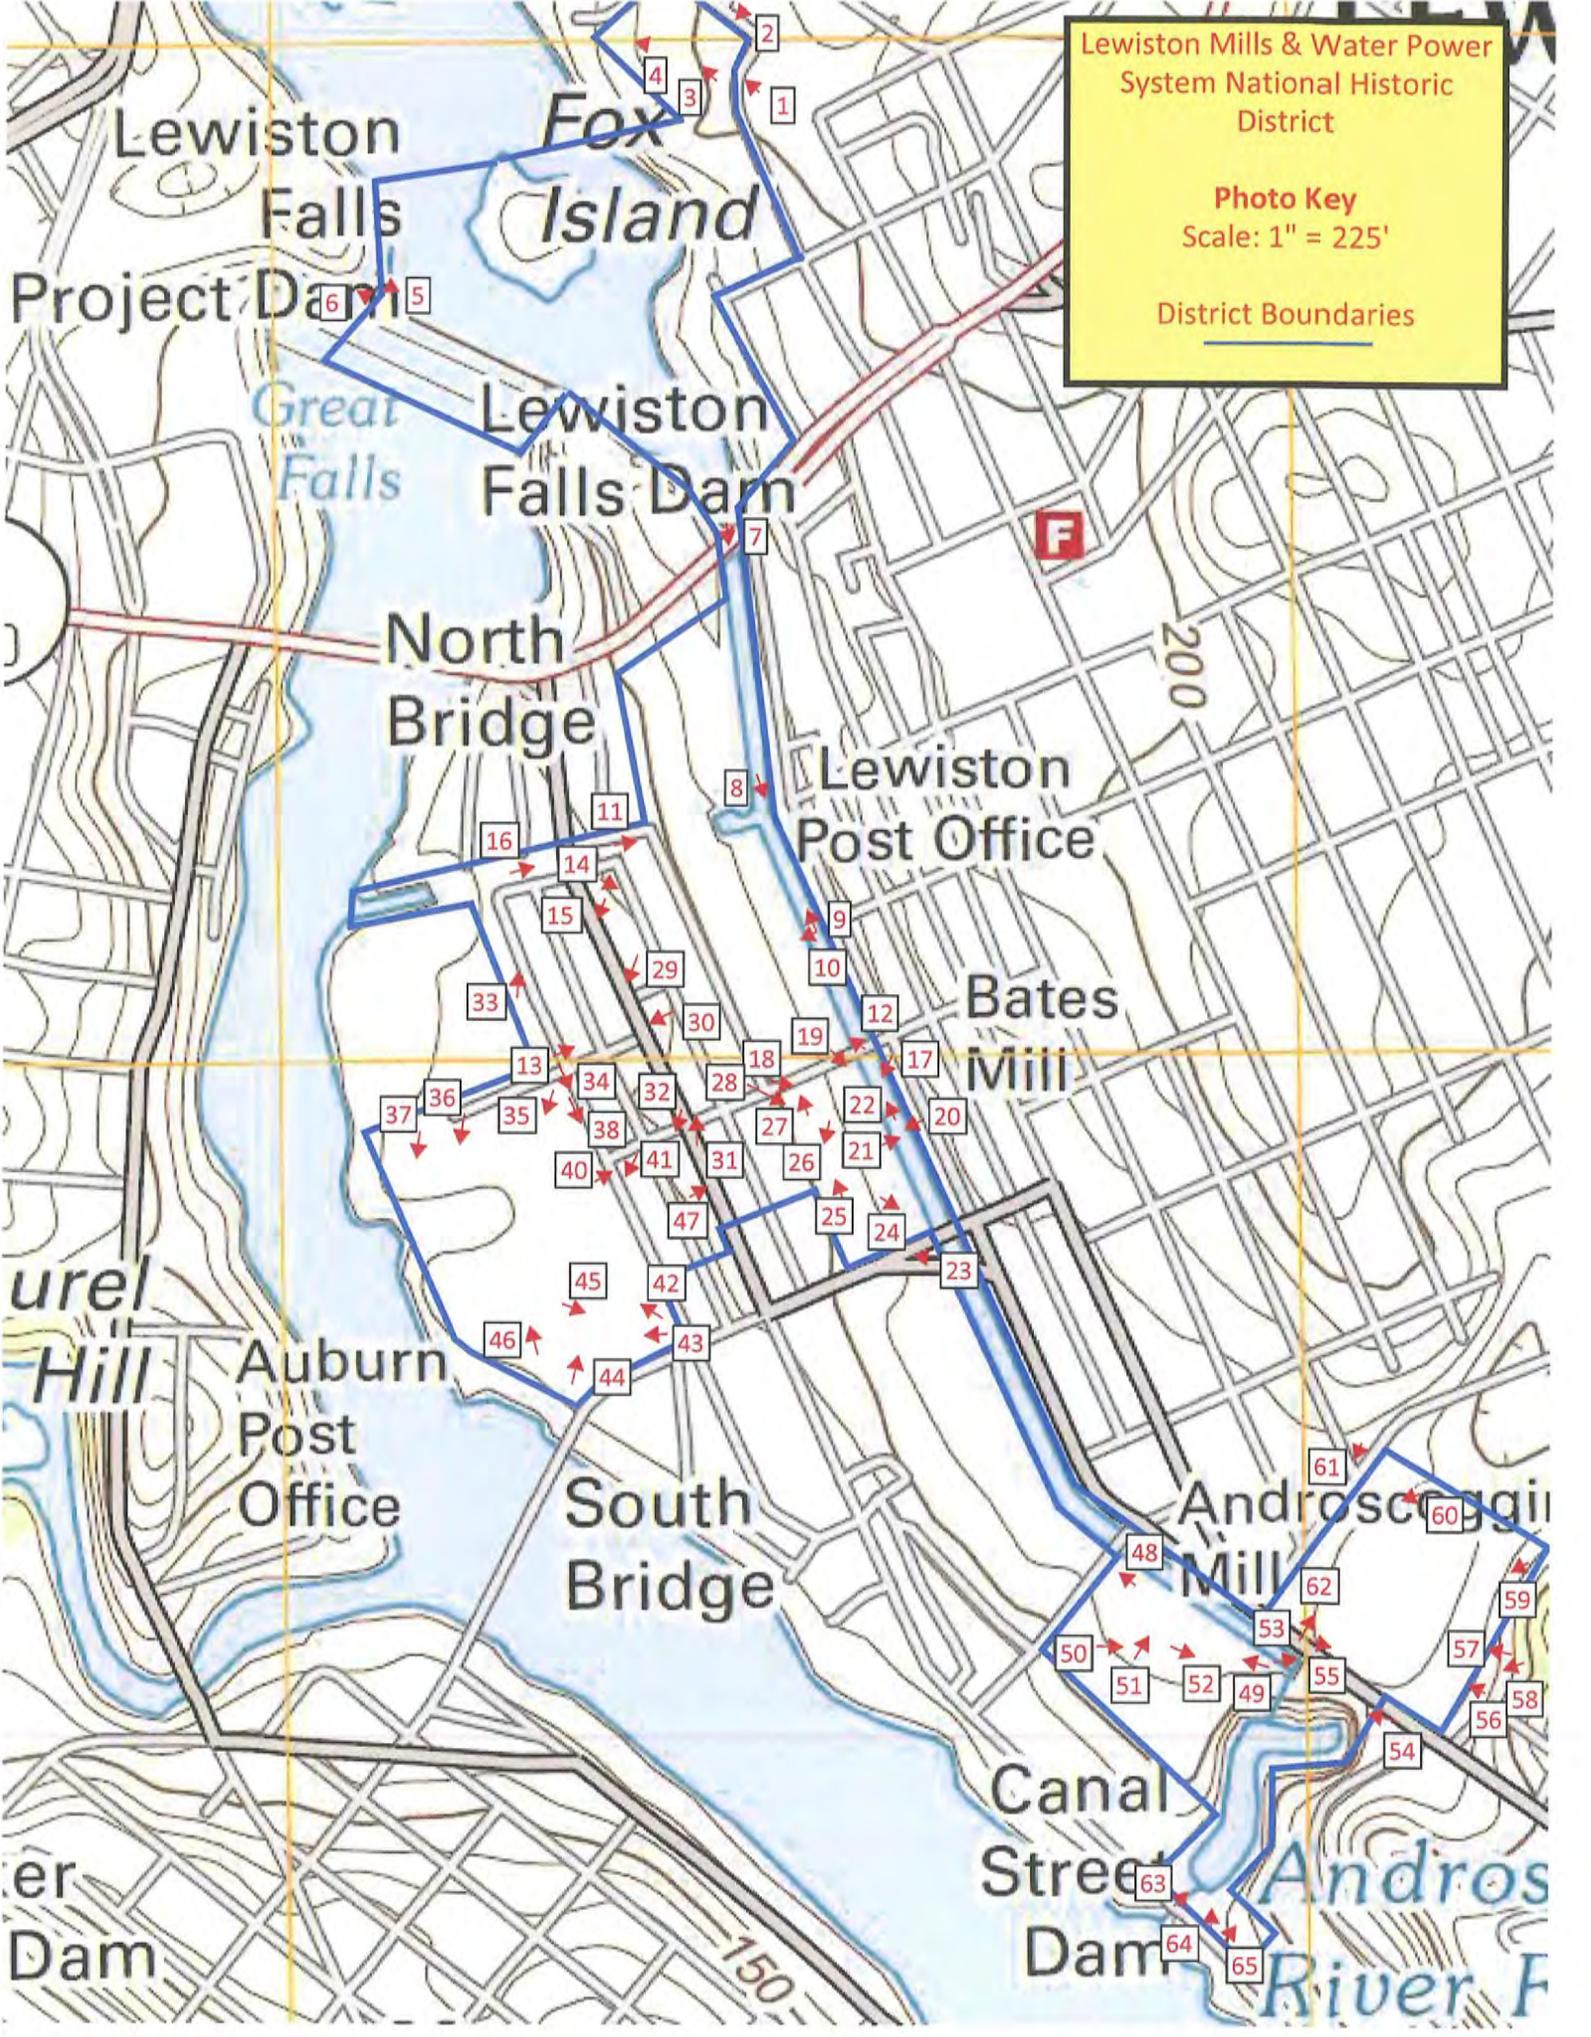
Photo Key
Scale: 1" = 225'

Lewiston Mills & Water Power System National Historic District

District Boundaries
