**The  
Lewiston  
Historic Preservation  
DESIGN MANUAL**

The  
Lewiston  
Historic Preservation  
**DESIGN MANUAL**

**The Historic Preservation Review Board  
City of Lewiston, Maine**

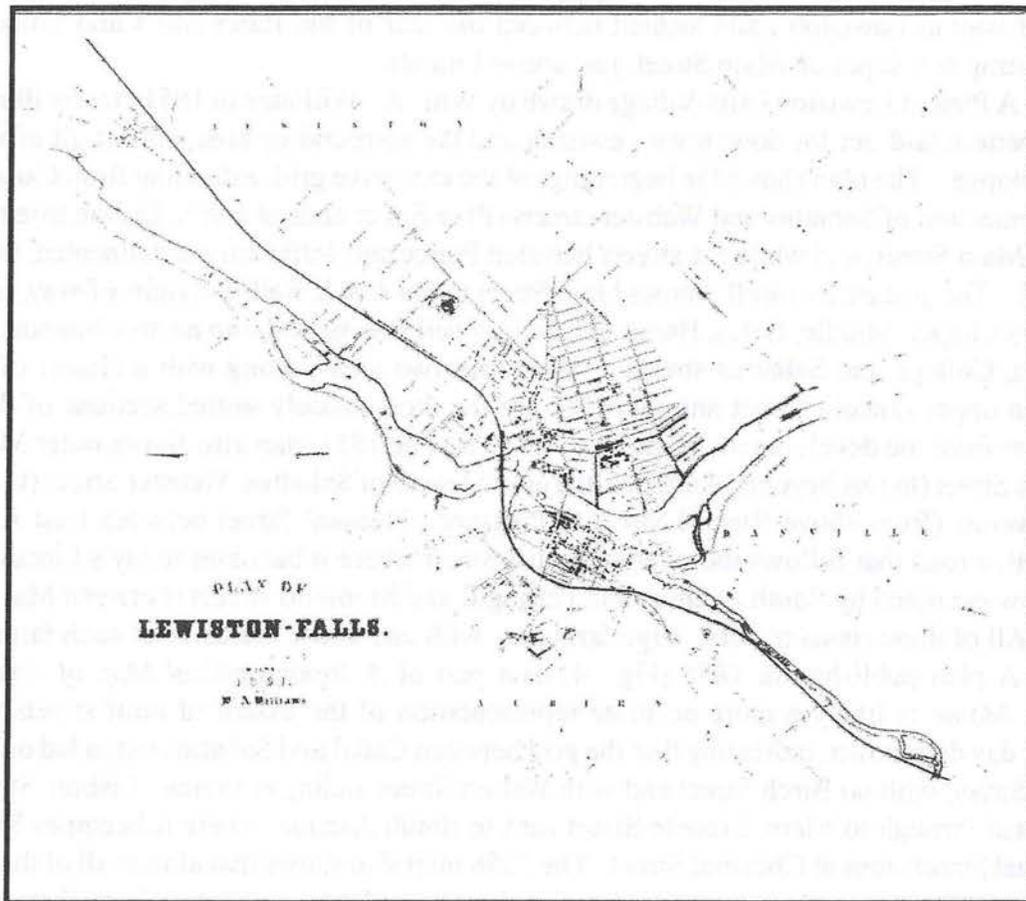
Fig. 3, Plan for the canals and mill sites, 1836

other Land at the Lewiston Falls...” While the plan was never executed, the property owners did incorporate for the purpose of developing the mill sites and building the canals, first as the Lewiston Falls Manufacturing Company in 1834, and in 1836 as the Great Androscoggin Falls Dam, Lock and Canal Company. The Great Androscoggin Company hired a second engineer to prepare a plan for the canals and the mill sites in 1836. This plan (Fig. 3) not only allocates lots for the mills along an extended canal system, it also, for the first time, indicates the grid pattern of streets that eventually dictated the development pattern of downtown Lewiston. Construction on the canals began in 1850, after the Company had been reorganized as the Lewiston Water Power Company in 1845 (later to become the Franklin Water Power Company).

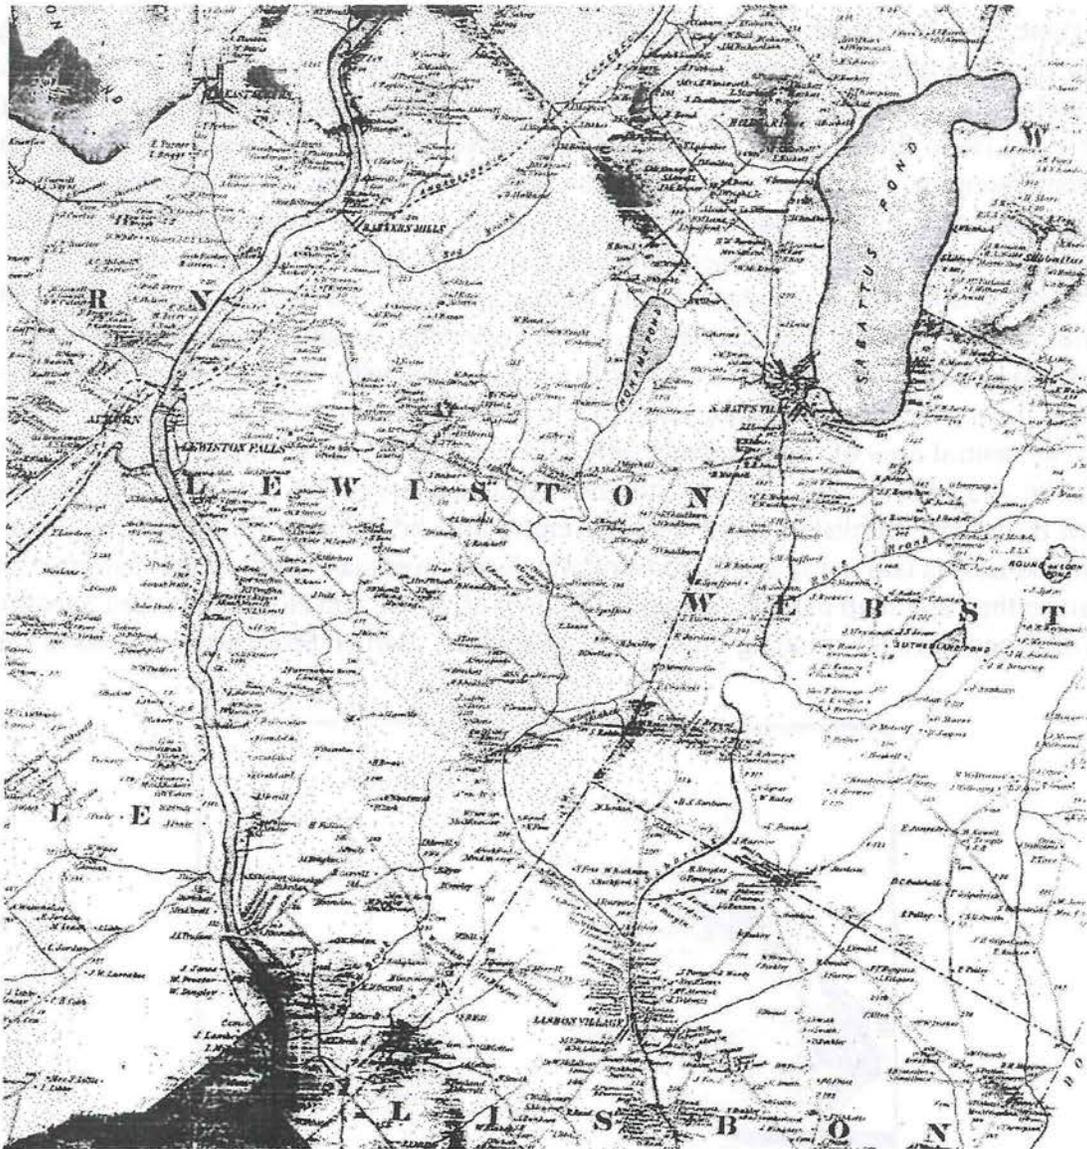
Fig. 4, A Topographical Map of Androskoggin County, 1858

A plan published in 1858 (Fig. 4) as a part of *A Topographical Map of Androscoggin County Maine* is likely a more accurate representation of the extent of built streets within the present day downtown, indicating that the grid between Canal and Sabattus extended only as far as Pierce Street, with no Birch Street and with Walnut Street ending at Pierce. Lisbon Street is now connected through to Main, Lincoln Street runs to South Avenue, where it becomes River Road, but Canal Street stops at Chestnut Street. The 1858 map also shows that almost all of the important outlying roads were in place, and all were dotted with residences indicating large farm lots - River Road, Ferry Road, Cottage, Dyer, Cotton, Montford, Gayton (all west of Lisbon Road) and Lisbon Road, Old Lisbon Road, the entire length of Webster, Crowley, Randall and Grove, Pond, Old Chadborne, Bradbury and No Name Pond Road in the area between Lisbon Road and the Sabattus town line, and the entire length of Montello, Hogan Road, Stetson, Switzerland, Taylor and Merrill Road in the Main-College Street corridor. Significant concentrations of residences are indicated at River and Ferry roads, along Old Lisbon Road, at South Lewiston, adjacent to Sabattus Village, at Lincoln and South Avenue, Pleasant and South, at Taylor and Main and at Barker's Mills. Each of these village like groupings also had a school indicated. The 1858 plan is the first map to document the existence of these roads and small villages, but most of the rural roads were in use before

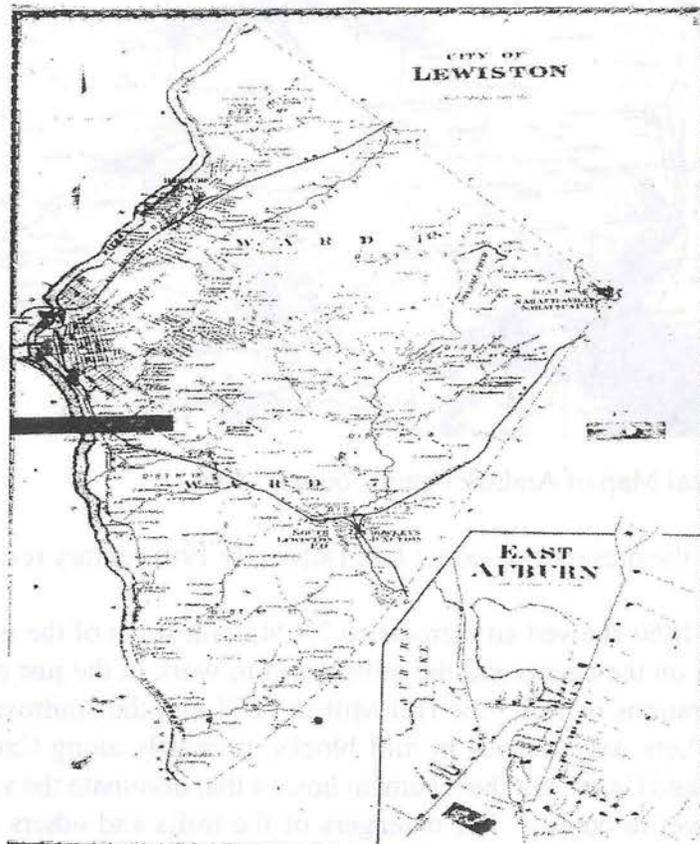
Fig. 5, City of Lewiston, 1871

The central area of the town was fully laid out by 1871, as shown on a map of that date entitled *City of Lewiston* (Fig. 5) (Lewiston had become a city in 1861) as well as in a lithograph *Lewiston & Auburn* published in 1875. The entire area bounded by Lincoln, Avon, Riverside, Campus and East is laid out in a grid, most of which was eventually built in that pattern. Streets added since the 1858 map include sections of Shawmut, Howe and Horton between Sabattus and Pine, with Pine Street now running from Bates to Sabattus. Bartlett Street now connects to Pleasant

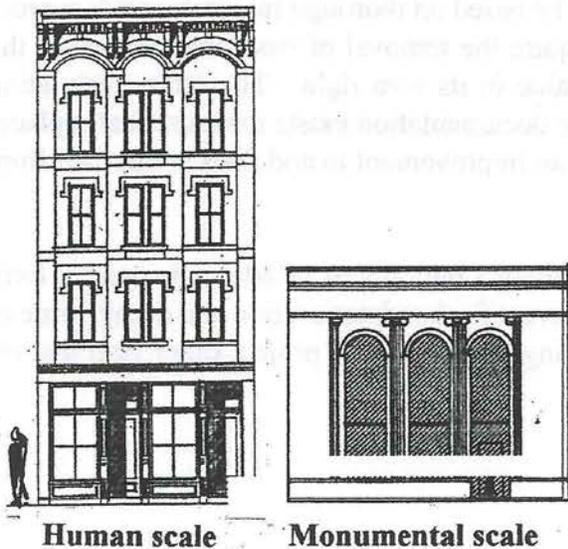
Fig. 7

**Building scale:** the visual appearance of a building or a facade as it relates to the scale of an adult, or the relationship of various architectural components to one another. A standard six foot eight inch tall door is said to be of **human scale**, while a three story portico that overwhelms the size of a pedestrian is said to be of **monumental scale**. (Fig. 7)

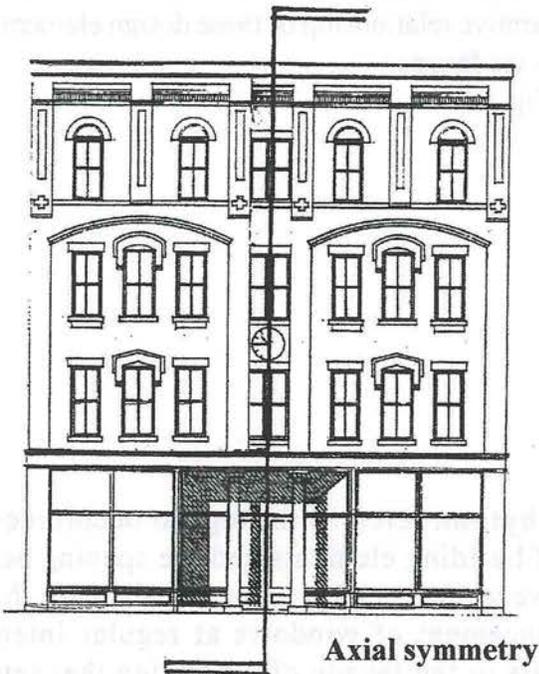
Fig. 12

**Balance and symmetry:** the balance and order of a building facade can be defined by a symmetry of design elements, such as two windows at either side of a centered door (axial symmetry), or through a balance of three dimensional forms (asymmetrical balance). (Fig. 12)

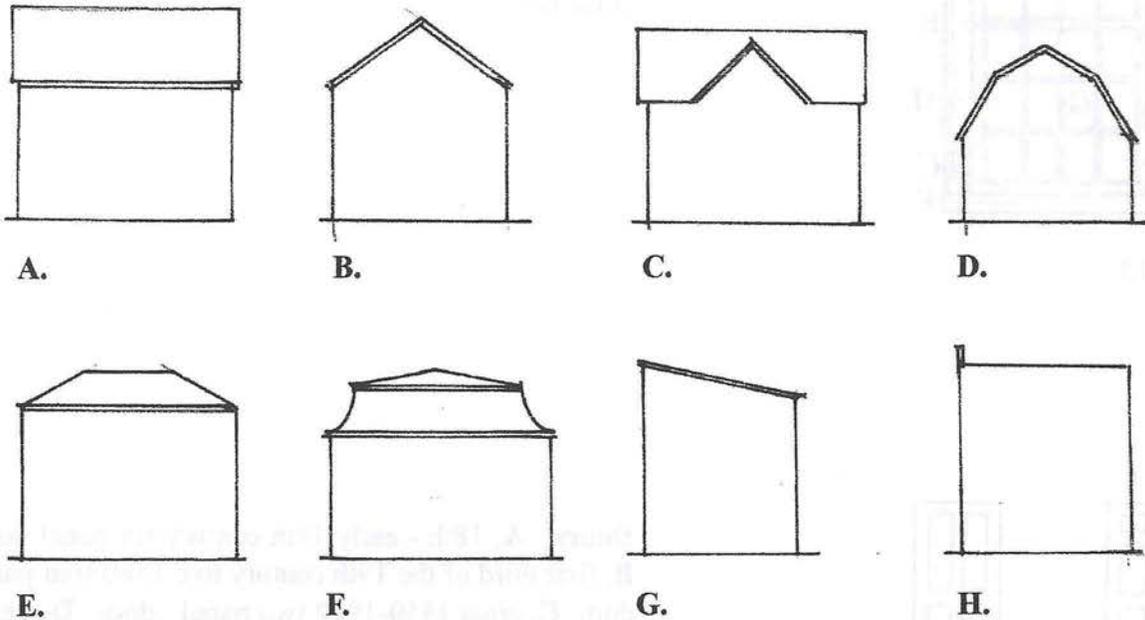
Fig. 13

**Roof forms:** A, end gable, B, front gable, C, cross gable, D, gambrel, E, hipped, F, mansard, G, shed, H, flat or low sloped. (Fig. 13)

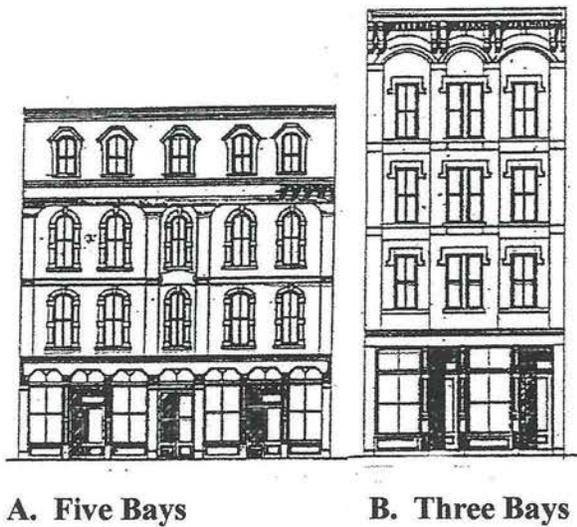
Fig. 14

**Bays:** the number of window and door openings in a facade, usually counted at the ground floor of a residence, at the upper floors of a commercial building that has a storefront. A, five bay facade, B, three bay facade. (Fig 14)

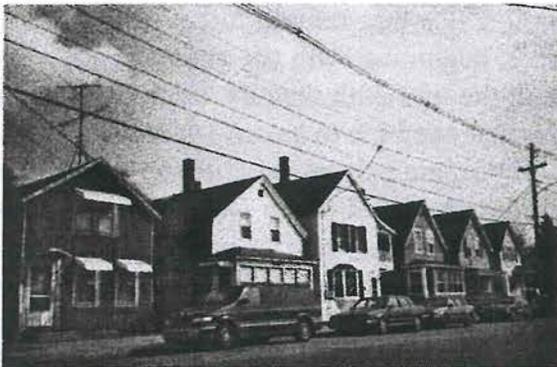
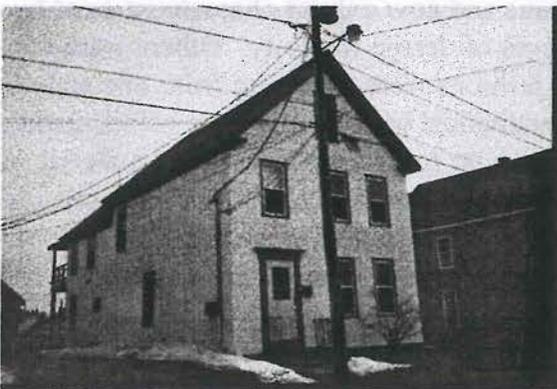
Figs. 18,19

**Vernacular construction, 1795-1950**, is by definition "a mode of building based on regional forms and materials" (Cyril M. Harris, *Historic Architecture Sourcebook*), an indigenous style whose main distinguishing characteristic is that it has no distinguishing characteristics.

Vernacular architecture is the everyday building form used by builders throughout history who were concerned with providing shelter rather than a work of art. Examples in Lewiston include many of the small houses in the Gas Patch section of Lincoln Street, and much of the two to five story tenement houses put up to house the flood of mill workers that came during the third quarter of the 19th century. In some cases, a builder has incorporated a single design element from a style contemporary with his construction, giving rise to the terms Vernacular Greek Revival (which might include a surround and transom at the entrance), or Vernacular Italianate (often with a bracketed hood at the entrance as the only form of embellishment to an otherwise stark facade). Despite the austerity and simplicity of vernacular architecture, it should not be dismissed as a valid style. Vernacular, as the background for the stylistic buildings that surround it, represents the typical building style of a working class community like Lewiston, where as many as half of the buildings built between 1795 and 1950 would likely fall into this category. (Figs. 18,19)

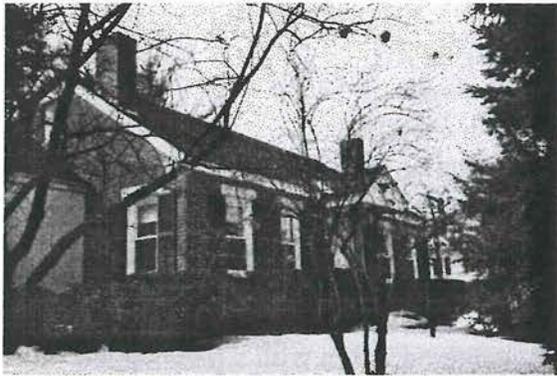
Fig. 20

**Late Georgian Vernacular, 1790-1810**, is a Post-Colonial interpretation of traditional English building forms that persisted after the Revolution throughout much of New England, and in

particular Lewiston between 1795 and 1810. The term Georgian when used as an architectural style, refers to the period beginning in 1735 that ended with the Revolution. The term Late Georgian Vernacular is used here to describe the few buildings constructed in Lewiston before the introduction of the more refined designs of the Federal period that followed. Unfortunately, it appears that no examples of this style remain within the downtown, but a number of excellent residences built in the 1790's exist in surrounding areas, notably at Ferry, Larrabee and Old Greene roads and at upper Main Street in the Barkersville area. Late Georgian Vernacular residences in Lewiston are of two types, the traditional "cape", and the larger houses, often but not always later, most being farmhouses. (Fig. 20)

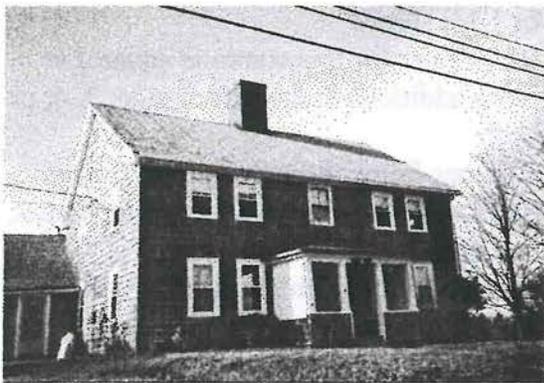
Fig. 21

**Larger houses (Fig 21)**

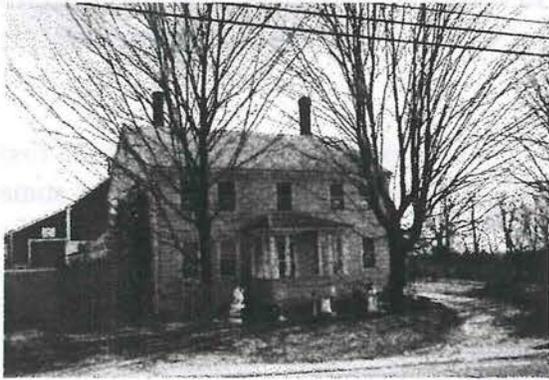
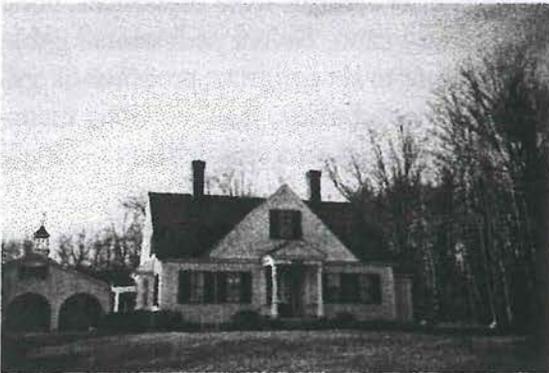
**Federal Style, 1790-1840**, more properly called Adam Style after the Scottish Adam brothers who developed the style and published a handbook of measured drawings based on classical prototypes. Popular in the United States from 1780 through the 1830's, the Federal Style appears in Lewiston during the second decade of the 19th century and continues through 1840.

The Federal Style is somewhat simplified and more refined than the Late Georgian Style that preceded it, the primary distinguishing design element being the elliptical fan light with slender sidelights at the entrance. (Figs. 22, 23)

**Distinguishing features:** key feature is the elliptical or semi-circular fan light over the entrance; all trim light and delicate; thin flat corner and sill boards; deep but lightly decorated cornices and rakes. Tall brick chimneys play important role as a visual element

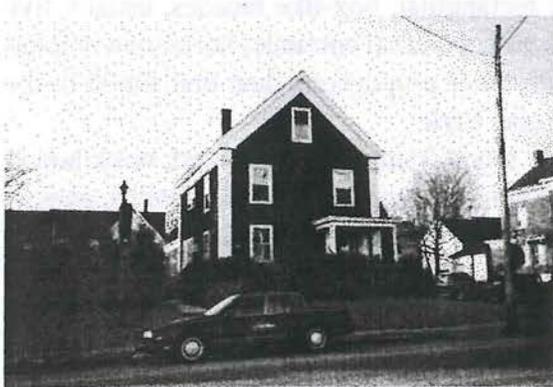
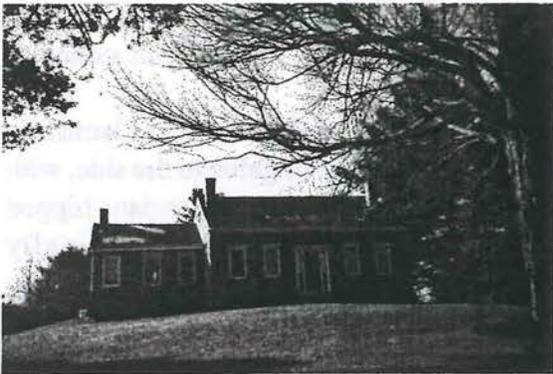
**Greek Revival Style, 1820-1860:** based on publications from the period depicting ancient Greek ruins, and made readily available in this country through the first of the American builder's handbooks, Greek Revival swept through the country during the second quarter of the 19th century, including Maine and Lewiston, where a small number of examples remain. While there are no examples of the classic Greek Temple form in the city, a number of residences and at least one church reflect the building tastes of this period. Greek Revival is a robust style, with heavy detailing and a sense of permanence, especially when compared to the delicate detailing and proportions of the preceding Federal Style (Figs. 24-25).

**Distinguishing features:** key feature is that round or segmental arches (invented later by the Romans) were never used in Greek Revival buildings; molding profiles are based on an ellipse (flatter) rather than the circle used during the Late Georgian and Federal periods; frame buildings were invariably painted white; wide corner boards now treated as pilasters, with capitals at eaves; deep sill boards, heavy rake boards; cornice may incorporate Greek frets, running key pattern, or dentils

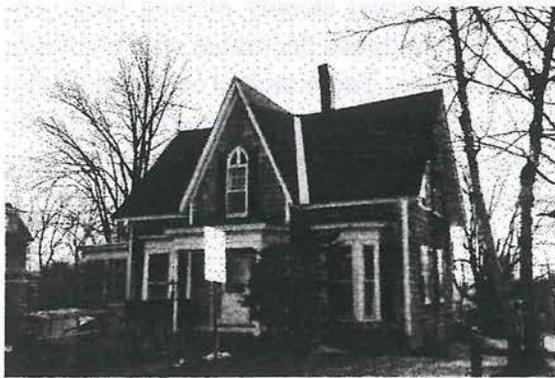
Fig. 26

**Early Gothic Revival, 1830-1860:** the first of the picturesque styles to appear in the United States, residential Gothic Revival was popularized by the writings of Andrew Jackson Downing and others as the “proper rural residence.” Along with the Italian Villa and Romanesque styles, Gothic Revival is generally classified as Early Victorian. (Figs. 26, 27)

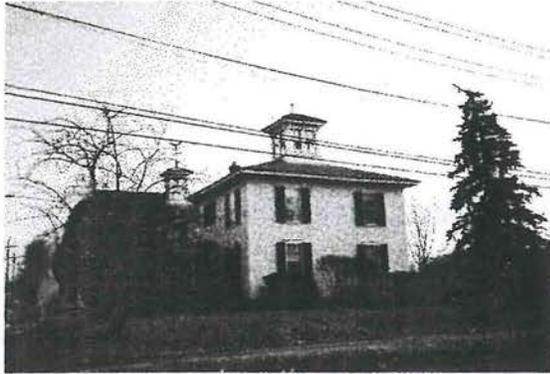
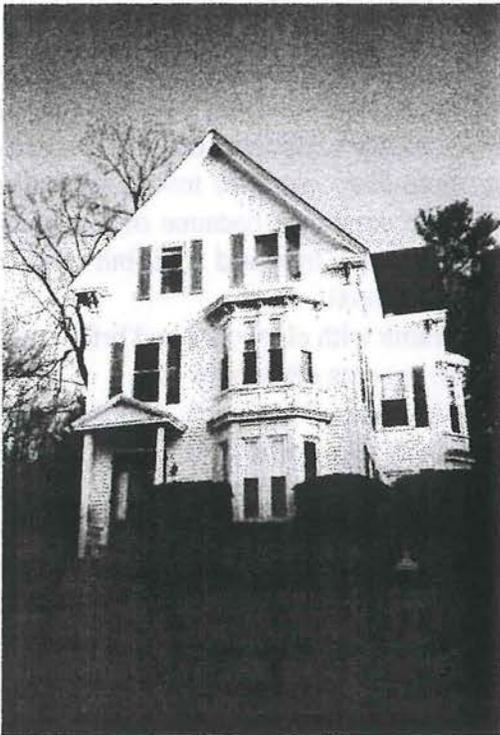
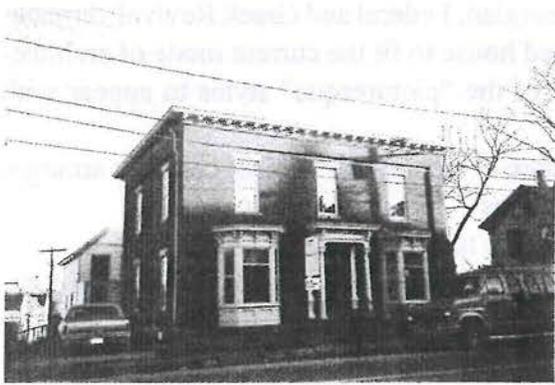
**Victorian Italianate, 1860-1890**, sometimes referred to as the “bracketed style,” draws its inspiration from the farmhouses and villas of Northern Italy. Entire neighborhoods, made possible by the opening of many new streets close to yet removed from the mills and the Lisbon Street retail district, provided the emerging upper middle class with the opportunity to build their own home on a spacious lot away from their place of business. Many such residences, especially in the area north of Sabattus Street, were built in the Italianate Style. In addition to the residences originally constructed in the Italianate Style, mass produced building components, such as the ever present roof

brackets or bay windows, were often applied to Late Georgian, Federal and Greek Revival vernacular structures, thereby "modernizing" an undistinguished house to fit the current mode of architectural detailing. The Italianate Style is one of the first of the "picturesque" styles to appear with great frequency in Lewiston. (Figs. 28 - 30)

**Distinguishing features:** key to Italianate is the use of brackets at every conceivable opportunity; towers and porticos common in other than Italianate farmhouse type; heavy moldings, well detailed window and door surrounds; bracketed hood at entrances

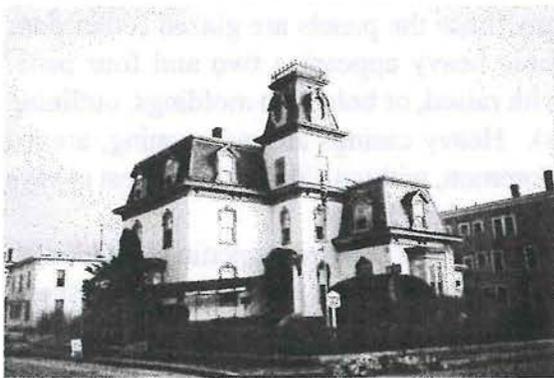
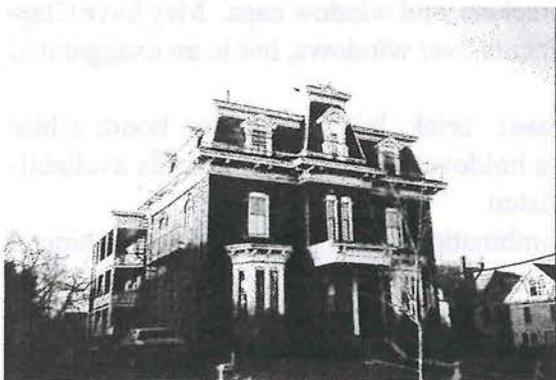
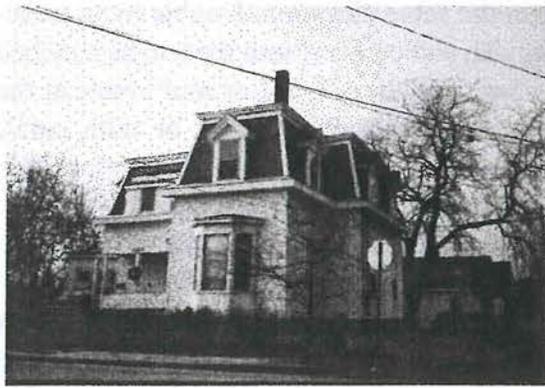
**Second Empire Style, 1860's-1880**, often called the Mansard Style because of its distinctive roof form, the Second Empire Style flourished alongside the Italianate in Lewiston. Basically Italianate in form and detailing, the double-pitched roof is often the only feature that separates the two styles, and like elements of the Italianate Style, mansard roofs were often added to existing buildings, not only increasing the head room in an earlier attic, but introducing a new outline to the skyline of residential neighborhoods. (Figs. 31 - 33)

**Foundations:** brick laid in common bond  
**Roofs:** double-pitched, with almost perpendicular sides tapering to a low pitched hip roof; always has dormers, with richly detailed windows and caps. Towers, if any, repeat mansard roof form, which may be bell-cast at lower edge. Cornices always pronounced, with deep eaves below a curb, the eaves decorated with sawn brackets in pairs set into a deep frieze. May have cast iron cresting, pinnacles and other decorative features aimed at drawing attention to the roof. Originally had slate tiles, may now be covered with wood or asphalt shingles

**Distinguishing features:** mansard roof is the obvious key; heavy Classical profile moldings, more ornate than that of the Italianate

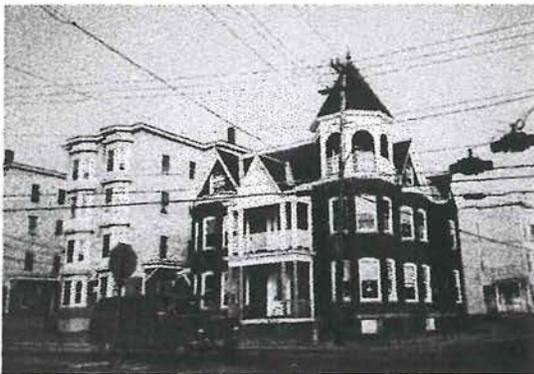
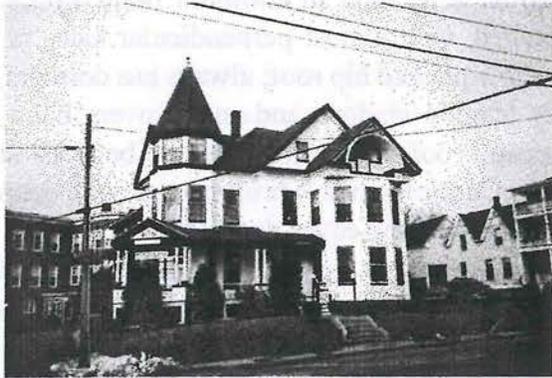
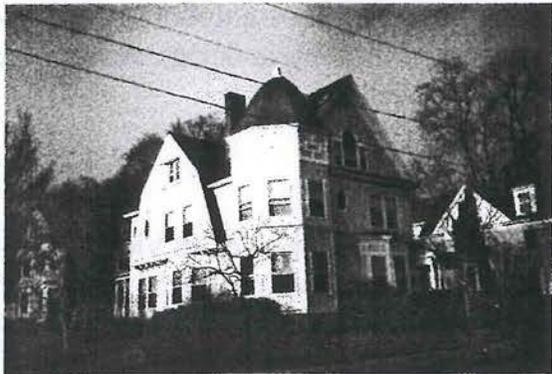
**Queen Anne Style, 1870-1900**, epitomizes the “picturesque” qualities of all Victorian period architecture. Lewiston is fortunate to have numerous examples of rare quality of this highly visible style. The term Queen Anne is a misnomer, as the results have little to do with the buildings put up in the 18th century during the time of the queen. If anything, the style is more reminiscent of medieval or Elizabethan English residential design. (Figs. 34 - 36)

**Distinguishing features:** irregular massing; long sweeping porches; overhanging gable ends at upper level; texture created through the use of a variety of materials and colors; carved and turned brackets, spindle work; elaborate hardware; combination of window types and shapes, including stained glass

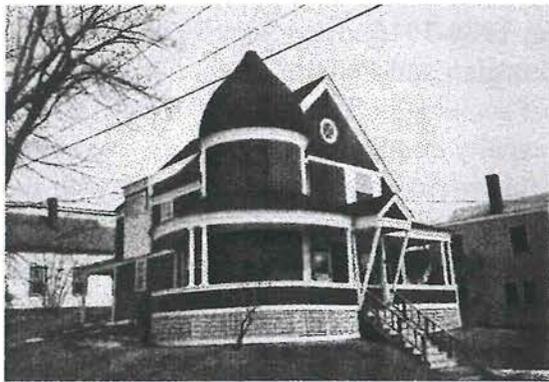
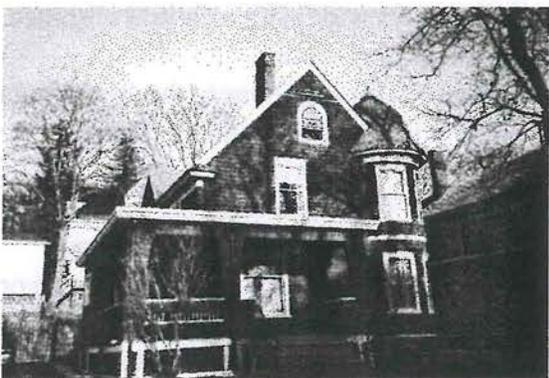
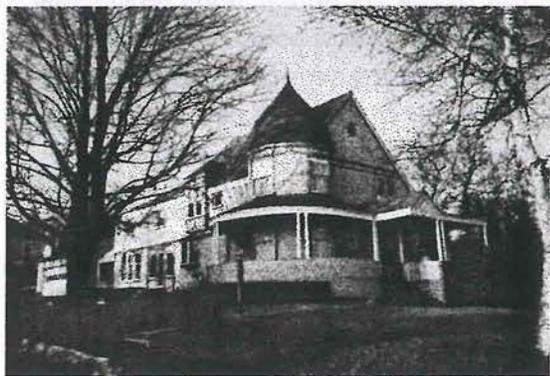
Figs. 37 - 39)

**Massing:** “summer cottages” usually a simple combination of a number of three dimensional forms under a series of low pitched roofs that give the building a distinct horizontal emphasis: in the “urban” form as found in Lewiston, a combination of irregular volumes, often with wide, sweeping porches, turrets and round towers; set on low foundations, close to the ground

**Distinguishing features:** wood shingles applied with out sill boards or corner boards. Long sweeping roofs on examples without towers. Scale of applied detail is larger than original Late Georgian or Federal antecedents; in the Lewiston examples especially, massing is usually very complicated

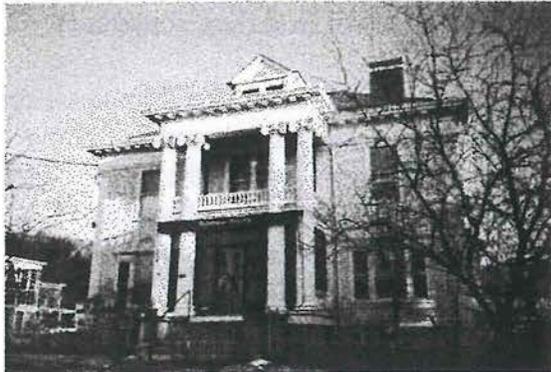
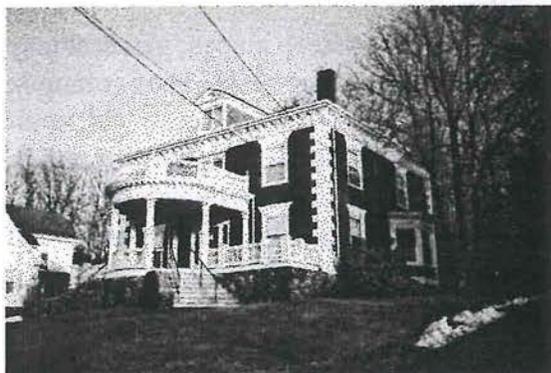
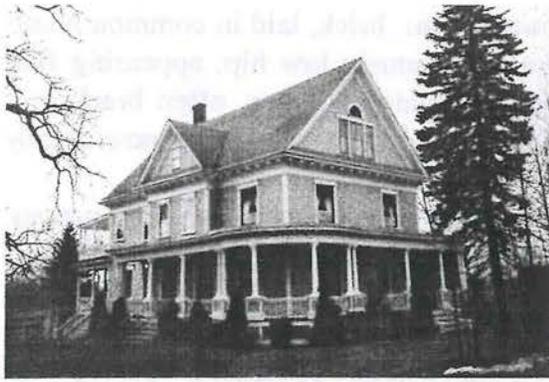
**Early Classical and Colonial Revival Styles, 1900-1915**, draw heavily on the massing, planning and decorations found in the earlier Georgian and Federal Styles. In Lewiston, the difference between the two styles is largely one of scale and affluence, with the Classical Revival examples larger, taller and more grandiose, usually employing a two-story, columned portico as its frontispiece. The Colonial Revival of this period, not to be confused with the plethora of "Williamsburg" inspired small residence constructed between the two World Wars, is based on true examples of earlier period residences. In both styles the result was a series of important refined and dignified residential buildings

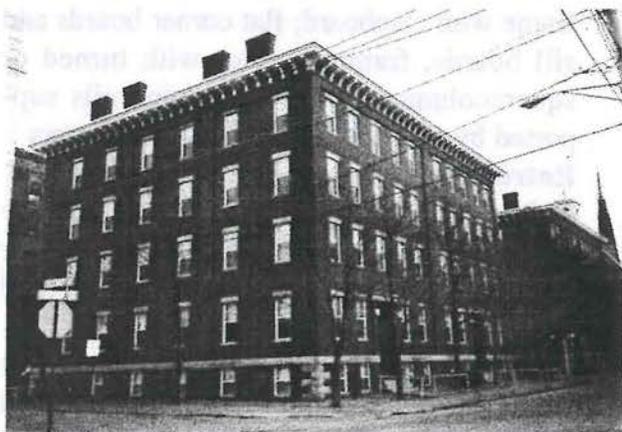
Fig. 43

**Mill Housing and Tenements, 1850-1900**, either constructed and managed by the various mills (called Blocks by the newly arrived French Canadians) or built by private developers as rental properties, this form of housing is the most visible of all residential construction in Lewiston. Mill blocks contained as few as four apartments for individual families (Androscoggin Mill Blocks on Park Street) or up to twenty or more rooms with a common dining room like the recently demolished Bates Mill Blocks on Canal Street. The Continental Mill Blocks on Oxford Street were the largest of the mill supervised residences serving individual employees. Tenement houses, including but not limited to Little Canada, contained as many as twelve apartments. Figs. 43 - 46)

**Plan:** tightly laid out apartments or individual rooms linked by a central hall

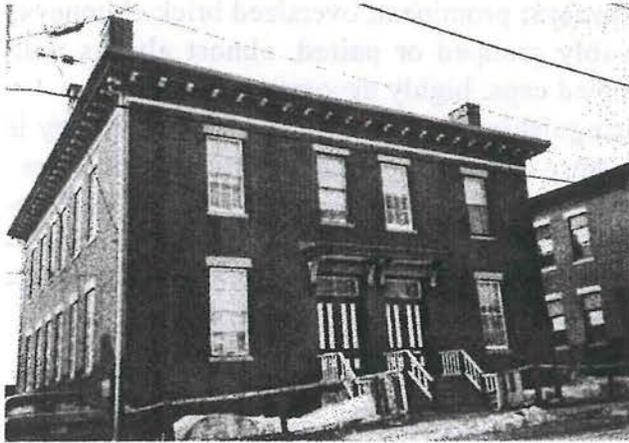
Fig. 44

**Foundation:** brick, laid in common bond  
**Roof:** extremely low hip, appearing flat; deep overhanging eaves, often bracketed; originally had sheet metal roofs, now usually built-up tar and gravel

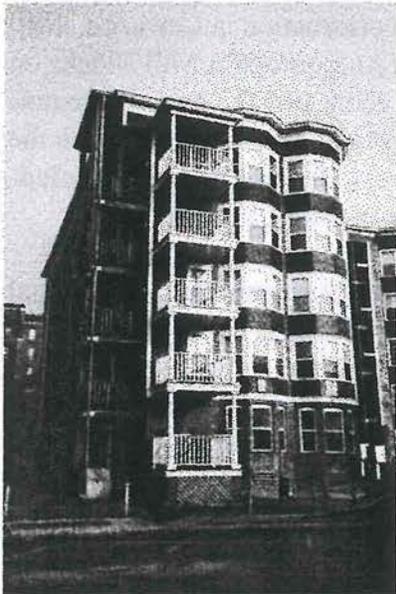
Fig. 45

**Plan:** footprint is rectangular, with apartments arranged off transverse central hall, or occasionally, off full depth side hall; compact planning to fully utilize rental space

**Roof:** flat with moderately overhanging eaves, many of which have brackets and a deep frieze panel as a cornice; built-up roofing

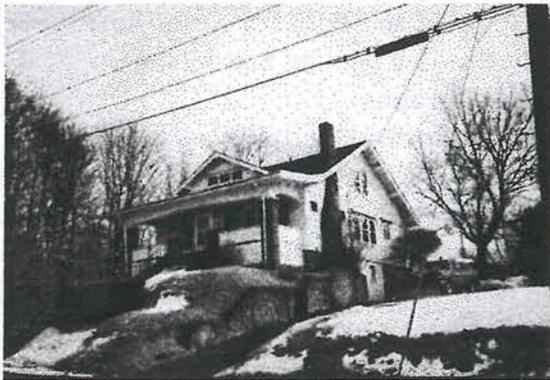
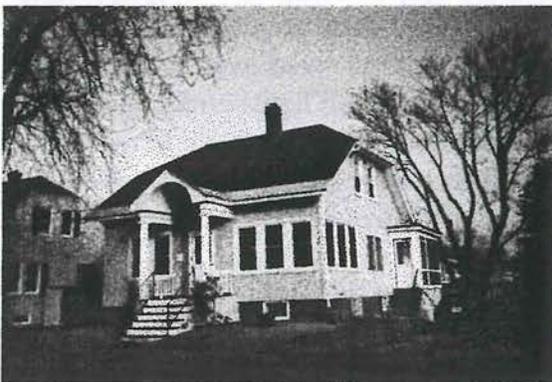
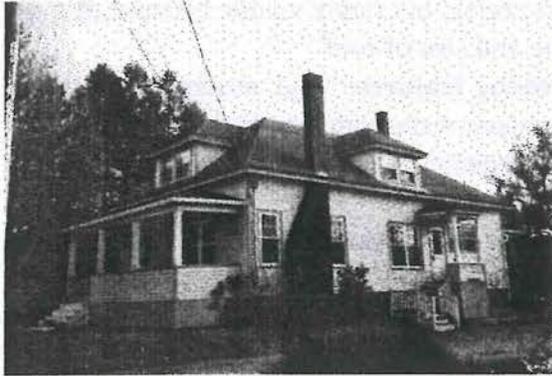
**Other Twentieth century Residential Styles, 1900-1950,** represented in Lewiston by more than one or two isolated examples include the Bungalow, American Foursquare, Dutch Colonial, English Tudor Revival, English Cottage and the Moderne styles. Most, if not all, of the examples were derived from builder's plan books and magazines, many employed mass produced, stock building materials, and virtually all are of small scale and situated on a separate suburban lot outside of the downtown area. (Figs. 47-49)

**Plan:** compact square or rectangular plan with a full width front porch enclosed by the front plane of the roof. May have a small rear ell or bay windows along side walls, but hardly ever has wings

**Massing:** box-like, self contained composition; horizontal facade emphasis caused by low overhanging roof. Roof supported by heavy posts at edge of porch. Porch often at least partially enclosed

**Roof:** low sweeping, double-pitch gable; hip; gambrel; almost always with dormers (often with a full width shed dormer at rear); wide overhanging eaves, sometimes with rafter ends exposed

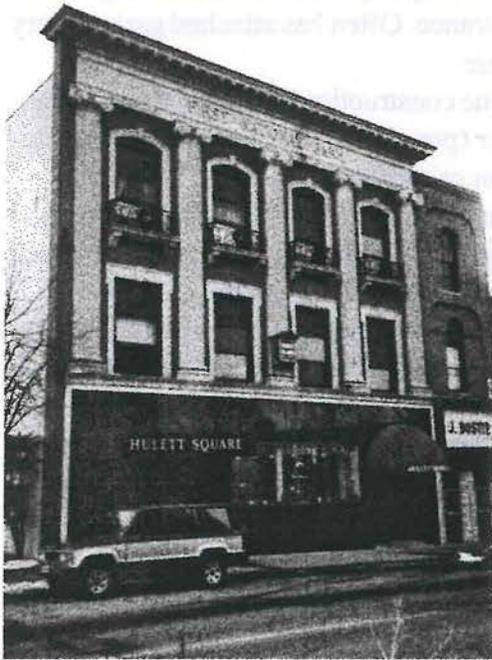
Fig. 58

**Commercial buildings:** (Fig. 58) generally gable roof facing the street, with or without a full pediments. Larger buildings have flat roofs with overhanging cornice. First floor store fronts at brick structures usually defined by granite piers and capitals supporting a granite. Full width window lintels, with facade divided into three to five bays with a slightly recessed entrance bay. Storefronts at frame examples usually are enclosed with wide wooden pilasters, sometimes with cast iron capitals but more often with wood trim; (cast iron pilasters and lintels came very late in this period, are extremely rare and must be protected when found). Windows follow residential examples, doors often a glazed panel. Key in Lewiston is a flat granite lintel over windows in brick examples, as no typical columned temple form commercial structures exist. Simple, bold detail.

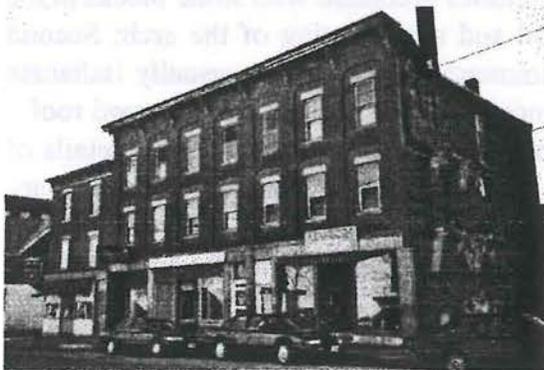
Fig. 61

**Commercial structures** (Figs. 61, 62) are often three bays wide, three to four stories tall, and grouped as units in a row. Keys are a heavily bracketed cornice hiding a shallow shed roof, the use of dark red pressed brick laid in common bond, often with projecting belt courses defining each floor level, brick arched window openings with 2/2 sash. broad expanses of plate glass as shopfront, with wood, cast iron or granite posts and lintels, the posts describing a three bay unit rather than each bay as found in the earlier Greek Revival. Transitional Greek Revival/Italianate examples, which abound on Lisbon Street, carry over the flat granite lintel at upper floor window openings; plate glass windows have narrow frames either of wood or metal, with full width fixed transoms above and a paneled base below; cast iron entire shopfronts were introduced during this period

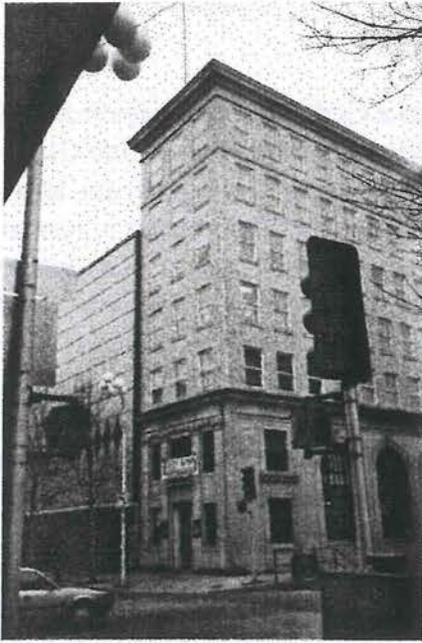
Fig. 76

are of steel frame construction sheathed in stone or brick; varying in height from four to seven stories. They are invariably flat roofed and, depending on the time of construction, may have an ornate cornice in a Classical order, or as in post 1930 versions, be with-

out a cornice. The earlier Commercial Style buildings may have a one or two story Classically detailed, ashlar stone base, with normal sized windows at each level, or in some cases, with full height round arched openings. Windows in the base have elaborate hoods, pedimented or with a molded cap. Windows at the upper floors of the earlier models, and at all windows in the later variety, are rectangular, usually with 1/1 double hung metal sash or metal casements, all without any window frame or casing. Earlier examples may have a single horizontal belt course below the top floor, and the facades of later buildings are often divided by full height pilaster-like vertical wall sections, but all are otherwise undecorated and stark in appearance. Entrances are usually recessed and have double doors of glass set in metal frames

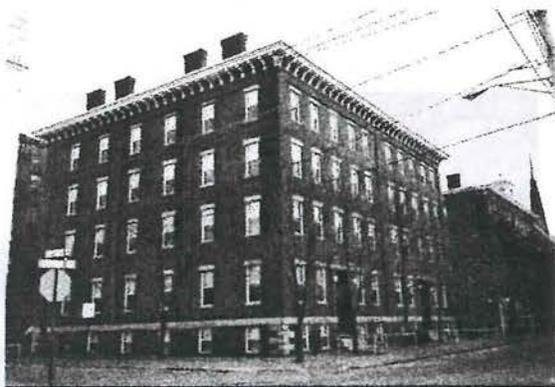
Fig. 77

The Continental Mill blocks along Oxford Street were rehabilitated to provide new apartment space in this somewhat neglected section of the downtown. The rehabilitation had minimal impact on the original buildings (a change in the entrances, the construction of an exceptional system of fire escapes at the rear). The two structures appear much as they would have when they were erected. (Fig. 77)

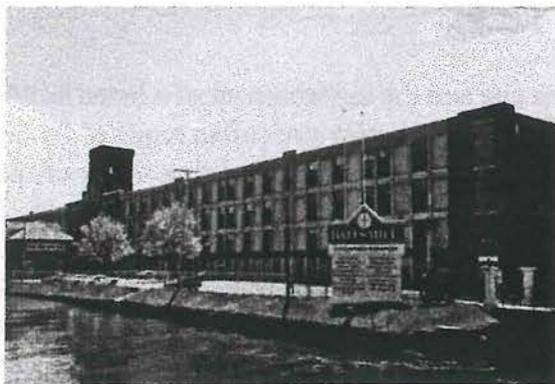
Fig. 78

The Bates Mill complex, with its variety of uses, (many of which are unrelated to the actual mill buildings and its water power), retains its original identity, an obvious and clear statement that the building was originally a cotton mill. (Fig. 78)

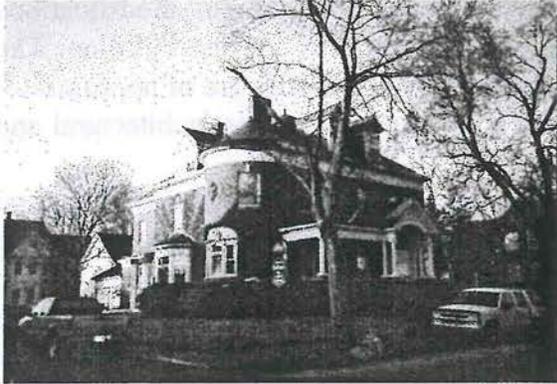
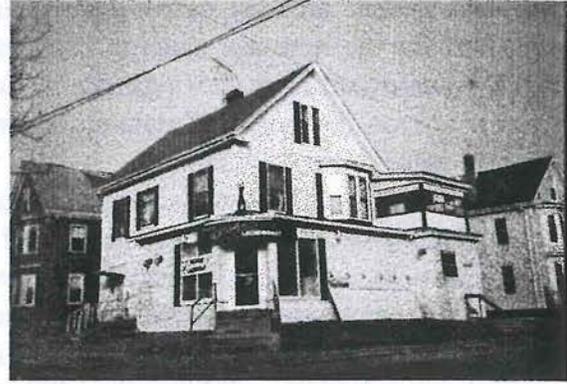
Some reuses are natural for a specific building, others are not. The Clifford House, Main Street, has been very well converted to use as offices, while the appearance of this residence has suffered dramatically with the addition of a commercial store front. (Figs. 79-80)

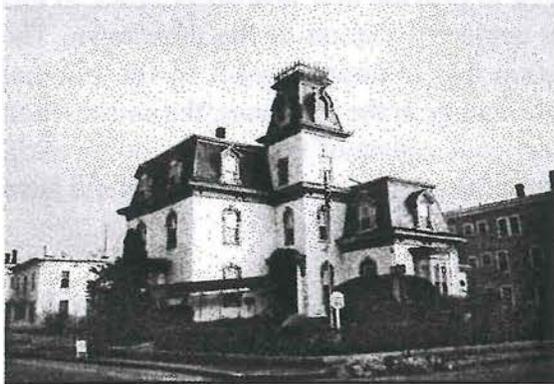
Fig. 81

In some cases, the reuse may not be the culprit, the planning and design is. In these two funeral homes, with basically the same space requirements for each, the old Dr. Milton Wedgewood house at Pine and Pierce streets, retains its integrity, while the addition at the Fortin Funeral Home was less successful. (Figs. 81-82)

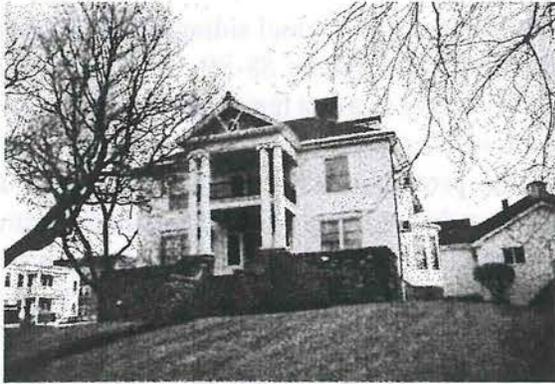
Fig. 83

Standard 1 is also concerned with changes to the site and the environment of a listed building, especially changes that may take place to provide parking for a new use (often required by the city's zoning code). The consequent loss of large landscaped open lawns fronting many of the original homes of the well-to-do, especially along Main Street near Frye Street, lessens the visual impact of the particular residence and the economically important role that the owner played in the development of the city. The structure at 253 Pine Street, originally a residence, then the home of Bliss Business College, and finally a funeral home, has retained its spacious, well planted front lawn through all the changes in use. The Joseph Gray House, Main and Frye streets, however, has paved all of the open courtyard that fronted the building. Given the office nature of this building, the need for off-street parking is recognized. While no other alternative site was available near the offices, landscaping the remaining area of the paved parking lot, and especially the planting of a dense hedge that would screen everything except the driveway, should have been considered to complement this exemplary rehabilitation project. (Figs. 83-84)

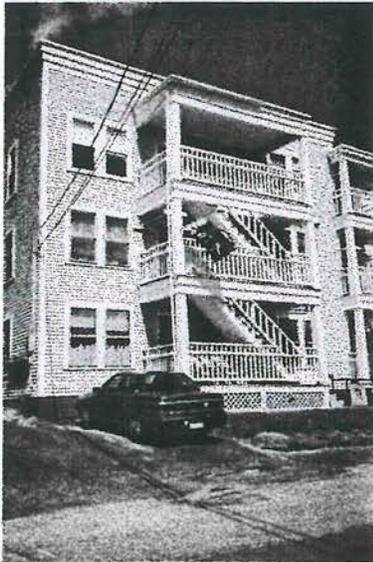
Fig. 85

The reuse of a residence as apartments, which in most cases will mandate fire escapes at all occupied floors, can indirectly create visual chaos that detracts from the character of a building (Figs. 85-86). An easy solution, where space permits, is to continue the tradition established by the builders of the mill tenement house, where the rear is used not only as a porch, but includes the fire escapes (Fig.87).

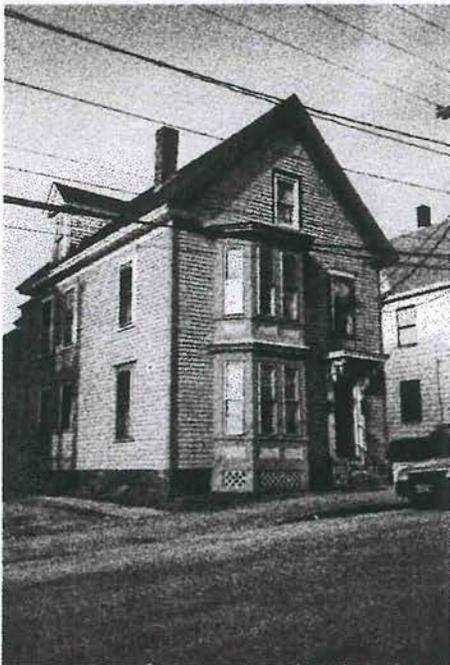
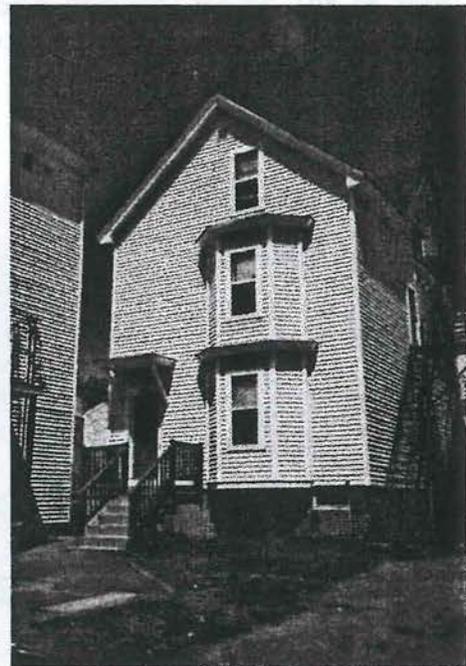
One of the more common alterations is the replacement of the original siding material with a substitute material (aluminum or vinyl siding) as illustrated in Figures 88-89. Removal and replacement of the existing siding material should be allowed only as a last recourse, and then only if the siding is damaged or deteriorated beyond restoration. Replacing traditional clapboards or shingles with vinyl or aluminum siding does not treat the problems that caused the decay and deterioration. The same problems are likely to reoccur once the wall has been encapsulated with a non-breathing material, one that can be permanently dented or scratched and cannot be painted without incurring the same paint failure problems associated with wood siding. However, it should be recognized that the new siding material may not be, in many instances, the major problem. If properly applied, including the retention of all window and door trim, projecting bay window units and door hoods, corner boards, and cornices, and repeating the exposure of the synthetic material to match the exposure of the original material (ie: 3 1/2" wide clapboards), it may be possible to retain most of the character of a listed building as a compromise solution to this pervasive problem.

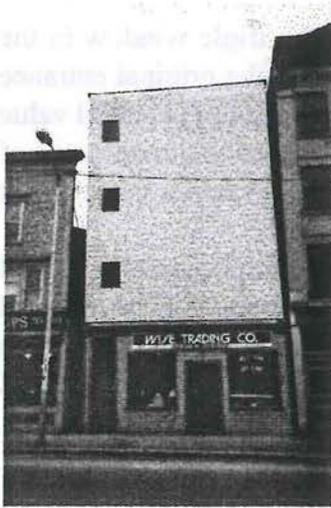
Fig. 90

The application of aluminum or vinyl siding that totally obscures the original facade of a period building, such as that at the Wise Trading Company (Fig. 90), the installation of a porcelain panel curtain wall (Fig. 91), or the screening of an original facade with a glass wall (Fig. 92), where the original facade is hidden behind the glass should be avoided, since in almost every case, the original facade can be restored.

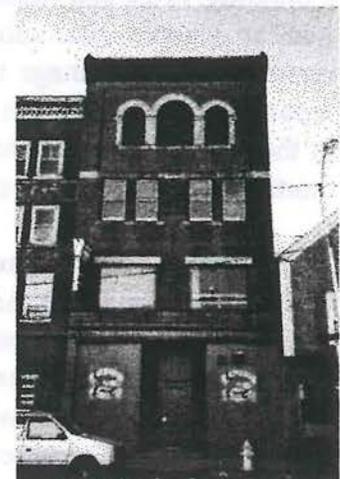
Fig. 95

replacement of the original 2/2 sash at the third floor, the in-filling of the triple window in the fourth floor, and the total obliteration of the ground floor facade, including the original entrance (Fig. 95). The total effect of these incremental changes drastically reduces the architectural value of this National Register Historic District listed building, and is illustrative of the importance of considering each and every change proposed at a listed building, no matter how minor it appears at first reading.

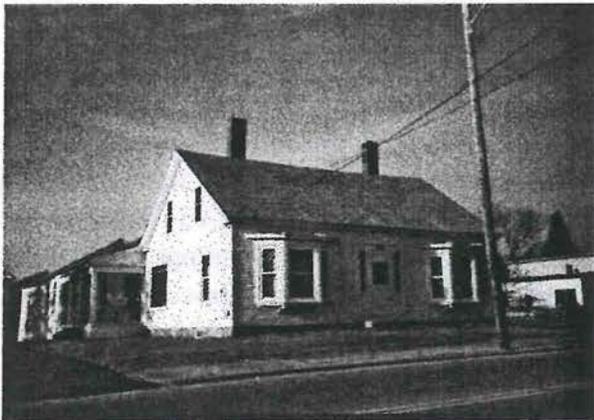
Fig. 96

The addition of Italianate period bay window units at a late eighteenth century Federal period cottage destroys the character of the building (Fig 96), as does the removal of the original entrance at a Greek Revival cape and its replacement with a large picture window (Fig. 97). Both "improvements" should be avoided in the future, as the alterations to each of these important residences lessens the architectural value and the visual impact of the properties.

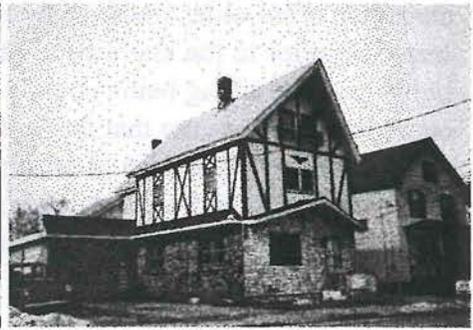
Fig. 104

Standard 3 is concerned with the authenticity of new work that may be proposed as part of a rehabilitation project. Conjectural designs that make a building appear older than it really is, or attempt to imitate features that never existed but would change the character of its original architectural style to another style should be prohibited. Such changes can be as localized as false muntins in a shop window or an entrance door modeled after an early period design, as shown below (Fig. 102-103), or can include the total alteration of a building to a style that never existed in Lewiston, like the "Swiss Chalet." (Fig 104).

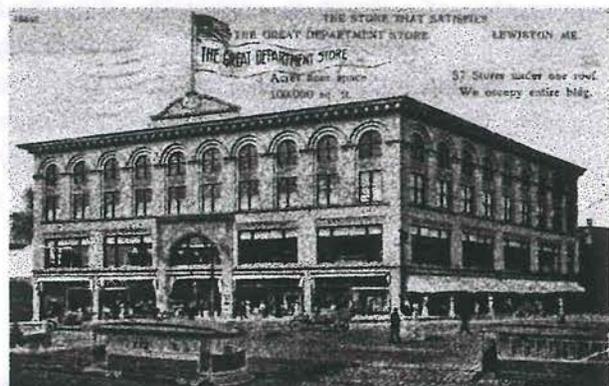
Fig. 111

At first glance, the 1930’s redesign of the 1898 former B. Peck Store at the head of Lisbon Street (Fig. 110) appears to be an innocuous pre-war modernization of what was at one time the largest department store in the state. When compared to early postcards and photographs (Fig. 111), however, the removal of the first floor and the roof cornice, as well as the alteration of the sash at all levels, denudes the facade of its prior visual importance. The removal of the two cornices completely alters the scale and facade emphasis of the structure, from what was a horizontal, finely detailed building to a stark non-directional block.
