**The  
Lewiston  
Historic Preservation  
DESIGN MANUAL**

The  
Lewiston  
Historic Preservation  
**DESIGN MANUAL**

**The Historic Preservation Review Board  
City of Lewiston, Maine**

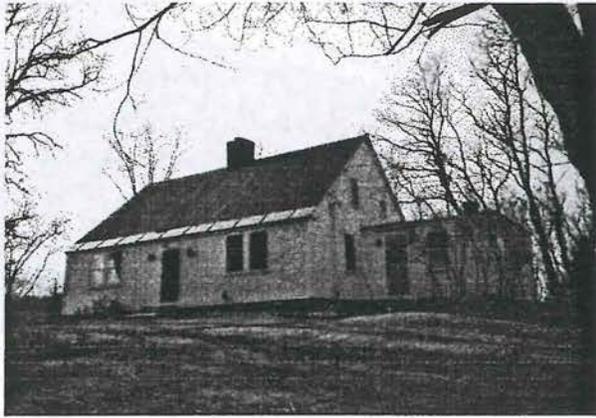
Fig. 112

Two of the more important features that can define a specific architectural style are windows, including the placement within a wall and the sash layout, and entrances. The one-story center chimney cape shown in Figure 112 has been inappropriately altered by pairing the two windows at either side of the central entrance, a design device that was not possible until mid-nineteenth century balloon framing became common. The windows should have remained separated, forming the traditional five-bay cape so common in Maine. The excellent Colonial Revival

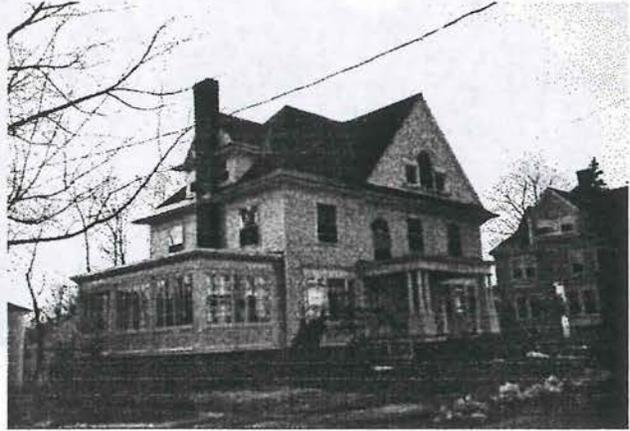
Fig. 113

residence shown in as Figure 113 illustrates a careful and respectful restoration, one that retained all the various sash patterns. Windows at the Old Kora Temple (Fig. 114) have had the sash and the casings in the third and attic levels removed, and have been blocked-in with plywood panels, affecting the visual appearance of this once excellent building. The Italianate residence shown in Figure 115, despite the careful attention paid to the rehabilitation of the two-story bay window unit and the roof brackets, has been compromised by the nondescript entrance hood supported by square posts. Literally hundreds of examples of entrances of this period and degree of detailing remain throughout the city, providing ample opportunity for design analysis.

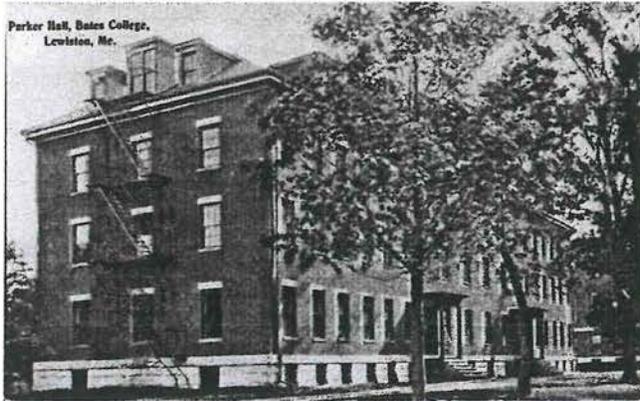
Fig. 116

Parker Hall, Bates College, was designed as a residence hall, with student rooms in the attic lit by individual dormer windows. Also, all students were required to provide their own stove, with the result that the roof line was punctuated in a rhythmical skyline pattern of chimney - dormer - chimney (Fig. 116). This roof line has been seriously compromised by the recent demolition of the original fabric and the construction of a full width, shed roof dormer that lacks scale, articulation and visual interest (fig. 117).

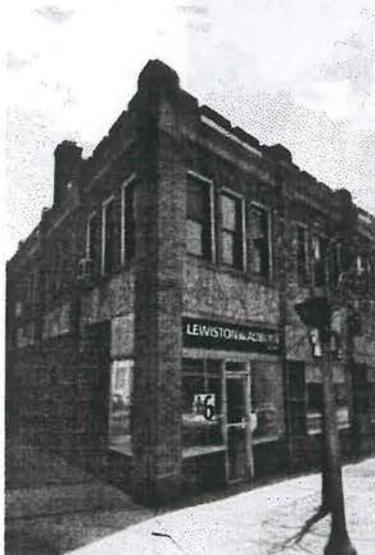
Fig. 118

Standard 5 is also concerned with the protection of the work of skilled craftsmen, as exemplified by the cast stone and concrete work at WCSH (Fig. 118), the glazed terra cotta panels at 195-205 Main Street (Fig. 119), and the exceptional use of pressed aluminum panels, black Carrera glass and exposed aggregate stucco at the Art Deco Lamey-Wellehan store (Fig. 120)

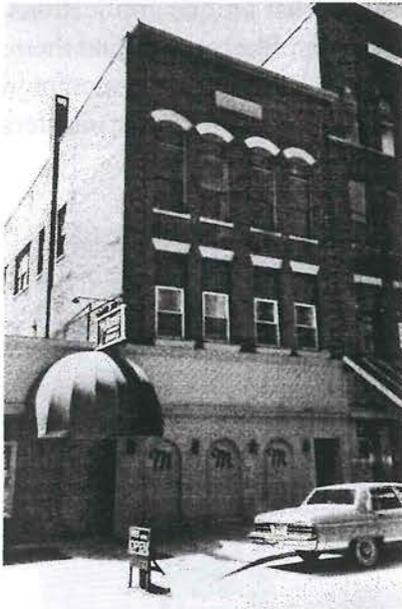
Fig. 123

The Greely Building (Fig. 123) has been altered by in-filling the openings at the second floor and the installation of 1/1 metal sash, the difference in the windows made readily apparent when contrasted with the original third floor units. In contrast to the Greely building, the four-story structure at 186 Lisbon Street has had the previously bricked-in third floor level windows recently restored. The owner simply copied the existing details found at the second and fourth floors, duplicating the casings, the center mullion and the 2/2 sash (Fig. 124)

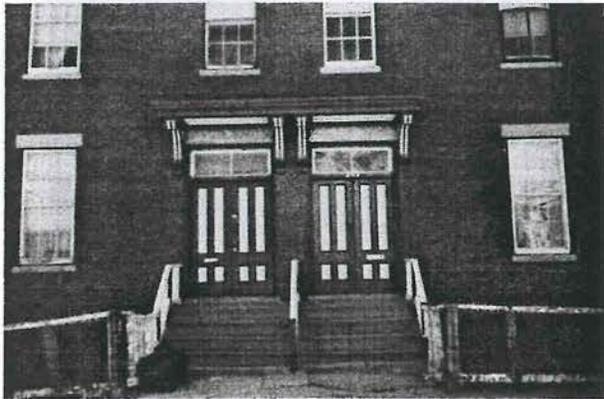
Fig. 125

The two photographs shown below are of two of the three remaining Androscoggin Mill Blocks on Park Street. Figure 125 shows the original double doors bracketed double entrance hood and wood stairs and entry porch. Figure 126 documents a number of unfortunate changes, including the removal of the double doors and the introduction of sidelights, the replacement porch in an inappropriate material, the addition of a second floor porch, and the replacement of the original wood hand railings with wrought iron. Ironically, the six-light flat transoms are original, not the two light design found at the left.

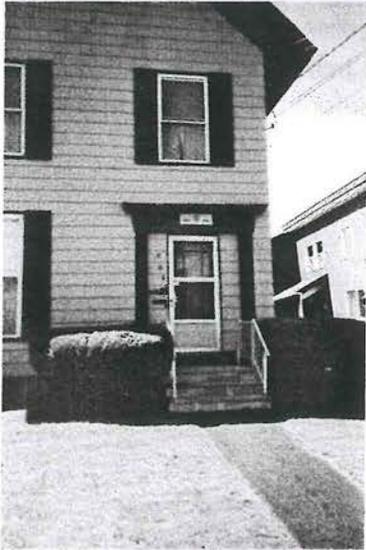
Fig. 127

In some cases, the entrance door has been replaced with a modern door, yet the original door enframing has been retained, as shown in Figures 127 and 128. Figure 129 illustrates the need to retain original materials when contemplating replacement, including but certainly not limited to porches, where brick replaced the original wood.

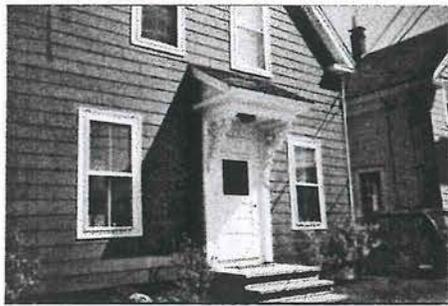
Fig. 130

As stated in Standard 6, deteriorated features should be repaired rather than replaced, and if replaced, they should be in-kind, the new design and material matching what is to be replaced. While much of the original fabric of the house shown as Figure 130 has been compromised by the application of artificial siding, great care was taken to preserve the exceptional sawn bracketed door hood. Unfortunately, no such care was given to the replacement of the original slender,

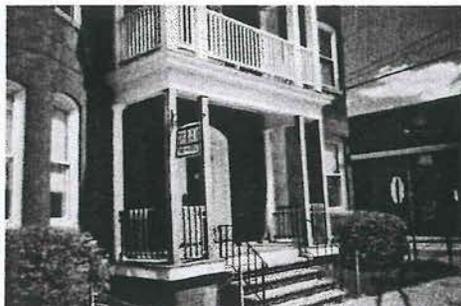
Fig. 131

round Doric columns at this front porch (Fig. 131). Figure 132 illustrates a well designed compromise to a problem concerning an entrance foyer designed to serve a local banking institution. The actual entrance to the bank is along the wall recessed behind the original facade of the bank, where the door has been removed from the original entrance and the entrance left open. This retains the original appearance of this excellent building while providing for better circulation and 24 hour access to the ATM.

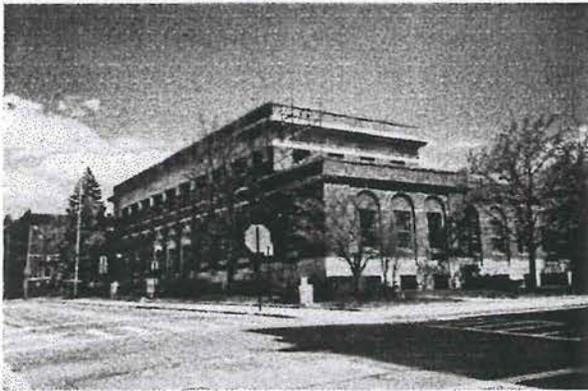
Fig. 138

Additions at either end of the Post Office duplicate the arched window bays, continue the water table and the belt course that divides the first and second floors of the original building, yet clearly read as later work (Fig. 138). An addition to the rear of a Greek Revival building retains the full entablature cornice and the size and trim of the windows at the front elevation, adding roof dormers to light the attic space (Fig. 139). Both photos illustrate the concept of compatibility yet subservience to the design qualities of the original building.

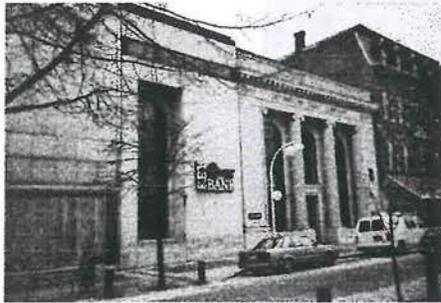
Fig. 140

An addition made to Key Bank (Depositors Trust Building) is perhaps the best example of a contemporary addition in Lewiston (Fig. 140). The new work matches materials, roof line, cornice line and two-story window opening, yet it does not copy the classic revival facade of the bank. A new facade next to the Music Hall (Fig. 141), attached to a greatly altered late 19th century shopfront, repeats the half-round window openings at the top floor of the Music Hall, retains the roof line of the earlier building while tying the eaves of the new roof to the flat roof of the one-story building to the left, reinforcing the horizontal line in the right section of the new building.

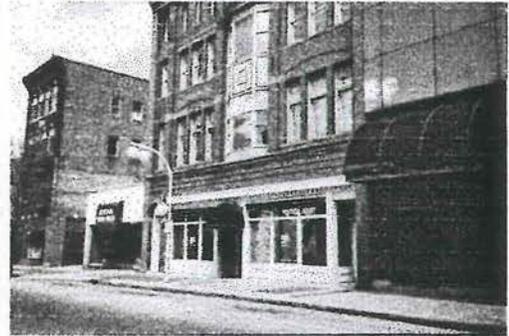
Fig. 142

The alteration of the first floor of the original Sands Building, designed to respect but not imitate the exceptional facade, is compatible because it repeats the three entrances and two rows of three shop windows, with transoms like those at the second floor, simulates in a contemporary manner the dentiled cornice at the roof and adds a simple first floor cornice to highlight the central bay unit and the excellent masonry of the original construction (Fig. 142).

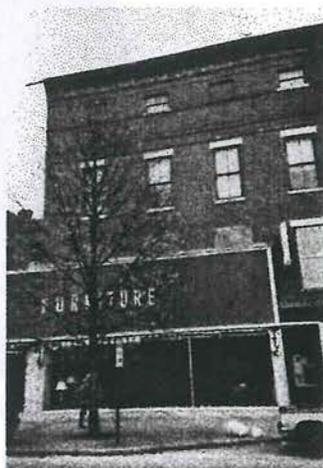
Fig. 146

without serious damage to the original brickwork), and at the left end of the College Block, a National Register listed building. Here the owner of a furniture store to the left extended his one-story aluminum and glass shopfront across the first three bays of the listed building, totally obliterating the ground floor and causing the blocking with brick of the three windows at the second floor level (Fig. 146).

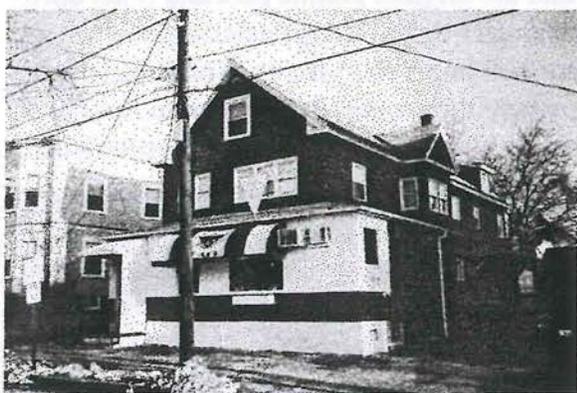
Fig. 147

The two photos below illustrate a reversible alteration (Fig. 147) and one that has destroyed the facades of two period buildings (Fig. 148). The restaurant shown at left has an in-filled front porch, which can be returned to its original condition and use since the front wall of the mixed use structure was not tampered with (the porch is a separate dining room). The two-building wide storefront at the right, however, is an extension of the first floor retail space. The front walls of both houses were removed to permit the expansion.

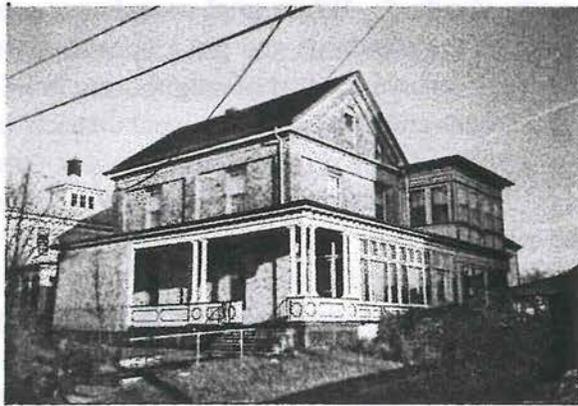
Fig. 149

Unlikely as it may appear at first glance, the drastic modifications to the Greek Revival residence shown in figure 149 are reversible. The wrap-around porch and the two story addition at the rear are both well designed but they virtually destroy the classical character of this interesting

structure. However, if so desired, both later features can be easily removed to expose the original design intent. Other additions are not so easy to correct, as witnessed by the addition made to the rear of an frame, L-shaped plan Italianate residence (Fig. 150).

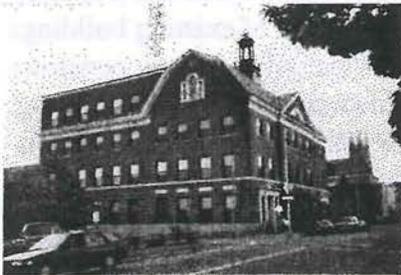
Fig. 151

A number of mid 20th century buildings have been put up in Lewiston that mimic an earlier style, many of which are incompatible with their surroundings. The design of the pseudo-Georgian style New England Telephone Company Building (Fig 151) was seriously compromised by the need to provide an enormous amount of floor space and volume. The massing, bulk, height and scale of this structure simply cannot be contained within a predominantly residential scale shell, a shell that rarely exceeds two to two-and-one-half stories in height

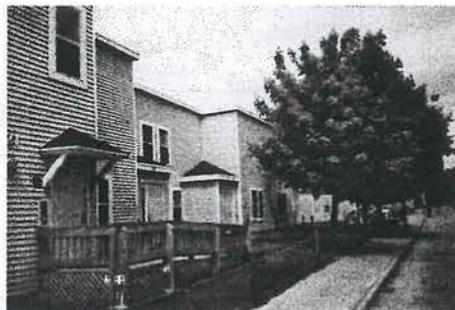
Fig. 155

The **width** of a structure is also controlled by city ordinance that establishes minimum and maximum side-yards for any site. In non-historic areas, simply subtracting the side-yard widths from the width of a particular lot will determine the maximum allowable coverage, or footprint, of a new building. Within a historic district, or contiguous to an individually listed property, this preliminary determination must be reviewed by the Review Board to insure compatibility with the width of neighboring buildings. In-fill being proposed within the Lower Lisbon Street historic district or otherwise along a commercial street, where buildings abut each other at the side lot line, must retain this spatial relationship, filling the street frontage. In such cases, however, the maximum width of any section of a proposed in-fill project should not exceed the average width of the surrounding structures. If an in-fill lot is wider than its neighboring lots, the mass of the facade can be visually diminished by breaking the elevation into a number of bays (Fig. 155) that are compatible with the width of the buildings on the rest of the block.

The compatibility of building widths, especially in a pedestrian related environment like the Lower Lisbon Street and the Kennedy Park historic districts, is critical to maintaining a sense of *rhythm*. The repetition of facade widths along a street frontage establishes a comfortable reference point for a walker. The principal of rhythm can best be experienced when walking along a row of shops, where the first floor has been separated into bays of a similar width, sometimes the width being a function of the common width of neighboring buildings, other times, such as at the Centennial Block on lower Lisbon Street (Fig. 156), created by the use of granite or cast iron piers set at regular, pedestrian related intervals. At the Music Hall (Fig. 157), the impact of the largest building in the downtown, 148 feet in width, has been moderated by dividing the facade into six 18 foot wide bays, each separated by heavy masonry piers.

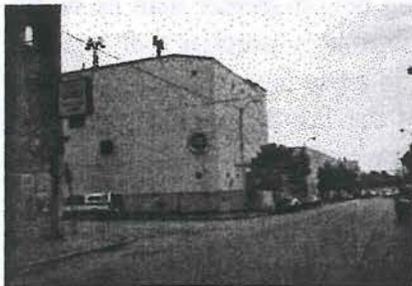
Fig. 158

**Scale and Massing** are also directly related to personal experience. Buildings are regarded as pedestrian in scale when they compliment the scale of man, colossal when they overwhelm a pedestrian. Scale and massing must be judged in context, however, as in the case of the Country Kitchen Bakery (Fig. 158) opposite the Lower Lisbon Street historic district. (This building is drastically out-of-scale in its present location, while their second bakery, of almost equal scale and massing, located between the Hill Mill and the Androscoggin Mill, is compatible with its surroundings.) Conversely, a building may be out of scale when it is too small for its surroundings, like the cottage shown in Figure 159 in Little Canada. Scale is determined by a perception of how a particular facade or detail relates to a human being. Traditionally sized windows and doors are easily comprehended as non-confrontational. Large scale shop windows or commercial entrances, unless they have been broken down in size and scale, do not relate as well (Fig. 160).

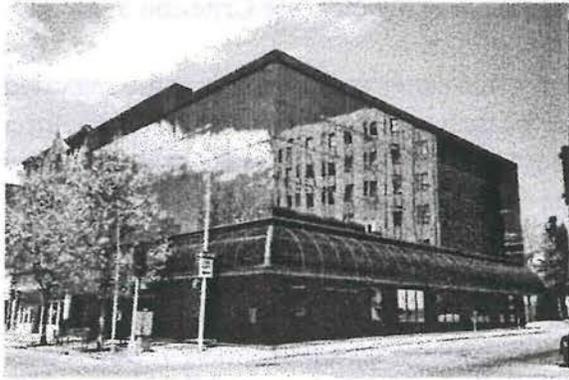
Fig. 161

The use of traditional building materials also contributes to the perception of a human scale—clapboards, shingles, stone and brick are of a comfortable, non-threatening scale, while porcelain or glass facades (Fig. 161) do not relate to either a human being or to the surrounding environment. Scale and massing is of great importance when designing new construction to be constructed in the city's residential neighborhoods, where an out-of-scale building can seriously compromise the visual appeal of the area. Even if height, setback, side yards and the use of materials are in conformance with building codes and the other standards and guidelines for new construction, the visual impact of an out-of-scale building, like that superimposed over an elevation of lower Lincoln Street, is obvious (Fig. 162).

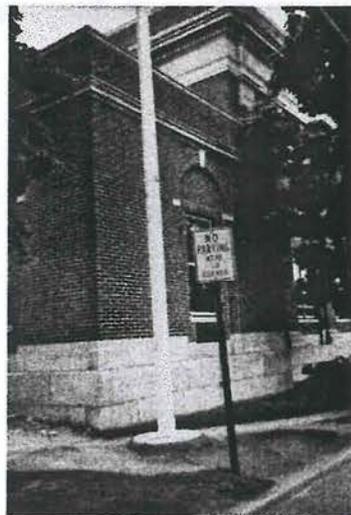
Fig. 167

New in-fill construction that either connects to or abutts a listed building must be designed so that there is a design link between the two units that clarifies the change in architectural design. Links are often a simple return, where an entire new wall is set back from the plane of an elevation of the old building, or an indentation as narrow as the width of a brick that provides a visual break between the old and the new. If the new building, or the link itself, is of a different material than the old, the link may also be flush with the wall of the old. The Lewiston Public Library (Fig. 166) and its connection to the Lisbon Street section, and the U. S. Post Office (Fig. 167) with its later flanking wings, are examples of a satisfactory link.

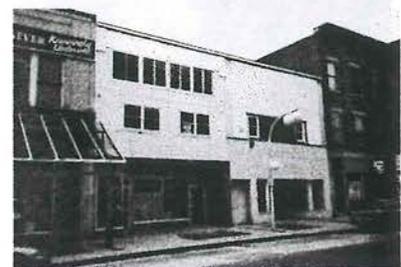
Fig. 171

It is also important that window and door openings be of the same proportion and orientation (usually vertical) as the openings in neighboring buildings. Figure 171, the two buildings contiguous to the Union Block illustrate a lack of rhythm, with distinctly horizontal window openings contrasting with the vertical openings at buildings on either side of these two structures. As such, these buildings are incompatible. Windows at new in-fill buildings should be a product of their own time. Vertical casements, 1/1 sash double hung windows, fixed sash and hopper or awning windows may be appropriate at some proposed buildings if all other considerations such as proportion, spacing and orientation have been satisfied. Windows that incorporate small sized panes of glass, in imitation of 18th century windows are discouraged..

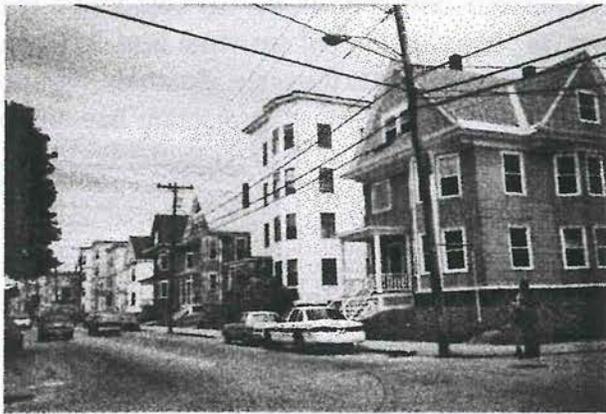
Fig. 172

The type of roof proposed for new in-fill construction will vary by specific location, as most of the residential streets, such as Bartlett Street, exhibit a number of roof forms, from cross-gable to flat to pedimented gable (Fig. 172). In such situations, any one of the three roof forms

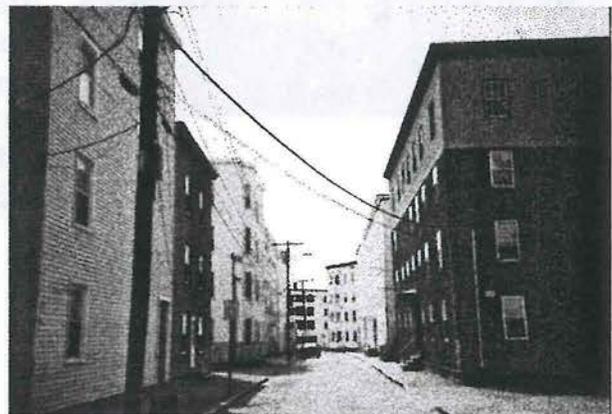
Fig. 173

would be acceptable, and the applicant should be allowed the freedom of selecting one that is compatible to the area. Little Canada, with one exception, consists entirely of flat roof structures (Fig. 173). New in-fill construction should reflect this trait by providing flat roofs, the flat roof further emphasized by a heavy cornice at approximately the same height as at neighboring structures. A section of lower Lincoln Street, shown in Figure 174, is primarily gable roof to the street, with the notable exception of the one flat roof building, a non-compatible roof form (as well having a non-conforming facade emphasis). Inherent in this criterion is the issue of orientation. The Lincoln Street block is primarily a row of houses that have gable roofs with the ridge lines perpendicular to the street, the roof forms create an interesting saw-toothed, rhythmical effect on the skyline. This should not be compromised. Conversely, this same sort of skyline interest has been achieved at the Lower Lisbon Street historic district. Here, with one exception, the roofs are

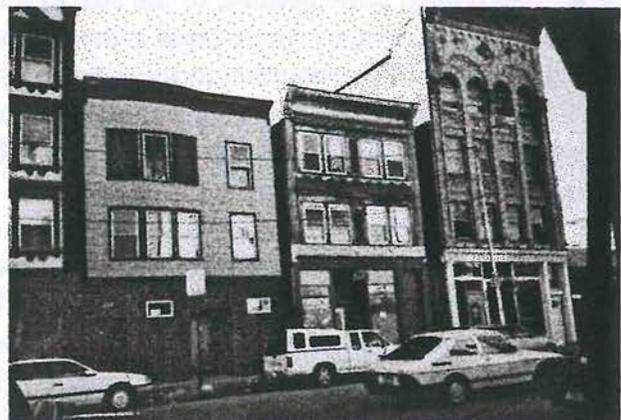
Fig. 175

flat or hidden behind horizontal parapets, but the skyline is made interesting by the changes in building heights (Fig. 175). Roof lines at in-fill construction should be simplified to reflect existing conditions. Dormers may be appropriate at gabled or hipped roofs, and flat, surface mounted skylights, if set to therear of the front elevation of the building may be considered.

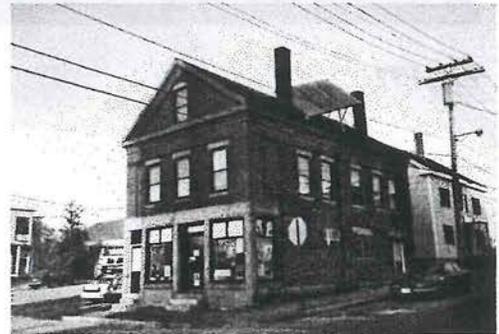
Fig. 181

While not specifically listed in Article XV, a sixth criterion will be addressed by the review board in their deliberations, **the placement and orientation of the in-fill structure on its lot.** Virtually all of the commercial and office buildings along Lisbon and Main streets occupied the entire width of the lot and were aligned along the sidewalk line in straight rows (Fig 181). The holes in the street-scape, or missing teeth, are the result of demolished buildings. Apartment

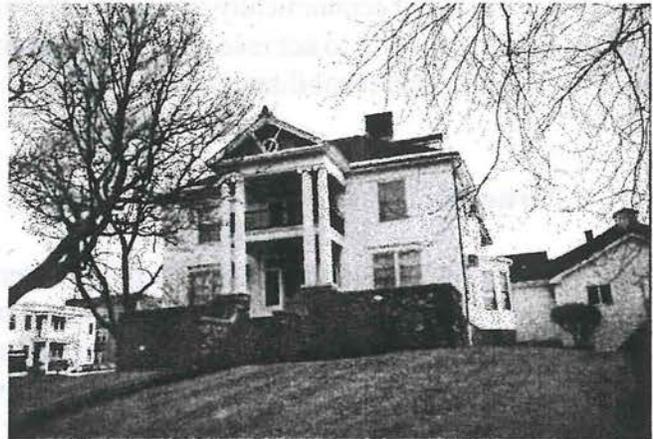
Fig. 185

New in-fill construction must relate to the existing conditions of the street-scape. As discussed above, new buildings along historically and visually important commercial streets should be designed so that they front directly on the sidewalk, without any side yards. The alignment and setbacks of residential in-fill should also follow existing conditions, but should be based on a site-specific street-scape. A section of a plate from the Sanborn Insurance Atlas (Fig. 184) illustrates a consistency regarding side yards and setbacks from the sidewalk, but also indicates “holes” in the street-scape (Fig. 185). In-fill proposed for either site should maintain the average setback of its neighboring structures.

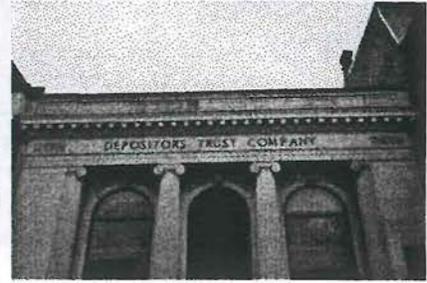
Fig. 194

Historic signs, such as the original name of a building (Sands Block, Odd Fellows Block, Kora Temple, Depositors Trust (Fig 194) and Lamey-Wellehan (Fig 195)) should be treated as historic artifacts and should be retained regardless of the current owner's or tenant's name. This includes early signs and advertising that have been painted directly on the wall surface (Fig. 196). In such cases, the original signs should not be counted as a part of the aggregate total for the area of signs permitted at a specific facade (see comments related to Section 2. b., below).

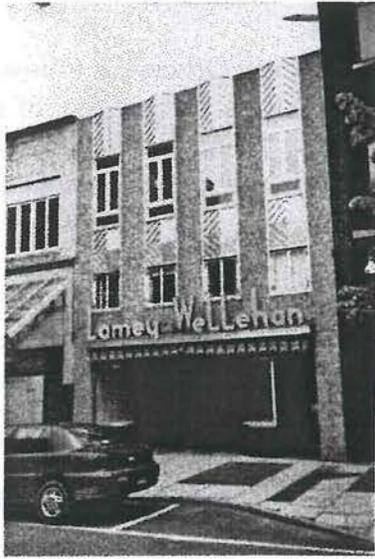
Fig. 195

**Materials** must be of the highest quality to withstand weather conditions. Exterior grade plywood for sign panels, cast bronze or brass applied lettering, painted sheet metal formed into letters that compliment the design of the facade (as in the case of the sign at the Art Deco Lamey-Wellehan building on Lisbon Street), and wood signs where the type has been incised are all appropriate. Also acceptable for use on a contemporary building within a historic district are letters and symbols of cut plastic or other durable material if they are applied directly to a wall surface (Fig 197). Internally illuminated thermo-formed lettering, signs meant to appear rustic in character, and imitation stained and leaded glass will be discouraged for use at a listed or a contributing building. Millwork used as borders of wall or projecting signs should have profiles related to the architectural style of the facade, or be of simple rectangular section. The outline of the sign panel should also reflect the architectural style of a facade, not as shown in Figure 198, a late eighteenth century "Chippendale" profile used at a mid-nineteenth century National Register listed building. The street address sign at Key Bank (Fig. 199), is a good example of relating a sign to its facade, in this case by making the sign the same size as one of the ashlar blocks on which it is placed.

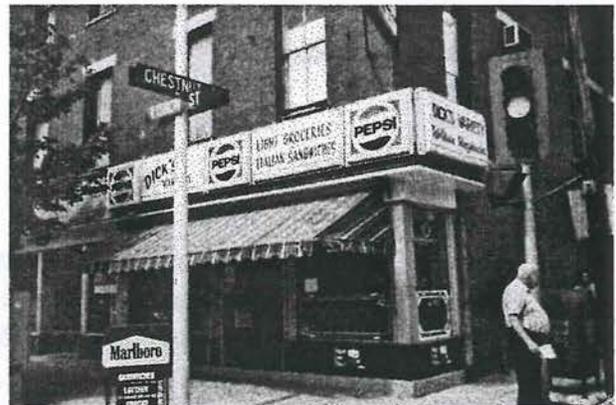
Fig. 201

**Comments and recommendations:** Because of the recent introduction of a number of small, so-called pocket parks and pedestrian walkways, especially along Lisbon Street (Fig. 201), the Review Board will also be concerned with signs that are visible from a publicly owned and maintained pedestrian way.

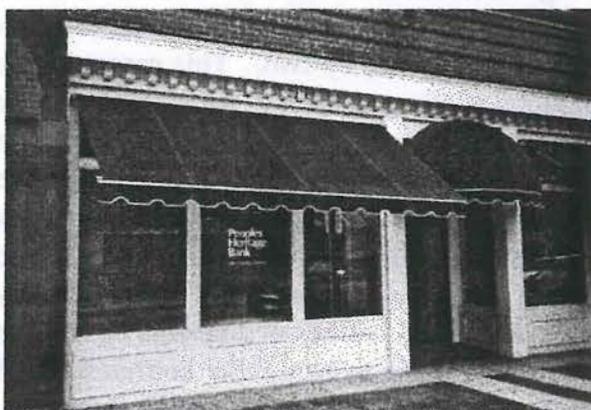
Fig. 202

**Comments and recommendations:** While back-lit signs are not permitted in the three residential zoning districts, there is no such clause regarding back-lit signs in non-residential districts. The Review Board will examine all such signs proposed for use at a listed building or within the total area of a historic district to assess their compatibility with the visual environment (Fig. 202).

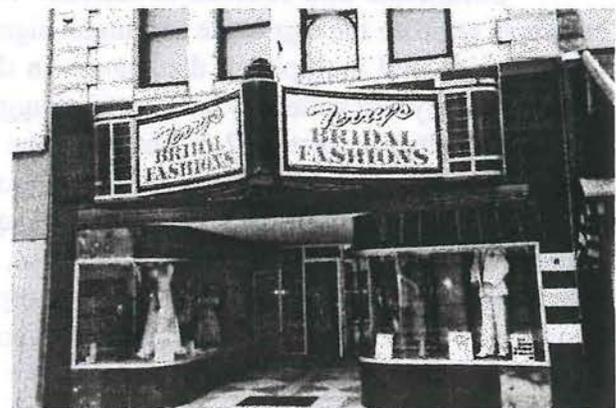
Fig. 203

**Section c. 2. 1.** identifies types of permanent signs that are permitted in non-residential zoning districts awnings, (Fig. 203), marquee signs (Fig. 204), projecting signs (Fig. 205) wall signs, and window signs, examples of each type existing along the length of Lisbon Street and contributing to the visual environment. An early postcard of Lisbon Street (Fig 206) shows the vitality and pedestrian scale established by awnings and signs.

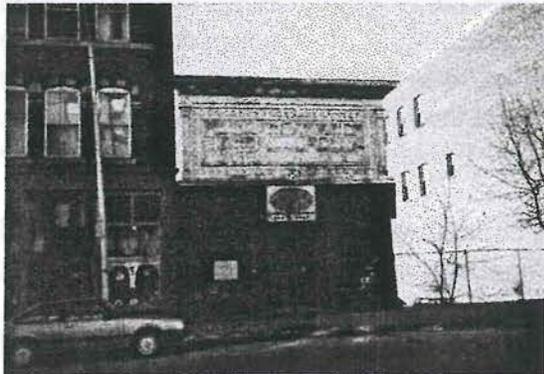
Fig. 210

**Comments and recommendations:** Most sign ordinances for historic districts or listed buildings regulate the aggregate maximum sign area per property by measuring the overall width of the facade and multiplying that figure, in the majority of cases, by two. This means that a building twenty feet wide may have up to an aggregate total of 40 square feet of signs. While either the 5% rule cited in Section 2. b. above, or the linear foot times two rule will most likely protect facades from being over-signed, the linear foot method is the simpler way of establishing size limits. The placement of the hypothetical 40 square feet of signs must satisfy the sign guidelines discussed above regarding location. Therefore, it is possible that the maximum allowable signage may not be approved by the Review Board, especially if the proposed location of a sign visually obstructs or will cause physical damage to important architectural features of a facade, or the sign does not conform to the rule that restricts the placement of signs to below the bottom edge of seconds floor window sills. Further, special requirements for signs within office residential zoning areas require that no part of any sign may extend above the roof level of a flat roof or the eaves of any other type of roof, except signs are allowed on lower mansard roofs and false fronts (Fig. 210).
